# DENDROBIUM MINE – LW11 EOP REPORT

# LW11 EOP REPORT

**ILLAWARRA COAL**  
 DENDROBIUM COLLIERY - AREA 3B  
 LONGWALL 11 END OF PANEL REPORT  
 GENERAL LAYOUT & MONITORING LINES

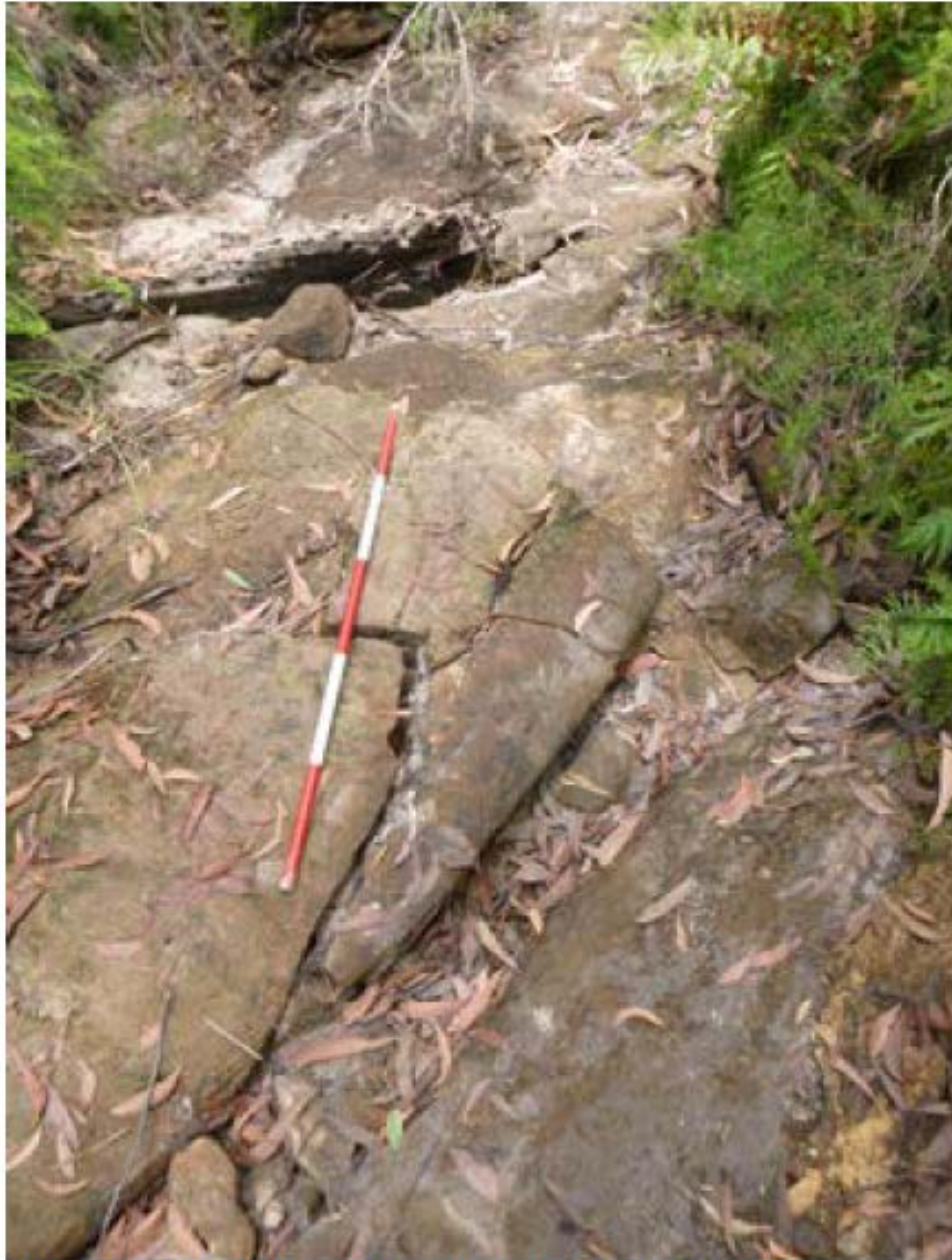
**Photo 5:** DA3B\_LW11\_008- Rock fracture, looking upstream along WC21. Taken on 14/01/2016.

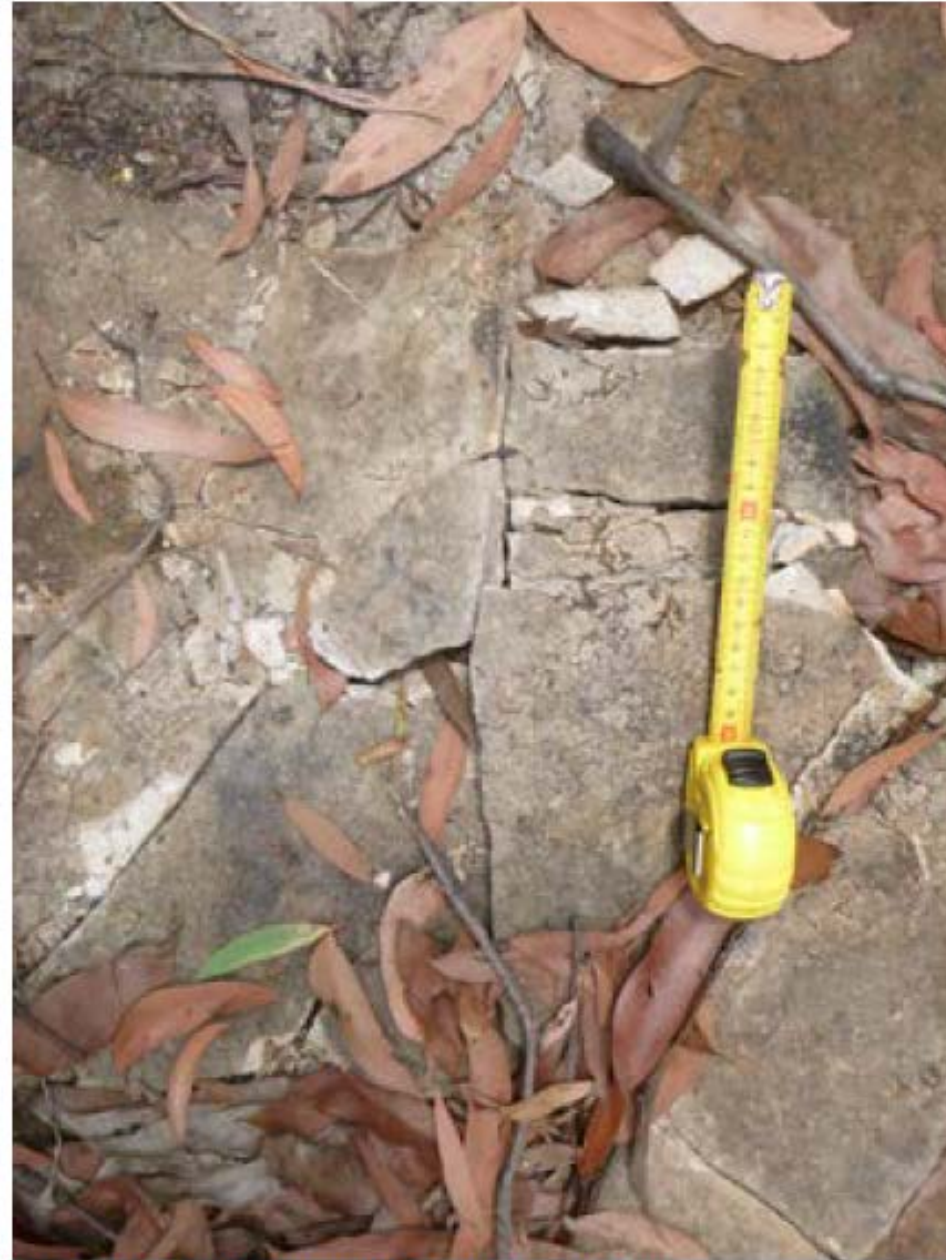
**Photo 6:** DA3B\_LW11\_008- Rock fracture, looking along WC21. Taken on 14/01/2016.

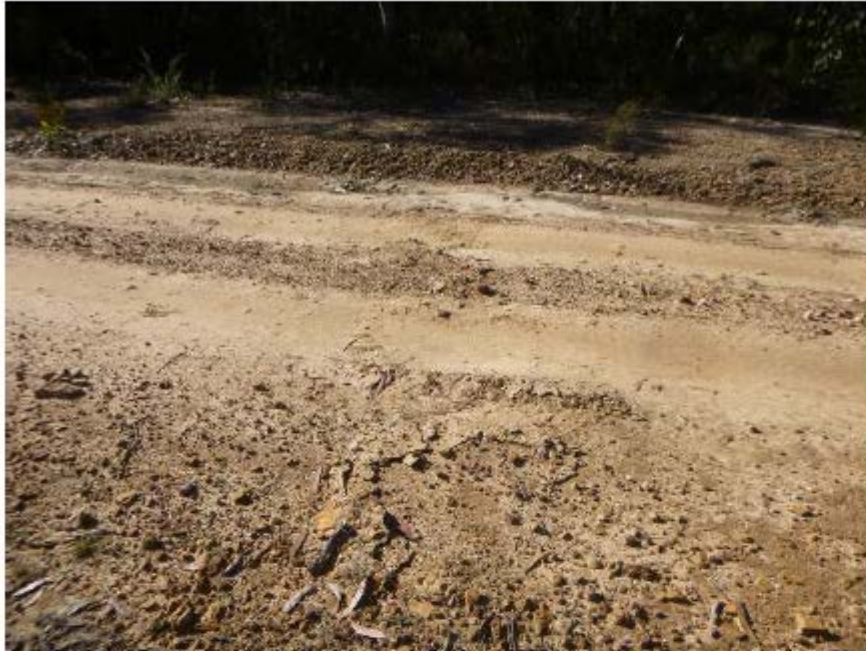
**Photo 13:** DA3B\_LW11\_001- Soil crack across Fire Road 6A. Uplift on the southern side of crack is only slightly evident in the photo. Taken on 1/06/2015.

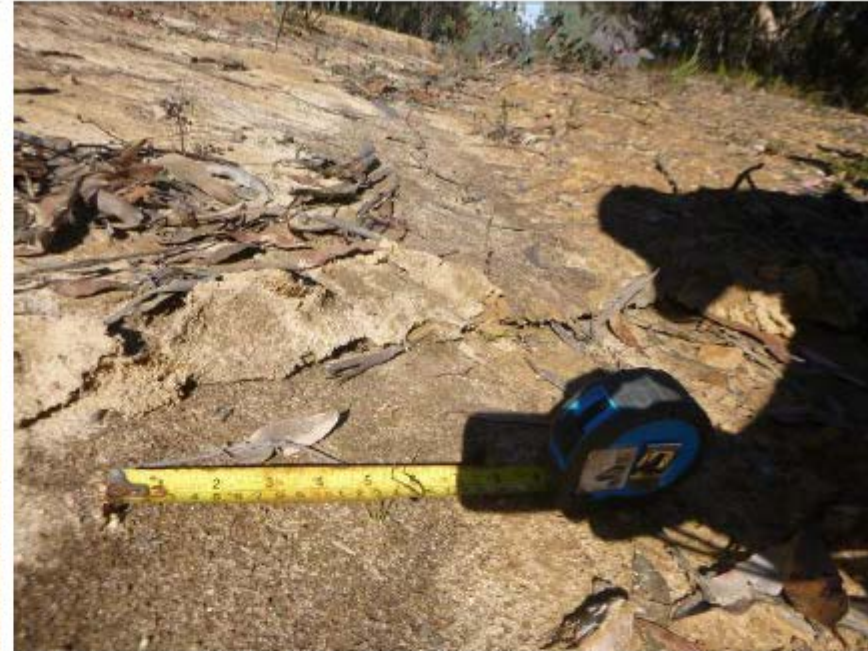
**Photo 14:** DA3B\_LW11\_001- Uplift on southern side of crack. Taken on 1/06/2015.

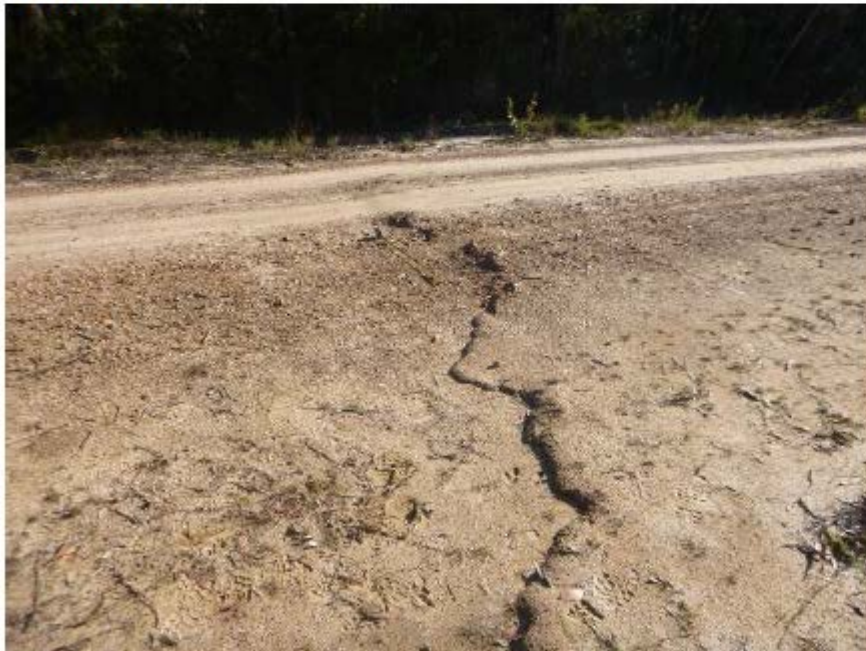
**Photo 15:** DA3B\_LW11\_002- Soil crack across Fire Road 6A. Uplift evident on the northern side of crack, more pronounced to the east of Fire Road 6A. Taken on 1/06/2015.

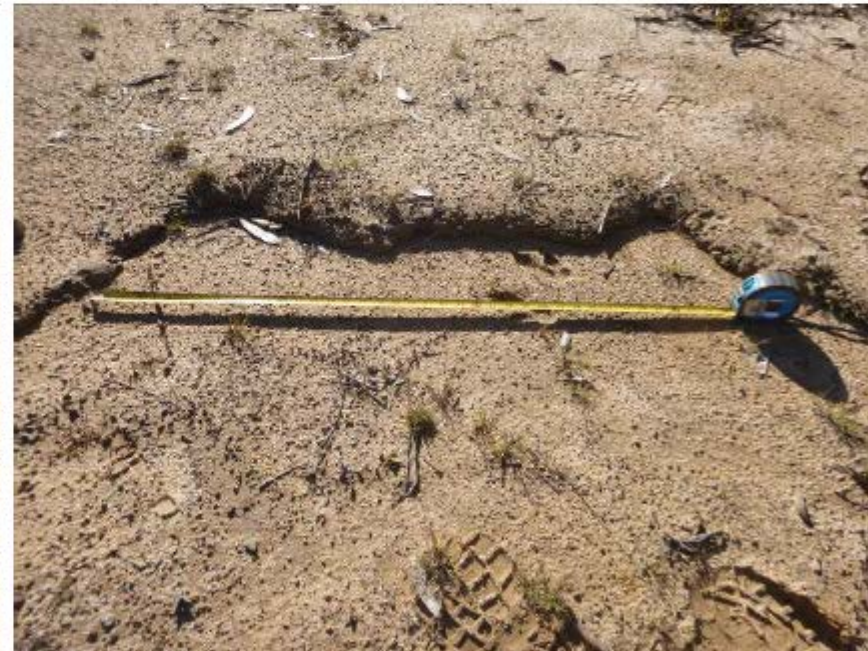
**Photo 16:** DA3B\_LW11\_002- Eastern end of soil crack. Taken on 1/06/2015.

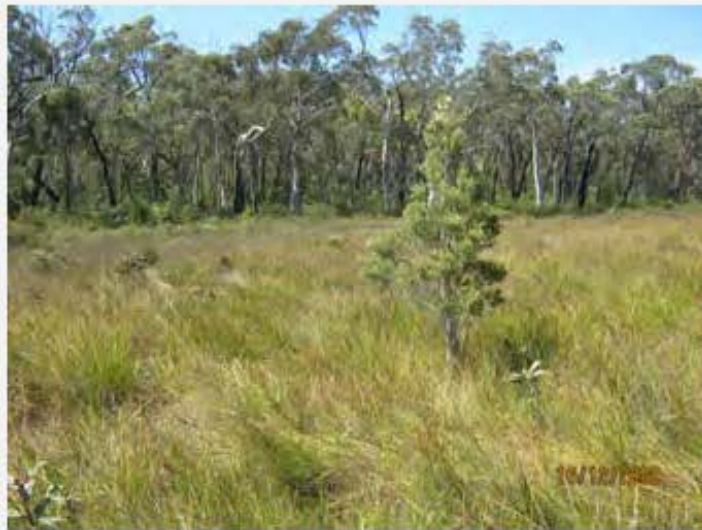
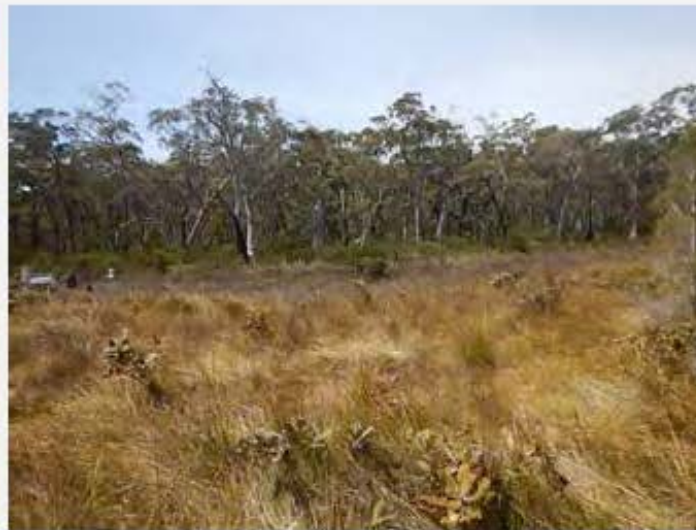
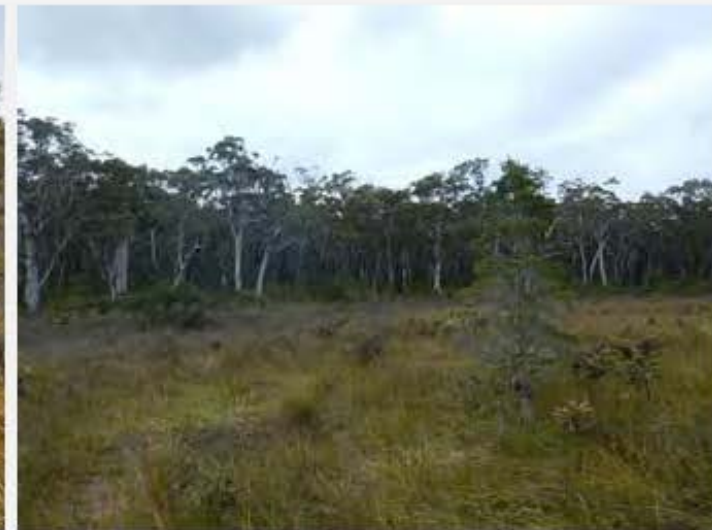
**Plate 3 Comparison of vegetation colouration at S1B-F2 South between spring 2009, spring 2014 and spring 2015.**
