**Re: Dendrobium Colliery Longwall 14 End of Panel Report - Aboriginal Heritage Assessment (#4872)**

## 1. Aboriginal Heritage Assessment

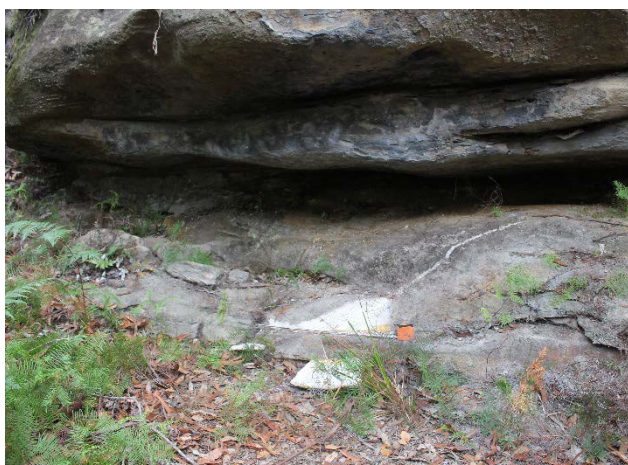
AHIMS site numbers	Site name	Results of inspections
52-2-1626	Browns Road Site 11	This shelter had visible impacts from subsidence movements. The impact is comprised of one main area of rock fracturing. Diagonal and vertical cracking are contained to the southern end of the floor of the shelter, including minor block fall. No lateral movement or opening of joints were visible within the shelter site. The sandstone shelter is actively exfoliating, possibly expedited by subsidence movements. Further localised cracking was observed to the north of the shelter, within a shared ridgeline. Cracking within the southern floor area measured to an approximate length of 0.7m and maximum width of 0.03m. The site was undermined by Longwall 14 on 28 January 2019. The two art panels remain in the same condition as described in Biosis Research 2011, and 2007. Macro vegetation was observed growing within the natural joint lines of the shelter.

**Plate 1: General Photo of Browns Road Site 11.**

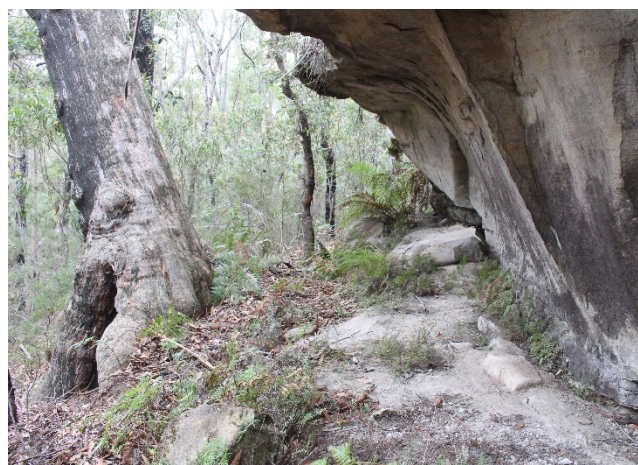
**Plate 2: General Photo of Browns Road Site 11 facing south.**

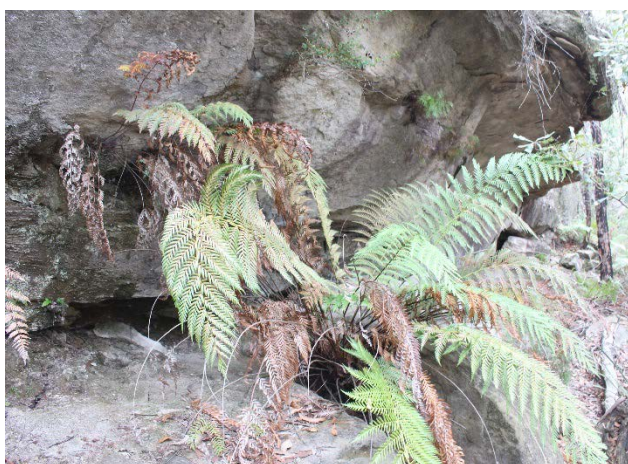
**Plate 3: General Photo of Browns Road Site 11 facing north.**

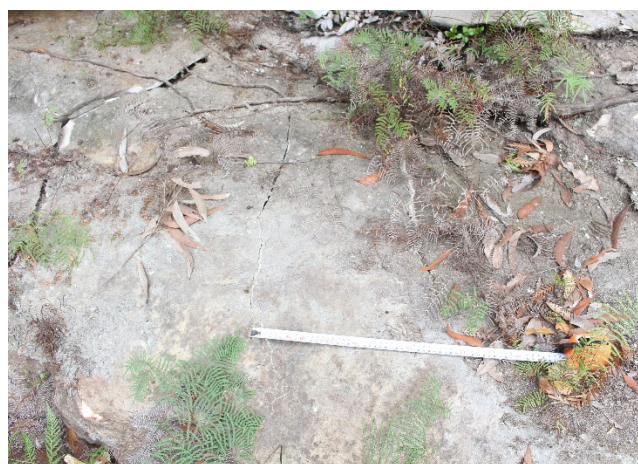
**Plate 4: Subsidence cracking north of the shelter.**

Recommendations	
	<b>Browns Road Site 11 (AHIMS ID# 52-2-1626) and Site 1 DB 1 (AHIMS ID #52-22229)</b>
1.	Notify relevant specialists and key stakeholders (e.g Aboriginal community groups).
2.	Continue monitoring program with condition assessment and photographic records As Per TARPS.

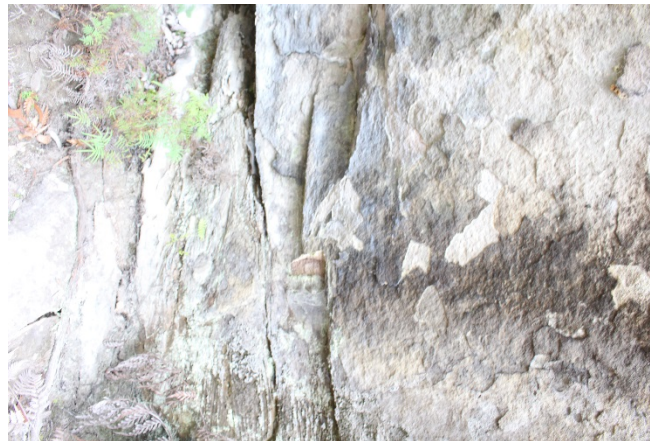
**Plate 6: Bedding planes located in the centre of the shelter.**

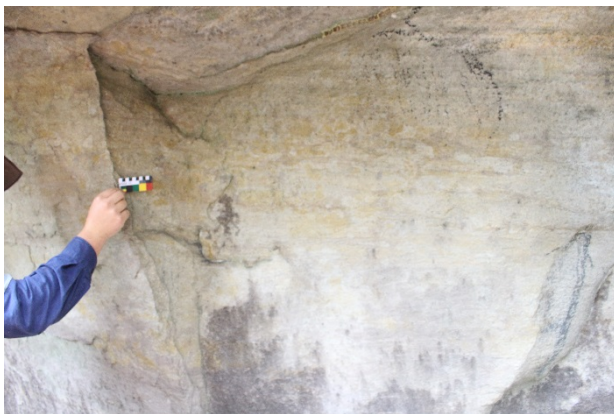
**Plate 7: Panel 1 Indeterminate charcoal motifs and charcoal eel motif.**

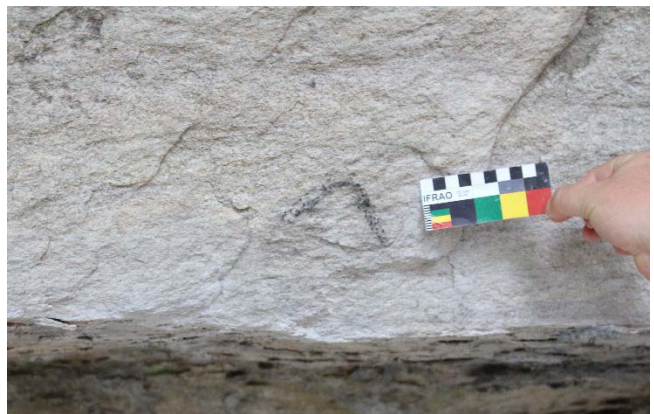
**Plate 8: Panel 1 Indeterminate charcoal.**

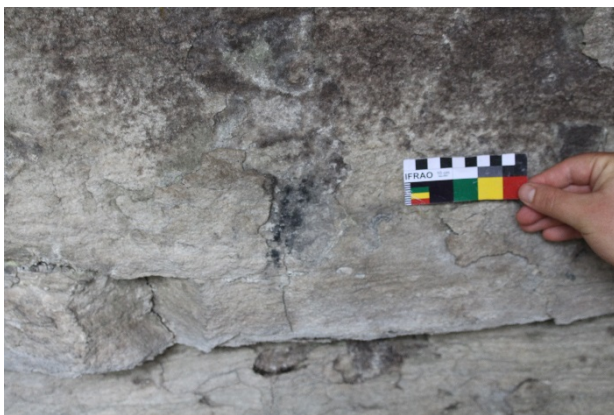
**Plate 9: Panel 1 Indeterminate charcoal.**

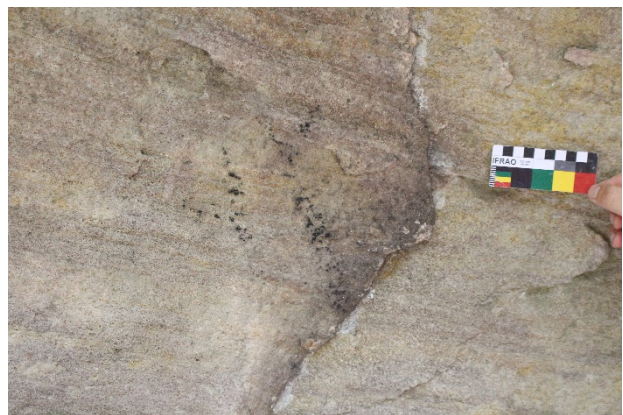
**Plate 10: Panel 2 Indeterminate charcoal.**

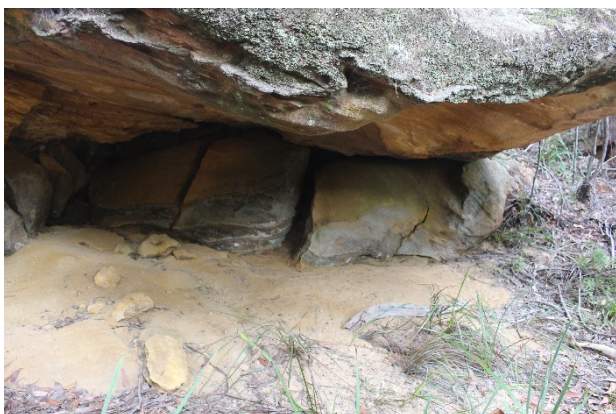
AHIMS site numbers	Site name	Results of inspections
52-2-2229	Site 1-DB1	This shelter had visible impacts from subsidence. The impact is comprised of two rock fractures with the largest having a maximum measurable length of 1m, and a maximum width of 0.03m. The fracturing is located within the back wall of the Aboriginal Site 1-DB1, this site comprises of a sandstone shelter containing art on the roof area. The shelter is 4.5m in length, 2m wide, 1.2m high with a sanded floor. The art is not directly impacted by the fracture, which is contained to the underlying, disconnected rock. The site was undermined by Longwall 14 on 28 January 2019. Access to the site was restricted during mining due to safety concerns. The art panel remains in the same condition as described in Biosis Research 2008, and 2009.

**Plate 11: General Photo of Site 1-DB1.**

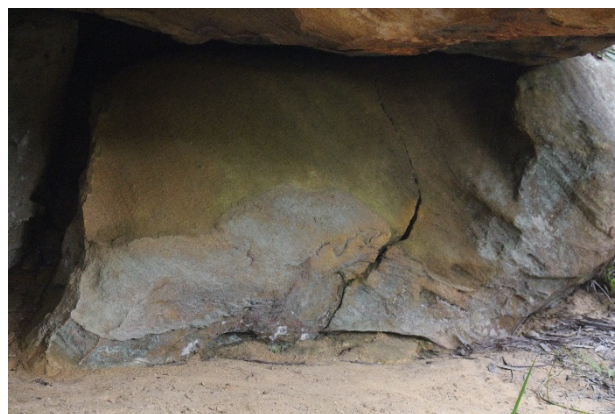
**Plate 12: Subsidence related cracking to the northern side of the shelter.**

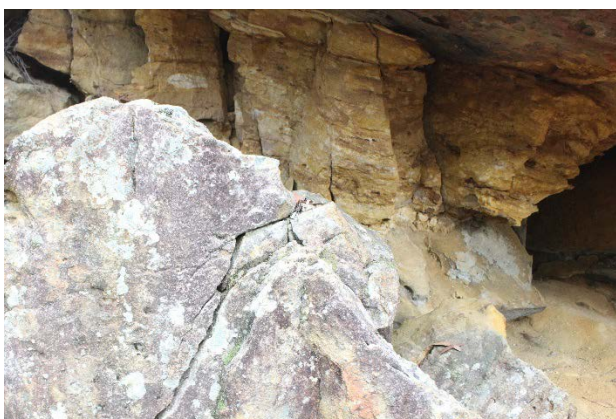
**Plate 13: Subsidence related cracking on the back wall of the north side of the shelter.**

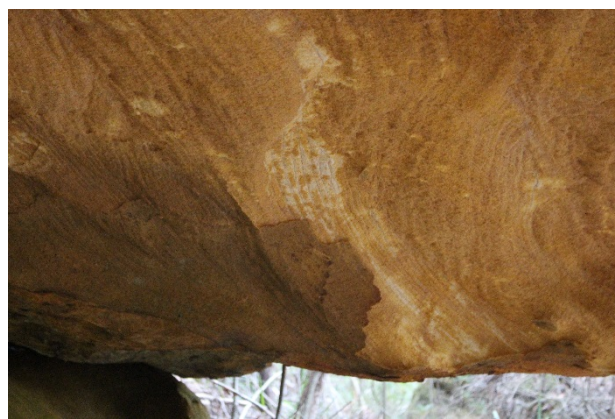
**Plate 14: Subsidence related cracking to the northern side of the shelter.**

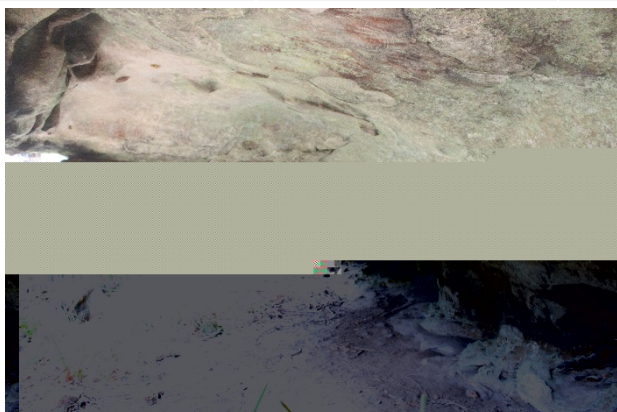
AHIMS site numbers	Site name	Results of inspections
52-2-3645	DM21	<p>This shelter was in the same condition as described by Biosis in 2011. There has been no movement of the horizontal bedding plane joints of the shelter and no cracking or exfoliation observed in relation to the extraction of Longwall 14.</p> <p>There has been no altered seepage or water movements in the shelter, and there is no evidence of water flow or recent micro-vegetation growth associated with any movement.</p> <p>The art panel remains in the same condition as described in Biosis Research 2008, and 2011.</p>

**Plate 15: General Photo of DM21 facing east. Panels 1, 2 and 3.**

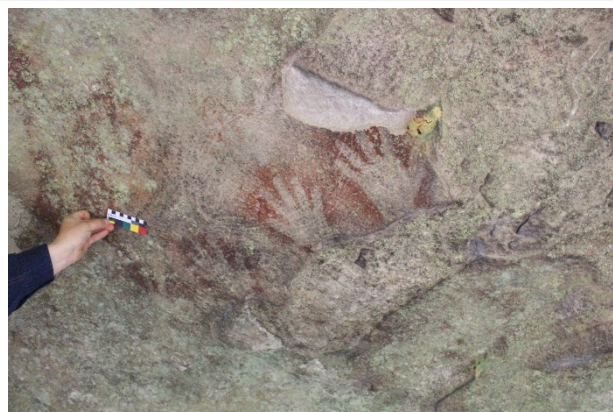
**Plate 16: Location of Panel 3, red ochre stencils with circular etching.**

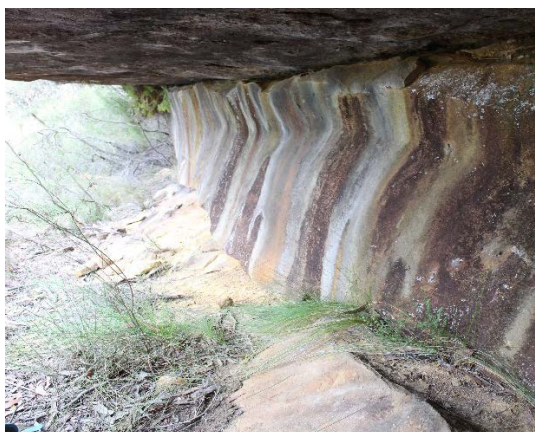
AHIMS site numbers	Site name	Results of inspections
52-2-3646	DM22	<p>This shelter was in the same condition as described by Biosis in 2011. There has been no movement of the horizontal bedding plane joints of the shelter and no cracking or exfoliation observed in relation to the extraction of Longwall 14.</p> <p>There has been no altered seepage or water movements in the shelter, and there is no evidence of water flow or recent micro-vegetation growth associated with any movement.</p> <p>The art panel remains in the same condition as described in Biosis Research 2007, and 2013.</p>

**Plate 17: General Photo of DM22 facing east.**

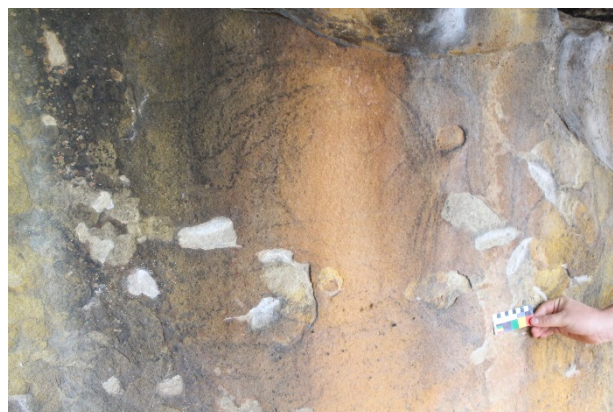
**Plate 18: Panel 1, charcoal outline of anthropomorphic figure and Panel 2, charcoal indeterminate.**

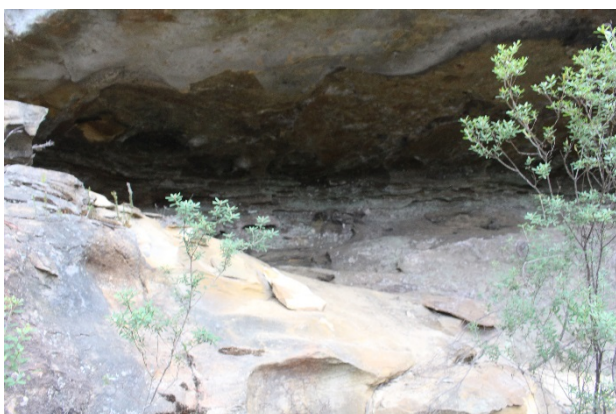
AHIMS site numbers	Site name	Results of inspections
52-2-1773	Upper Avon 37	<p>This shelter was in the same condition as described by Biosis in 2011. There has been no movement of the horizontal bedding plane joints of the shelter and no cracking or exfoliation observed in relation to the extraction of Longwall 14.</p> <p>There has been no altered seepage or water movements in the shelter, and there is no evidence of water flow or recent micro-vegetation growth associated with any movement.</p> <p>The artefact could not be relocated.</p>

**Plate 19: General Photo of Upper Avon 37 facing east.**

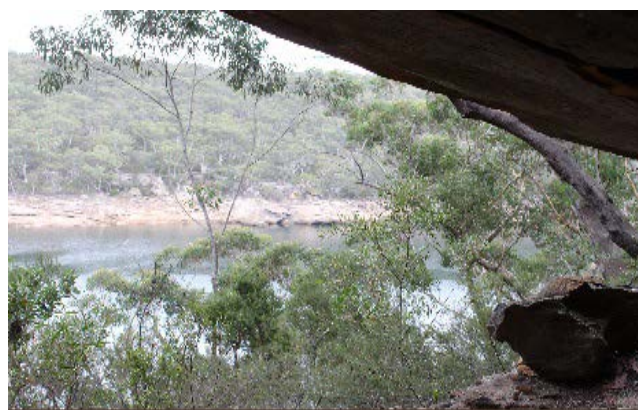
**Plate 20: General Photo of Upper Avon 37 facing south towards Lake Avon.**
