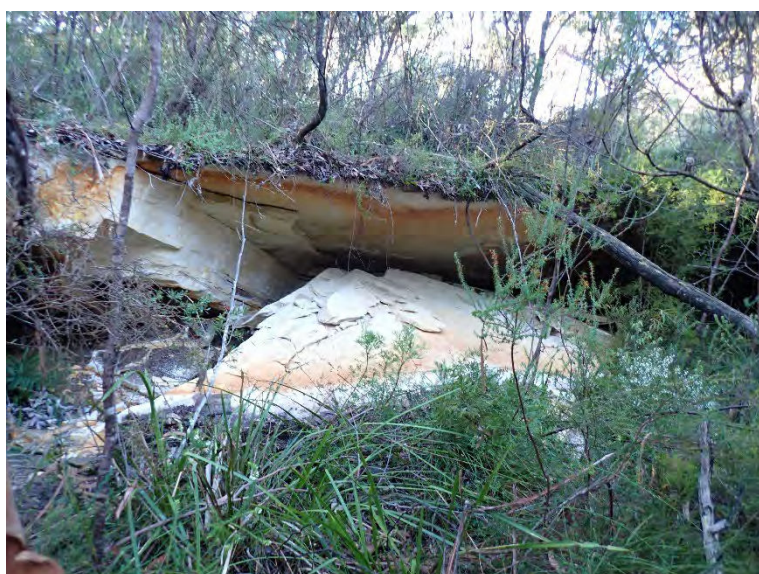
Impact *DA3C_LW21_016* was first observed on 11 July 2023 and consisted of a small rock fall ($\approx 0.14\text{m}^3$) at a step 10m north of tributary WC20 (Figure 1). On a follow up inspection on 26 July 2023, an increase in the rockfall area was identified. The following measurements were estimated at a distance due to safety concerns. The rockfall now has a length of $\approx 7\text{m}$, a width of $\approx 1\text{m}$, a height of $\approx 2.5\text{m}$, a total volume of $\approx 17.5\text{m}^3$ and a ground disturbance area of $\approx 20\text{m}^2$ (Photo 1 and Photo 2). Flagging tape is in place at the site as a safety precaution. Note- coordinates have been updated from previous report to better reflect the impact location.

DA3C_LW21_016 is now a Level 2 trigger as per the Dendrobium Landscape TARP (Table 1), specifically:

- Rockfall or overhang collapse at a cliff (step) site, where characteristics of the cliff have changed, and there has been significant ground disturbance.

Photo 1: *DA3C_LW21_016*, looking at the rockfall.
Taken on 26/07/2023.

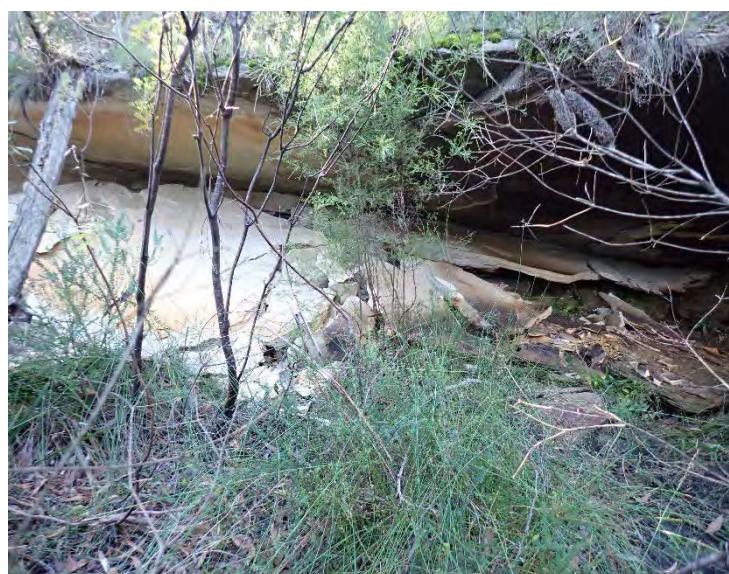
Photo 2: *DA3C_LW21_016*, looking at the rockfall.
Taken on 26/07/2023.

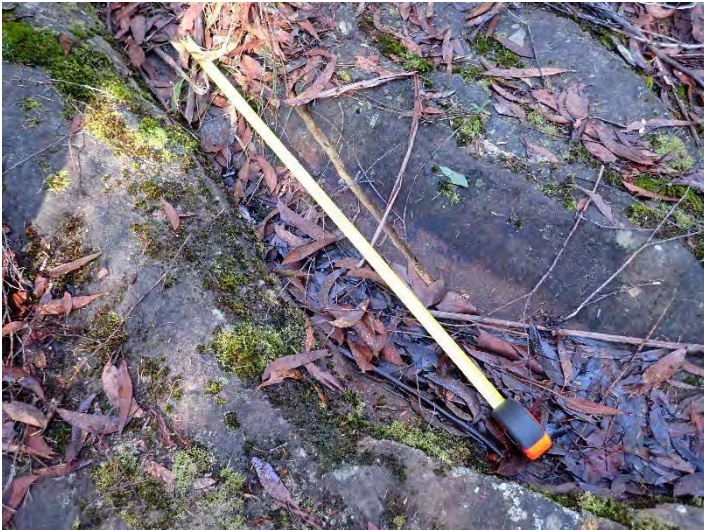
Impact *DA3C_LW21_017* consists of rock fracturing and uplift to 'WC20_Rockbar 15' on tributary WC20 (Figure 1). The fracturing has a maximum length of 2.6m, a maximum width of 0.012m and uplift of 0.02m (Photo 3 to Photo 6). No surface flow was present during the inspection however the impact is not situated in the direct flow path, therefore flow diversion is unlikely to occur.

DA3C_LW21_017 is a Level 1 trigger as per the Dendrobium Watercourse TARP (Table 2), specifically:

Photo 3: *DA3C_LW21_017*, section of rock fracturing.
Taken on 26/07/2023.

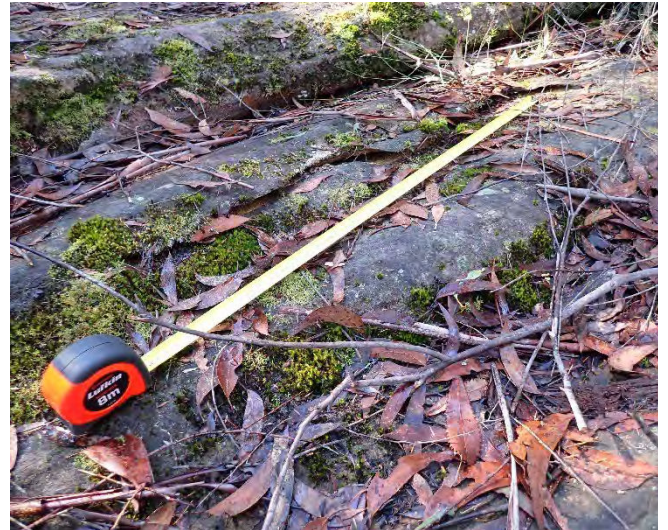
Photo 4: *DA3C_LW21_017*, section of rock fracturing.
Taken on 26/07/2023.

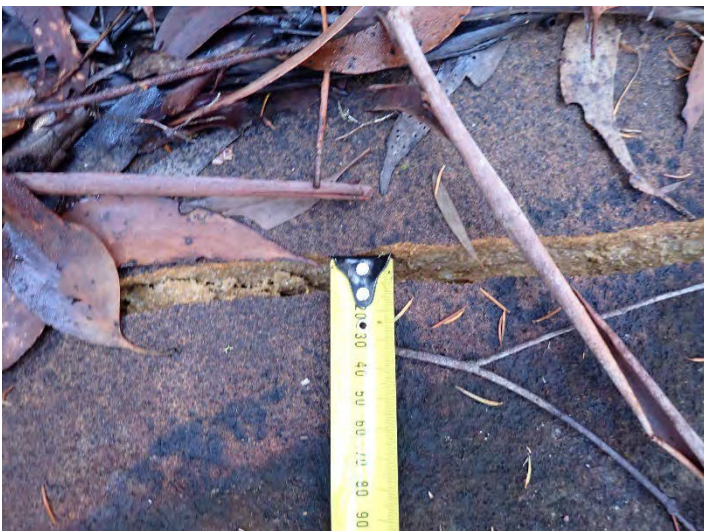
Photo 5: *DA3C_LW21_017*, width of the rock fracture.
Taken on 26/07/2023.

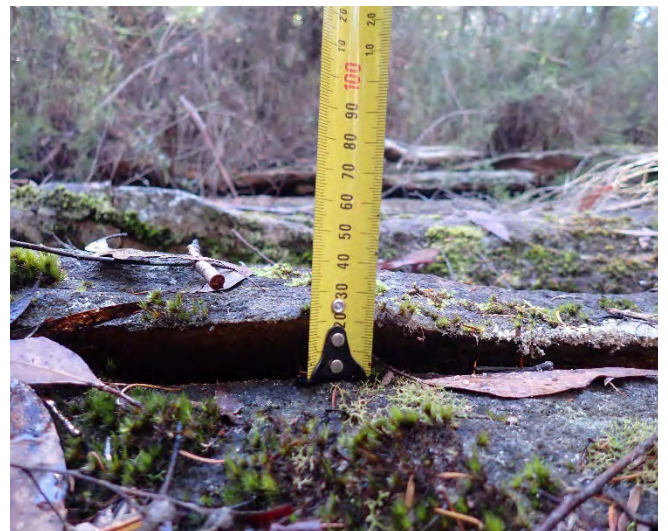
Photo 6: *DA3C_LW21_017*, section of uplift.
Taken on 26/07/2023.

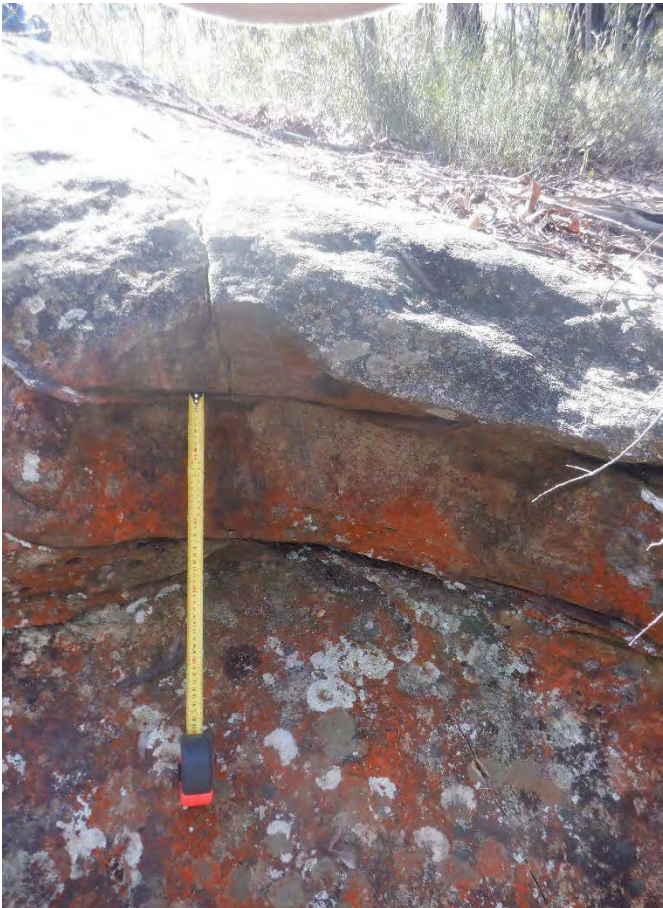
DA3C_LW21_018 is located approximately 105m north of tributary WC20 (Figure 1). The impact consists of two rock fractures to a rock outcrop/ledge. The fracturing has a maximum continuous length of 2.87m and a maximum width of 0.003m (Photo 7 to Photo 9). Flagging tape is in place at the site as a safety precaution.

DA3C_LW21_018 is a Level 1 trigger as per the Dendrobium Landscape TARP (Table 1), specifically:

Photo 7: DA3C_LW21_018, overview of rock fracturing.
Taken on 26/07/2023.

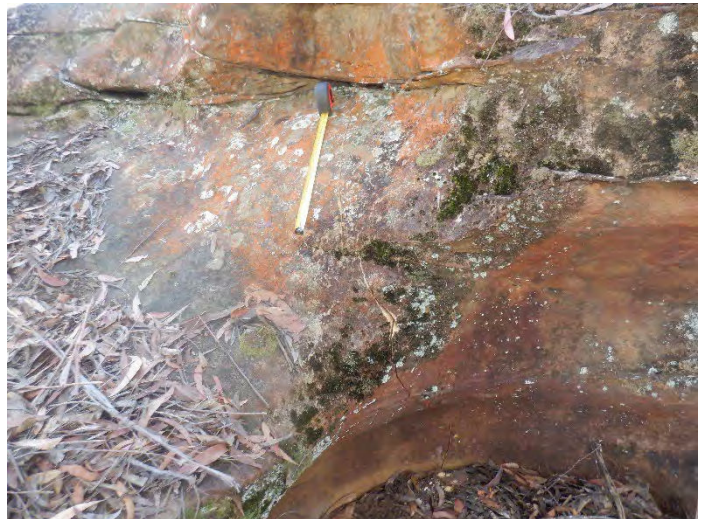
Photo 8: DA3C_LW21_018, section of rock fracturing.
Taken on 26/07/2023.

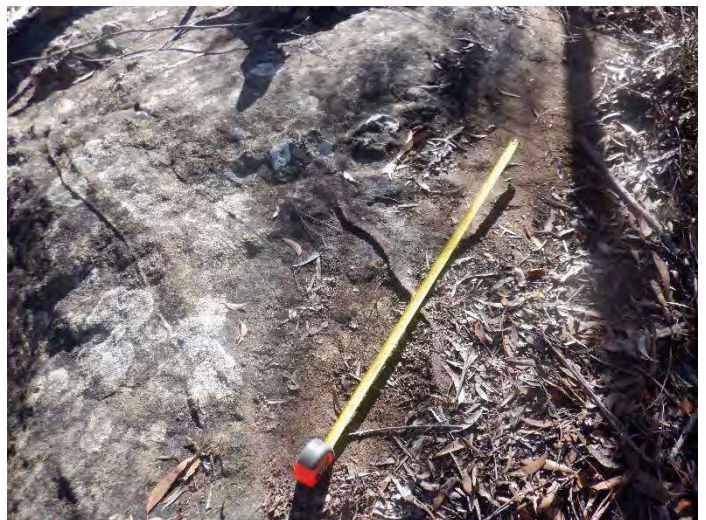
Photo 9: DA3C_LW21_018, section of rock fracturing.
Taken on 26/07/2023.

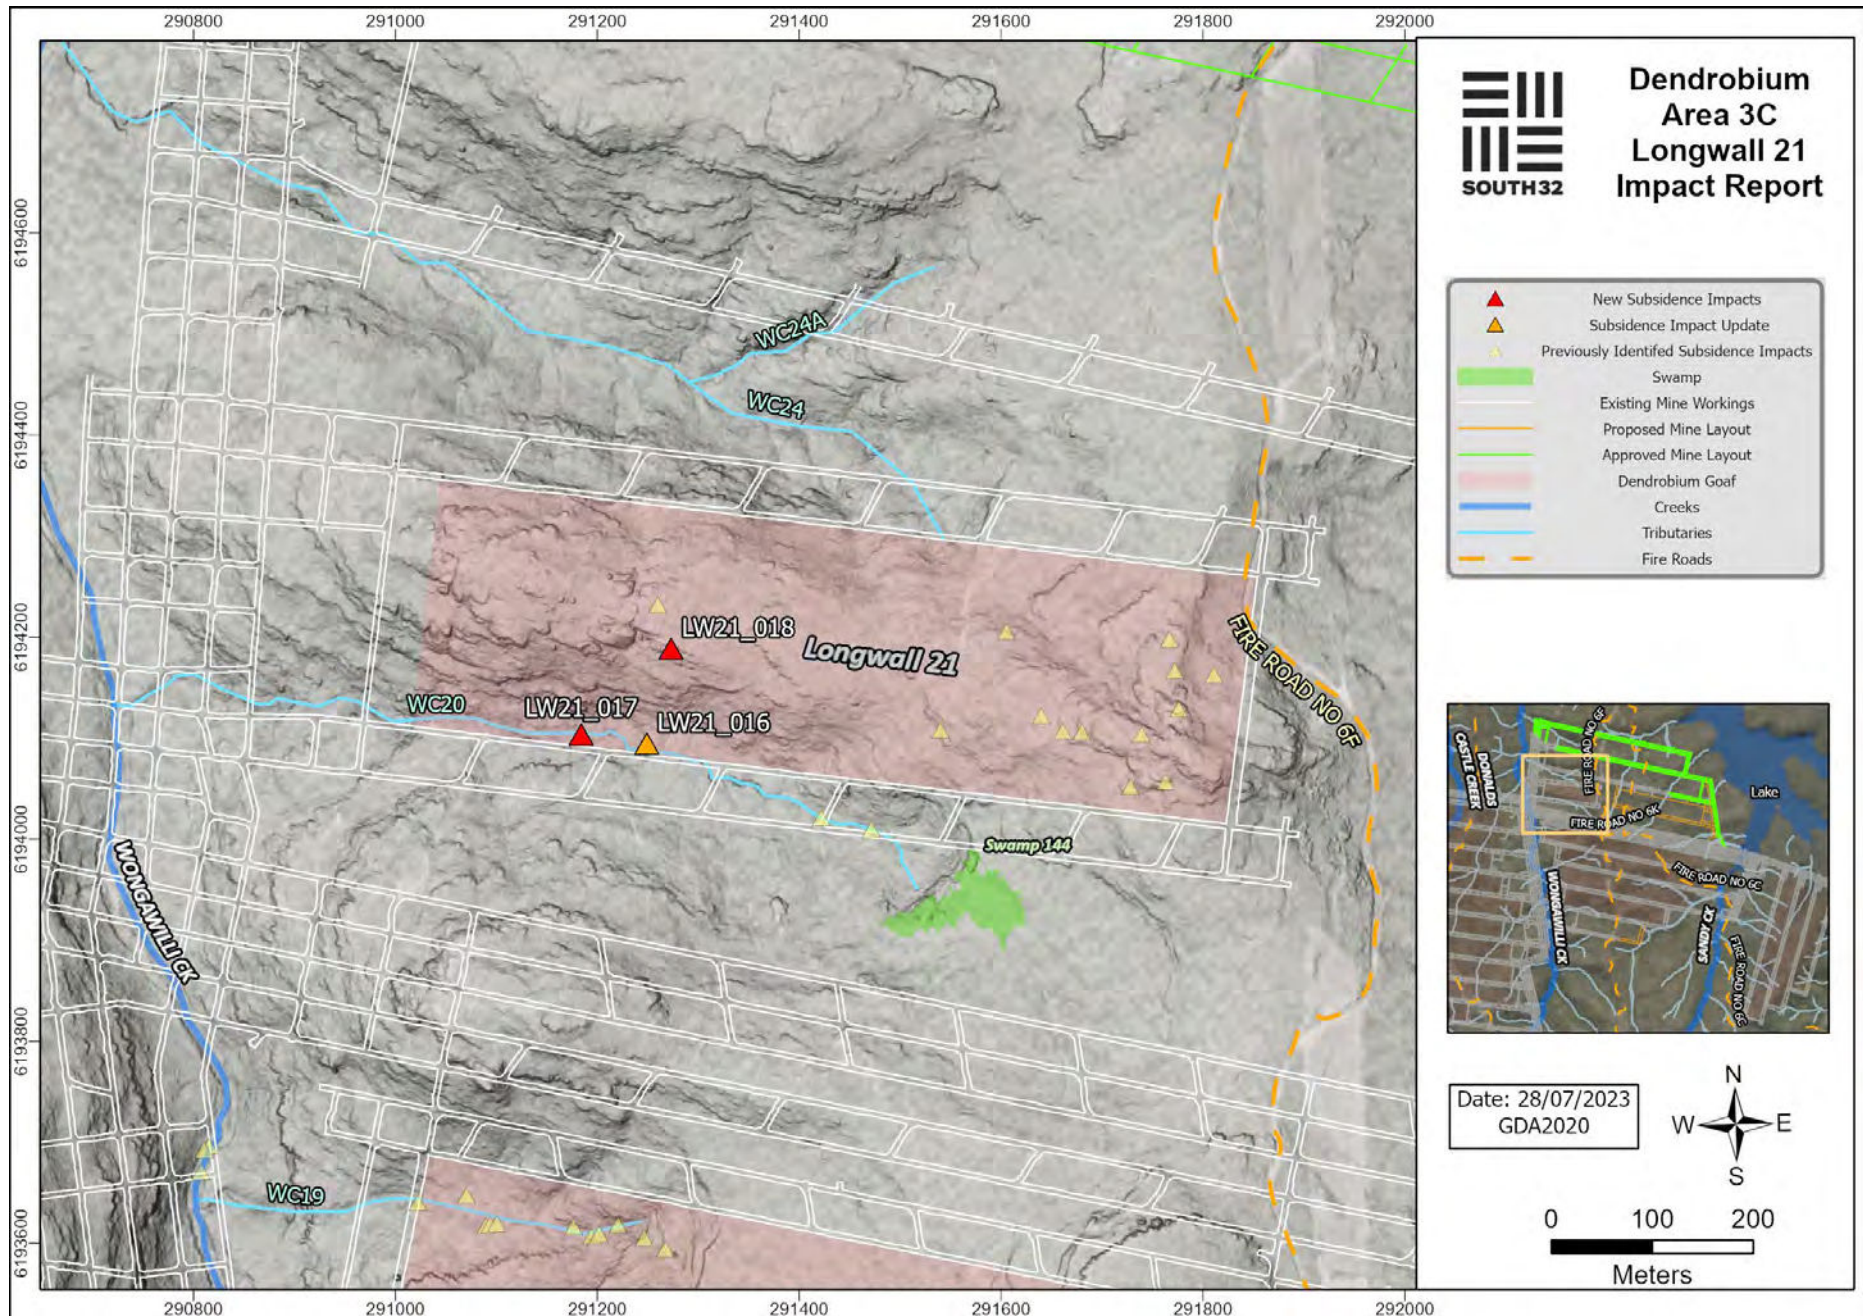
Figure 1: Latest subsidence impacts over Longwall 21 mining area in DA3C. Inset shows frame in relation to Dendrobium mining operations.
