From: [Zanotto, Linda](#)
To: [Camilla Edmunds](#); [Maria Dubikova](#); [Girja Sharma](#); [Glen Capararo](#); [Ravi Sundaram](#)
Cc: [Brassington, Gary](#); gabrielle.allan@dpie.nsw.gov.au
Subject: Dendrobium Mine - Review of distance to swamp impacts
Date: Friday, 8 September 2023 12:17:00 PM
Attachments: [Ltr WaterNSW - DA3 Distance to Swamp Impacts_08092023.pdf](#)
[Att 1 - Dendrobium Area 3A Update Report 230314_V2.pdf](#)
[Att 2 - WaterNSW letter - Dendrobium Impact Report 231314.pdf](#)
[Att 3 - 20230706c_ImpactReport-Hydrology-Swamp35b01_and 15a_19.pdf](#)
[Att 4 - R053c_Dendrobium-Distance to Swamp Impacts to June2023.pdf](#)

Re: Dendrobium Area 3C – Impact report – 31st July 2023

Monitoring of watercourses, swamps and landscape features is undertaken to identify subsidence impacts. These features are monitored by the Illawarra Metallurgical Coal Environmental Field Team (IMCEFT) monthly prior to mining, weekly during mining and monthly during the post-mining period. Monitoring is conducted in accordance with the approved Longwall 21 Subsidence Management Plan (SMP). Extraction of Longwall 21 started on 25 April 2023 and as of 1 August 2023 had progressed approximately

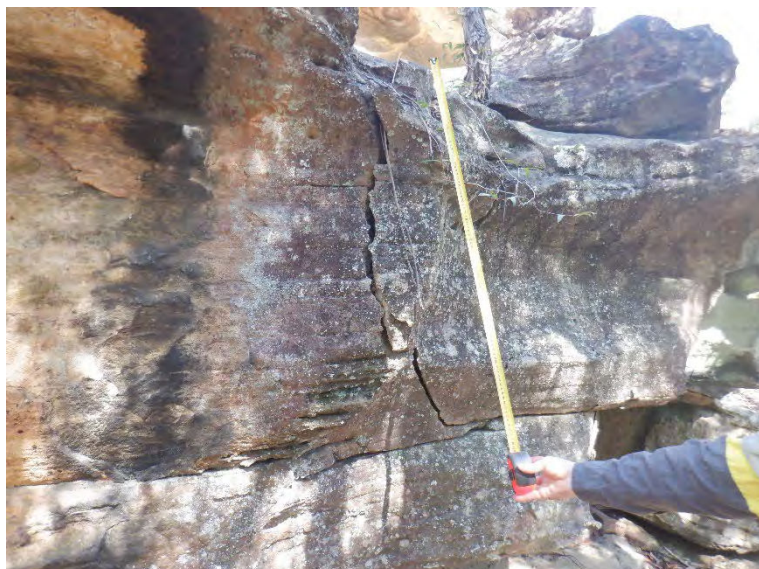
DA3C_LW21_019 is located approximately 210m west of Fire Road 6F (Figure 1). The impact consists of a single rock fracture to a rock step. The fracture has a continuous length of 2m, a maximum width of 0.03m and a maximum measurable horizontal depth of 0.3m (Photo 1 to Photo 3). Flagging tape is in place at the site as a safety precaution.

DA3C_LW21_019 is a Level 1 trigger as per the Dendrobium Landscape TARP (Table 1), specifically:

Photo 1: *DA3C_LW21_019*, looking at the rock fracture.
Taken on 1/08/2023.

- Continue monitoring program
- Submit an Impact Report to key stakeholders
- Report in the End of Panel Report
- Summarise actions and monitoring in AEMR

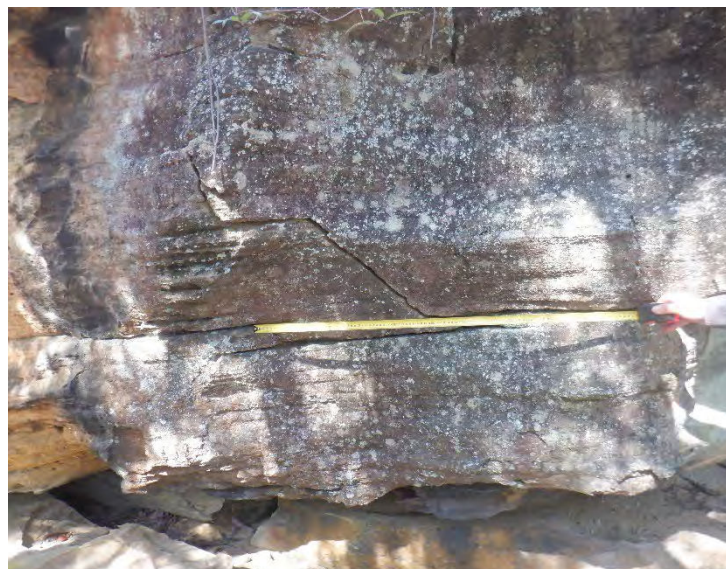
Photo 2: *DA3C_LW21_019*, looking at the rock fracture.
Taken on 1/08/2023.

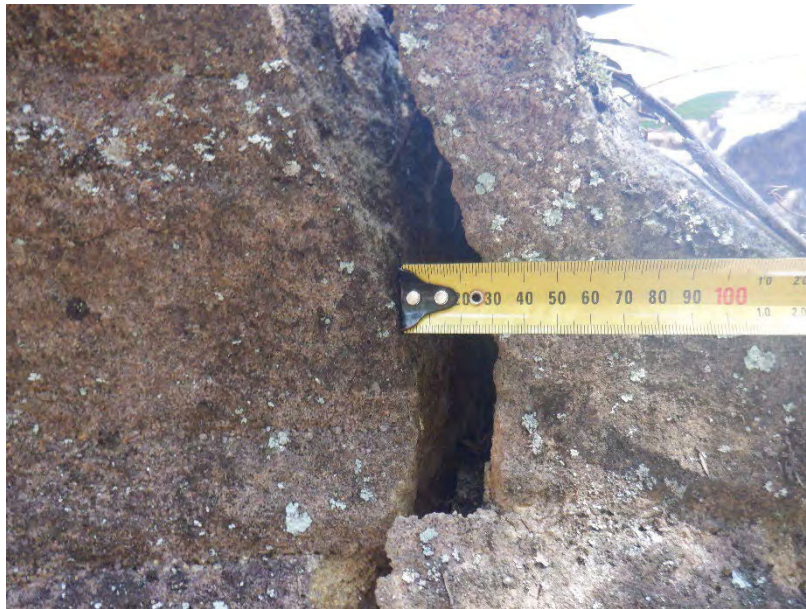
Photo 3: *DA3C_LW21_019*, looking at the width of the rock fracture.
Taken on 1/08/2023.

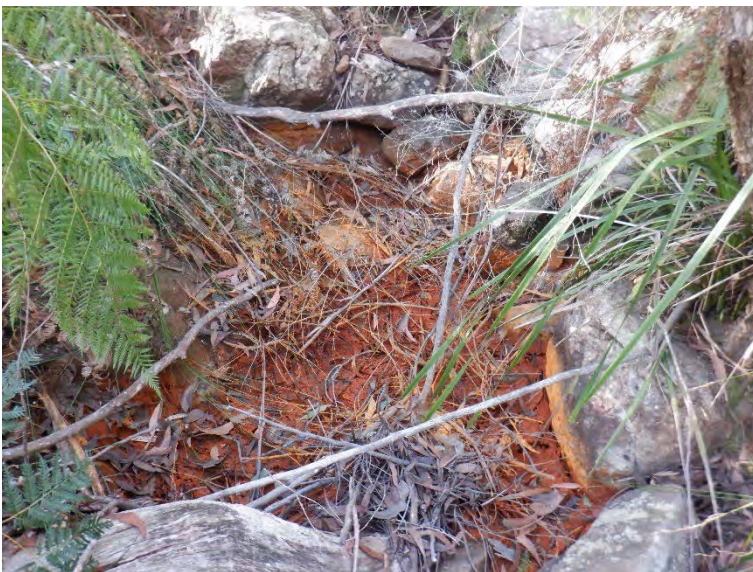
WC24 is a tributary of Wongawilli Creek that flows westward from DA3C mining operations (Figure 1). The upper reaches of the WC24 sub catchment were mined beneath by Longwall 21. Localised iron staining was observed along a 45m stretch of dry streambed on WC24 during the latest inspection (Photo 4 to Photo 7). The iron staining originates at *WC24_Pool 35* and extends downstream to *WC24_Rockbar 15*. During the baseline mapping of WC24, no surface water was observed in this part of the tributary, like latest observations. However, the recently recorded iron staining was not present in the baseline mapping. No other surface impacts have been observed in WC24.

DA3C_LW21_020 is a Level 1 trigger as per the Dendrobium Watercourse TARP (Table 2), specifically:

Photo 4: *DA3C_LW21_020*, section of iron staining in *WC24_Pool 35*. Taken on 1/08/2023.

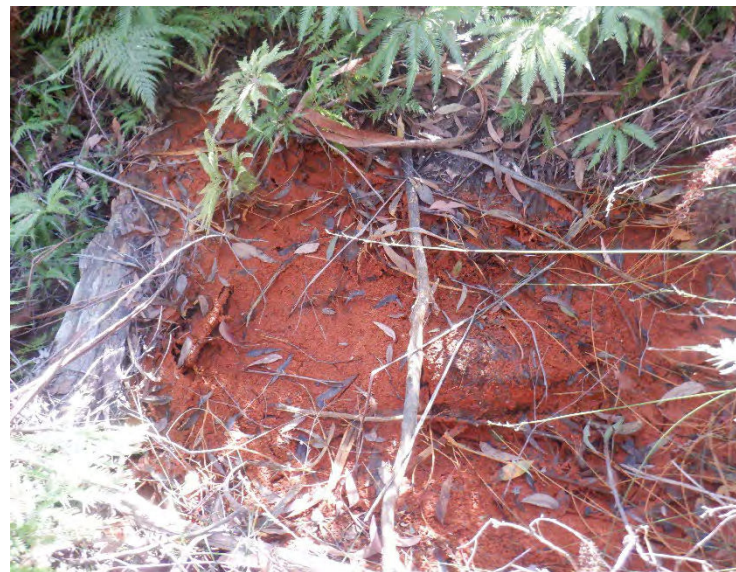
Photo 5: *DA3C_LW21_020*, section of iron staining in *WC24_Channel 18*. Taken on 1/08/2023.

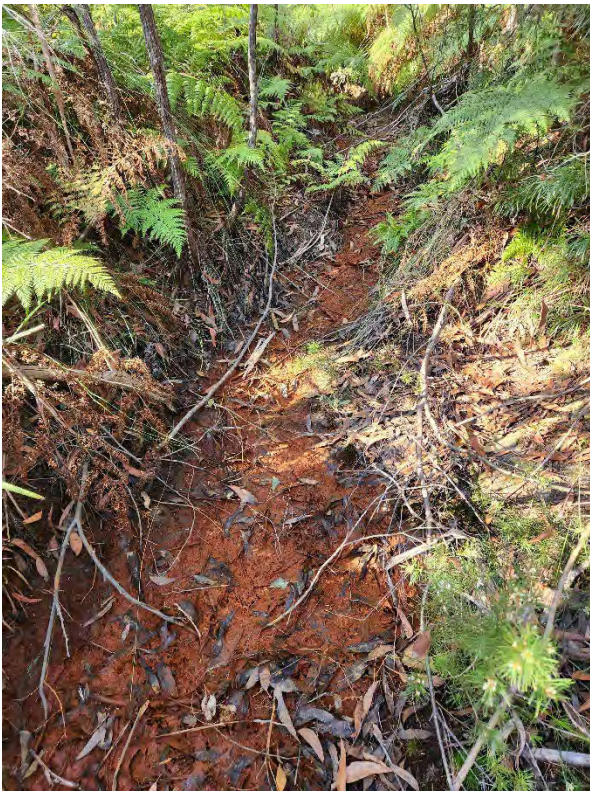
Photo 6: *DA3C_LW21_020*, section of iron staining in *WC24_Channel 18*. Taken on 1/08/2023.

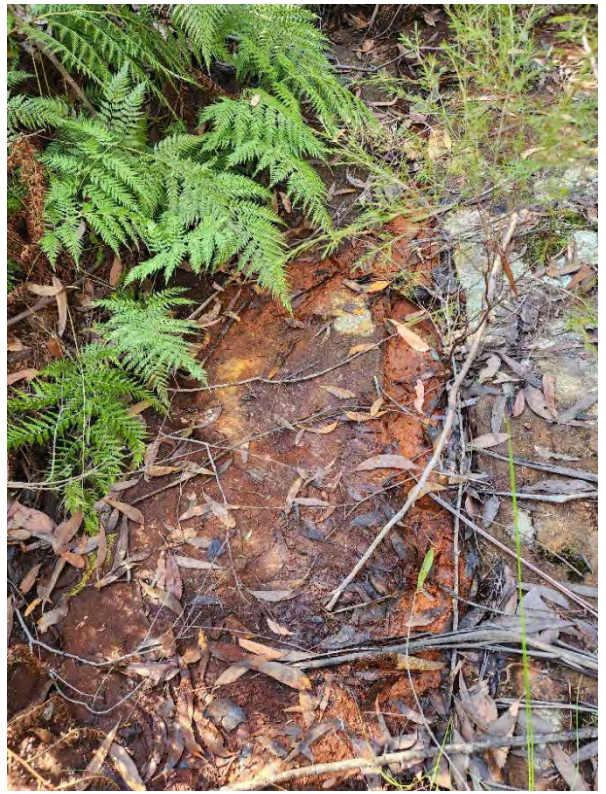
Photo 7: *DA3C_LW21_020*, section of iron staining in *WC24_Rockbar 15*. Taken on 1/08/2023.

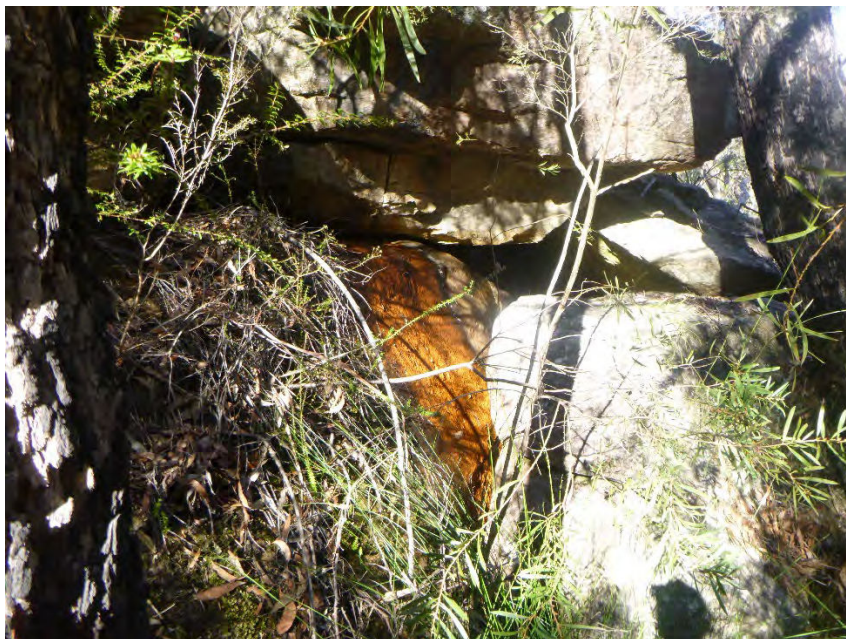
DA3C_LW21_021 consists of localised iron staining on the downstream basal step of Swamp 144 and the headwaters of tributary *WC20* (Figure 1). The iron staining originates from beneath a large boulder mid-way down the basal step (Photo 8). The iron staining is approximately 2m in length, 1m in width and disappears downslope into bushland. No other surface impacts were observed on or above the basal step.

DA3C_LW21_021 is a Level 1 trigger as per the *Dendrobium Watercourse TARP* (Table 2), specifically:

Photo 8: *DA3C_LW21_021*, overview of the iron staining. Taken on 1/08/2023.

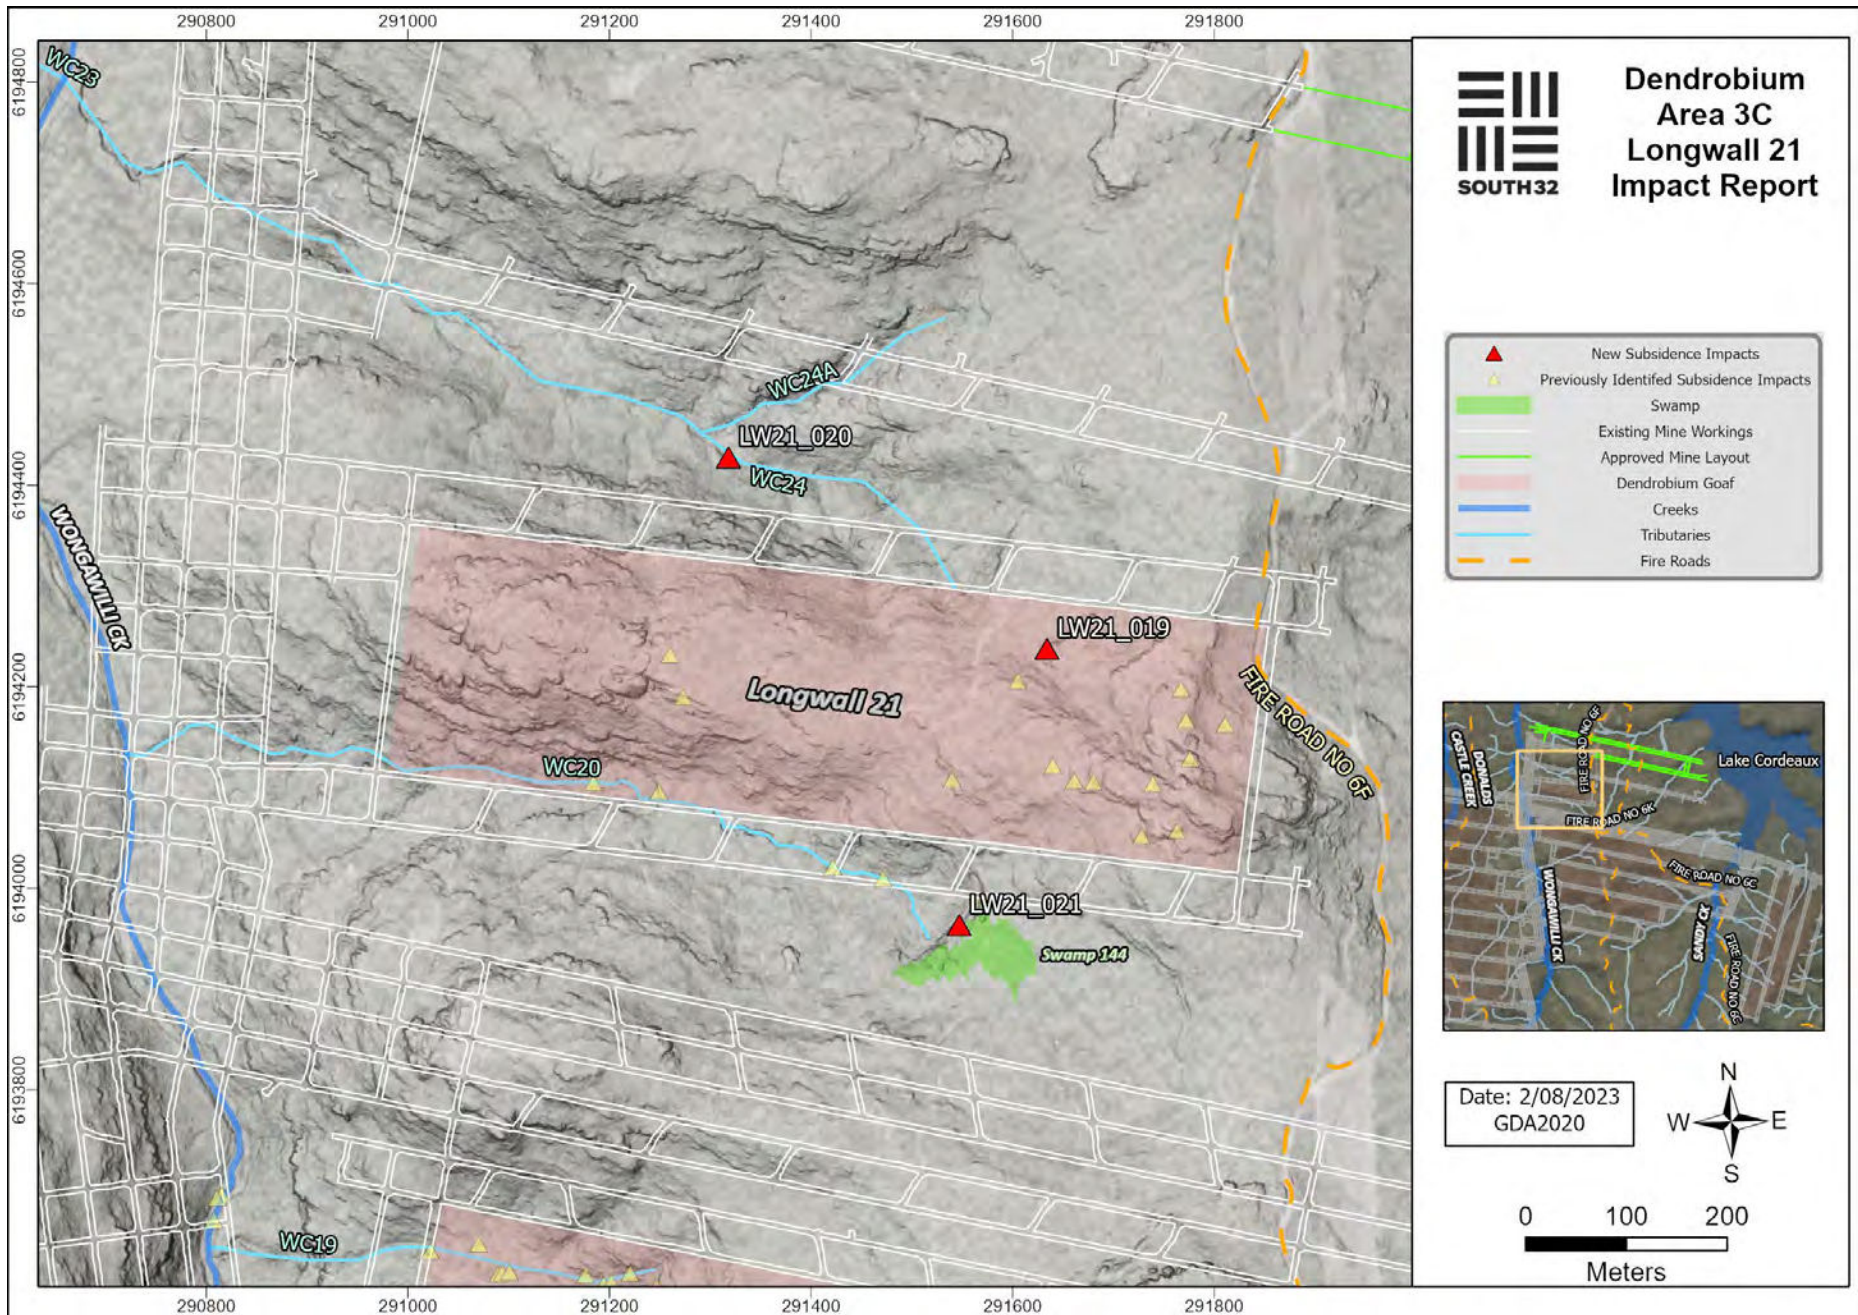
Figure 1: Latest subsidence impacts over Longwall 21 mining area in DA3C. Inset shows frame in relation to Dendrobium mining operations.

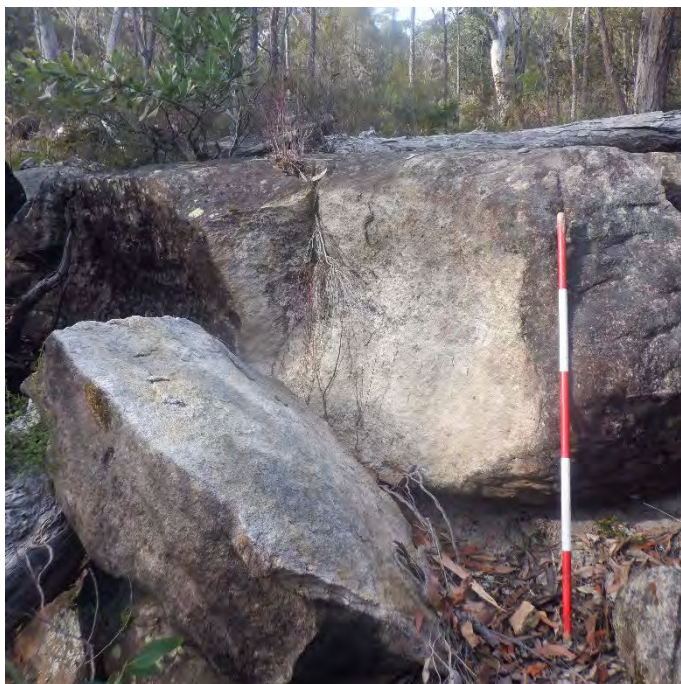
Impact *DA3C_LW21_022* consists of a rockfall from a rock outcrop/step approximately 420m west of Fire Road 6F (Figure 1). Weathered sections of rock face are observed along with fresh rock face. The impact is likely from a natural fracture which has opened further and fallen away due to mining. Approximate volume of the rock is less than 0.5m³ (Photo 1 to Photo 3).

DA3C_LW21_022 is a Level 1 trigger as per the Dendrobium Landscape TARP (Table 1), specifically:

Photo 1: Overview of boulder fallen away from step. Taken 7/08/2023.

- Continue monitoring program
- Submit an Impact Report to key stakeholders
- Seek advice on any other CMAs
- Report in the End of Panel Report
- Summarise actions and monitoring in AEMR

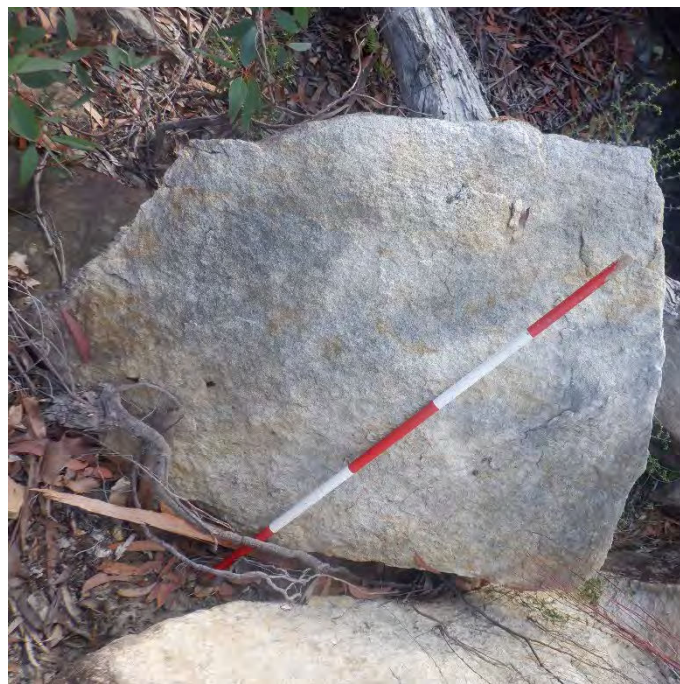
Photo 2: Rockfall showing unweathered rock, looking down from step above. Taken 7/08/2023.

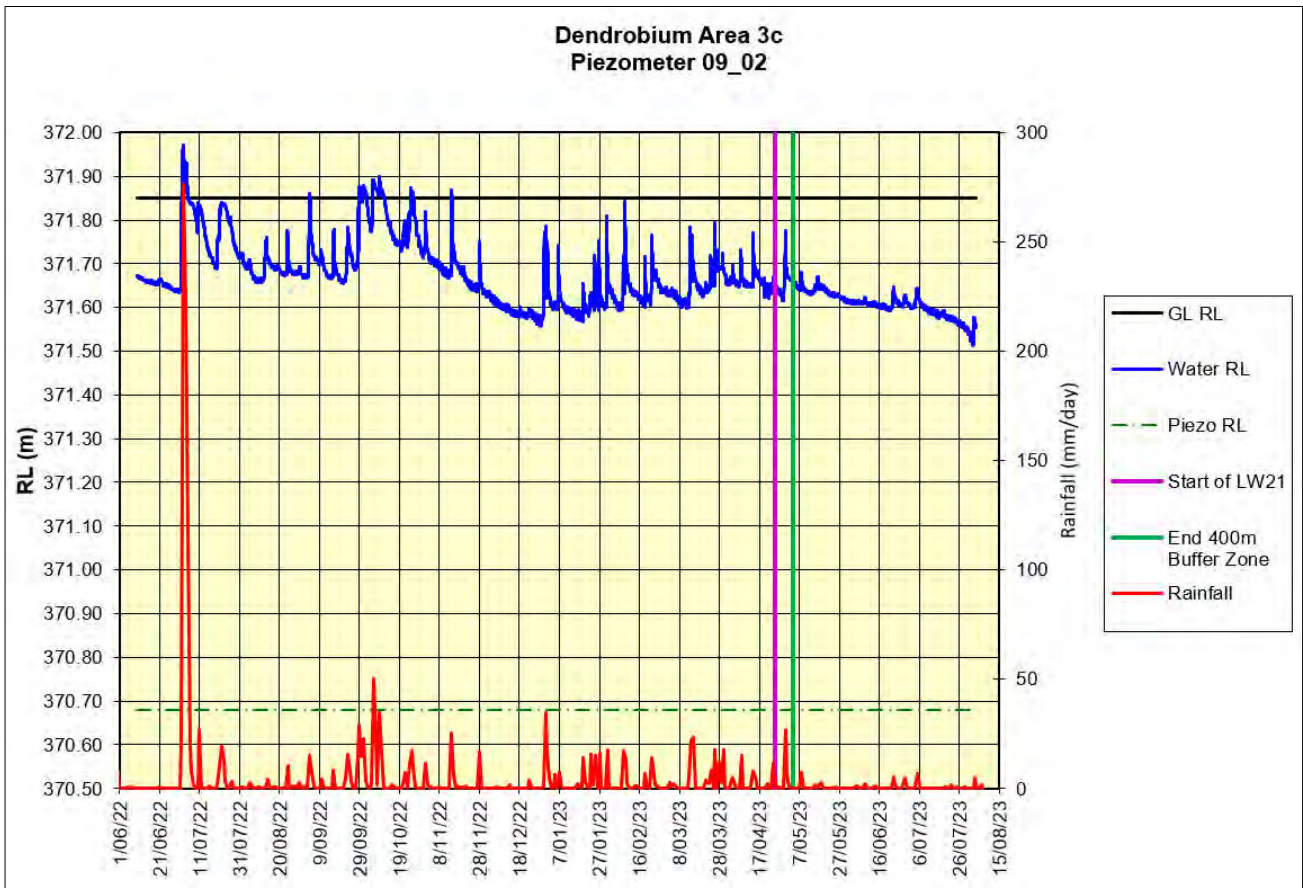
A near-surface groundwater trigger was recorded in Swamp 9 (Piezometer *09_02*) during recent analysis of groundwater data from the swamp. Site *09_02* is located 350 m east of the starting (eastern) end of Longwall 21 (Figure 1), i.e. within the longwall's 400 m buffer zone since the start of mining. The site exited the buffer on 4 May 2023. On 27 July 2023 the water level in the borehole receded below the lowest level recorded before mining (graph 1). There are two piezometers installed in Swamp 9 (one triggered and one not triggered).

These results contribute to a Level 2 trigger according to the SIMMCP (Table 1), specifically:

Graph 1: Shallow groundwater levels at 09_02, logged hourly, date range: 08/06/2022 to 03/08/2023

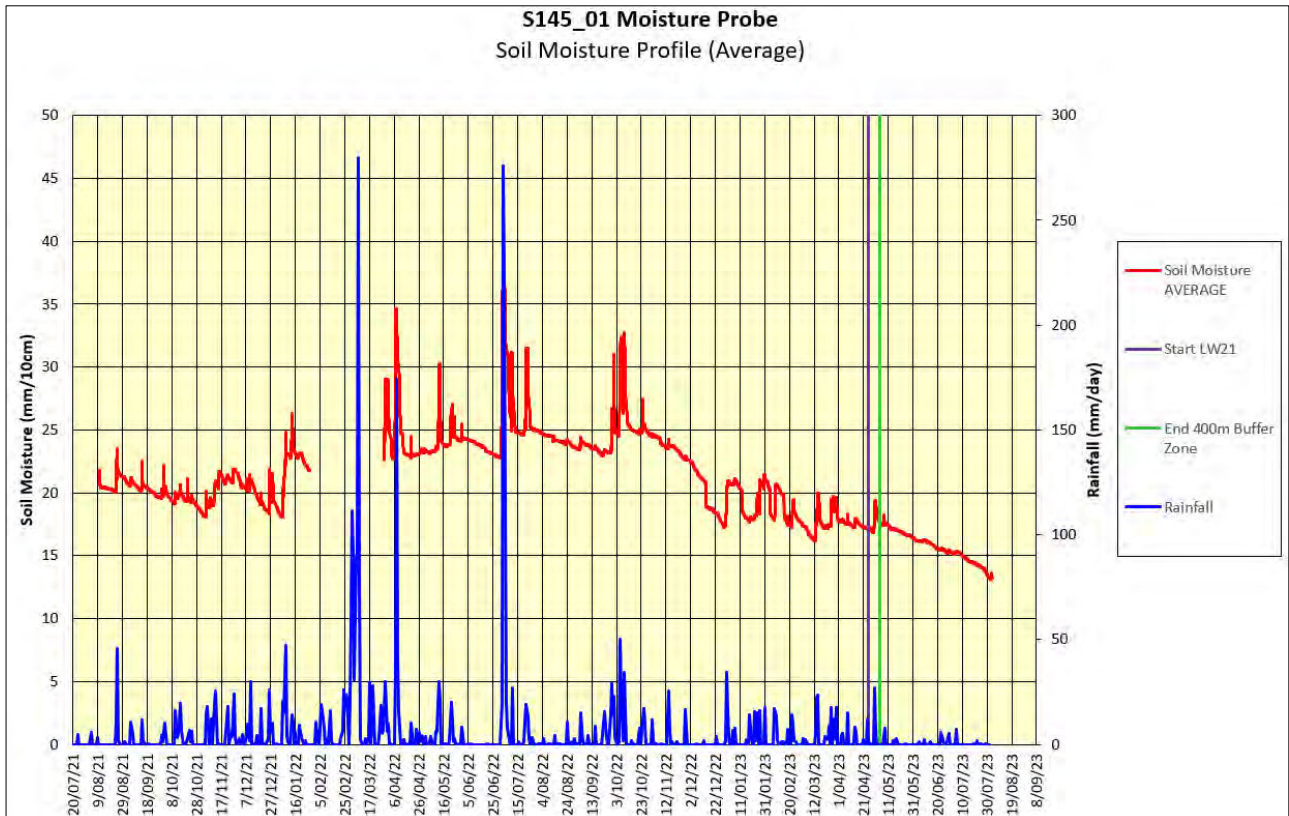
A soil moisture trigger was recorded in Swamp 145 (moisture probe *S145_01*). Site *S145_01* is located 359 m to the south-east of the starting (eastern) end of Longwall 21 (Figure 1), i.e. within the longwall's 400 m buffer zone since the start of mining. The site exited the buffer on 4 May 2023. On 3 June 2023 the average soil moisture value receded below the lowest level recorded before mining (Graph 2).

These results contribute to a Level 3 trigger according to the SIMMCP (Table 1), specifically:

Regarding the Level 3 trigger for this swamp, there is only one soil moisture probe in Swamp 145, therefore only a Level 3 trigger can apply.

Graph 2: Average soil moisture levels at S145_01, logged hourly, date range: 10/08/2021 to 03/08/2023

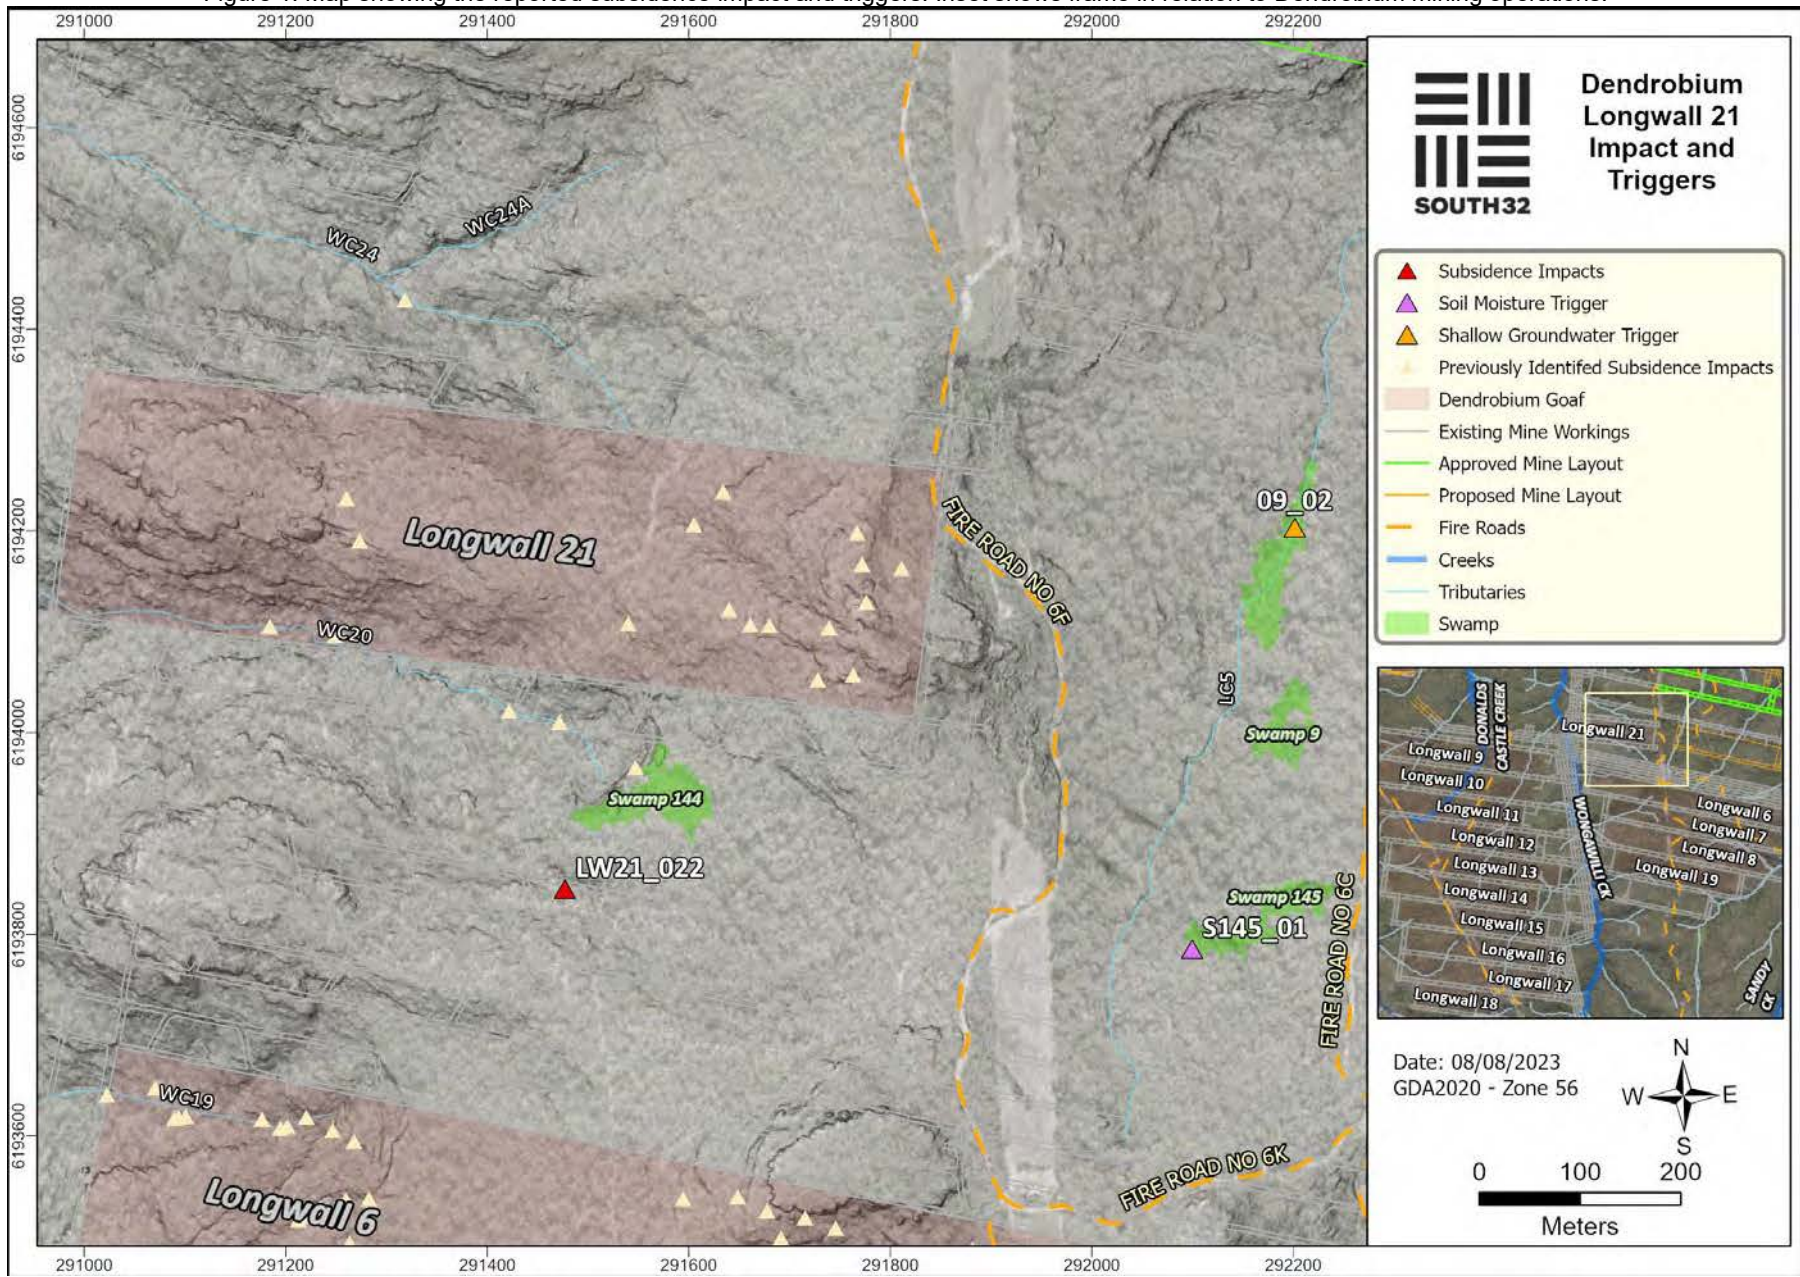
Figure 1: Map showing the reported subsidence impact and triggers. Inset shows frame in relation to Dendrobium mining operations.

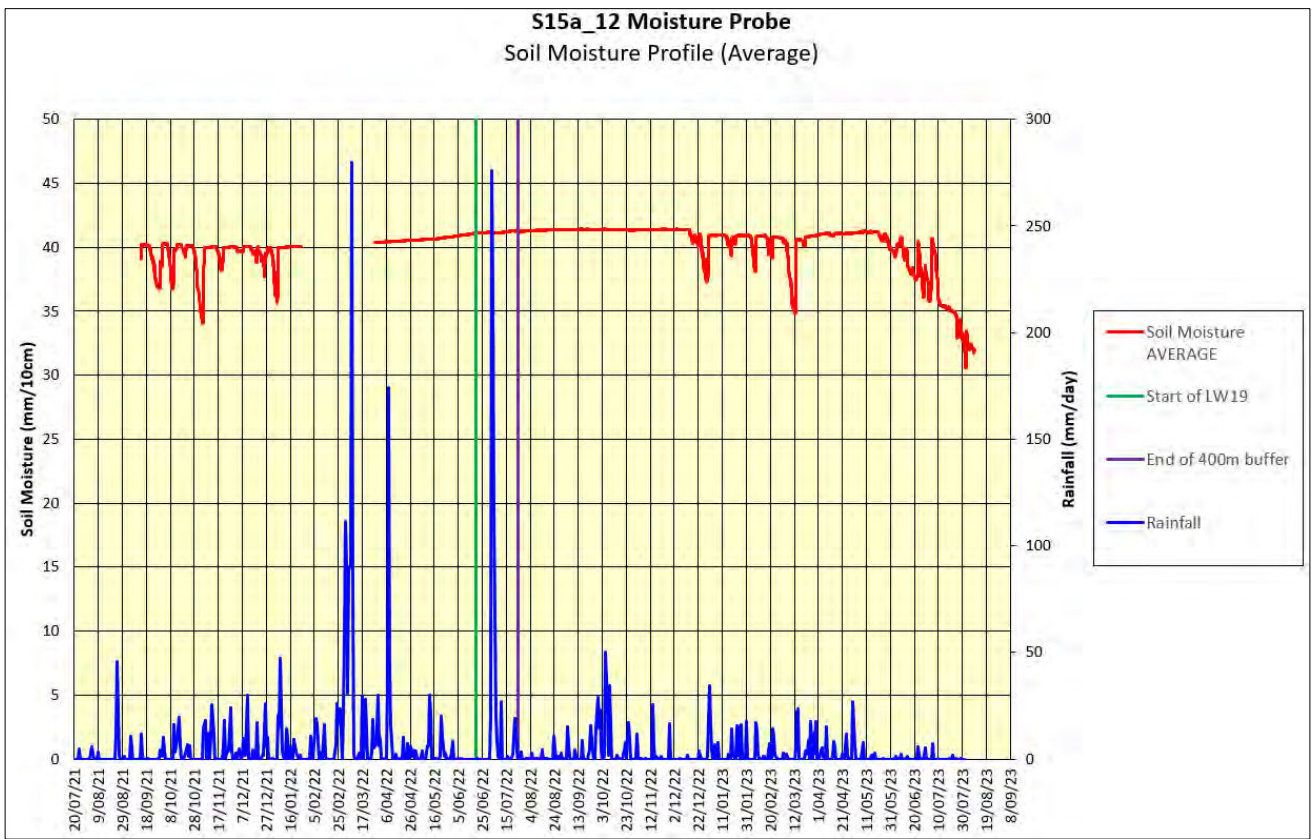
A soil moisture trigger was recorded in Swamp 15a (soil moisture probes *S15a_12* and *S15a_18*) during recent analysis of moisture data for the swamp. Site *15a_12* is located 172 m south-east from Longwall 19 (Figure 1), i.e. within the longwall's 400 m mining area since the start of mining. The site exited the mining area on 25 July 2022. On 25 July 2023 the average soil moisture value recessed below the lowest level recorded during the monitored period before mining. Site *15a_18* is located 275 m east of Longwall 19, within the longwall's 400 m mining area since the start of mining. The site exited the mining area on 9 July 2022. On 18 July 2023 the average soil moisture value recessed below the lowest level recorded during the monitored period before mining.

As soil moisture triggers in the other three sites within 400 m of mining in Swamp 15a were reported previously, these results contribute to a Level 3 trigger according to the Dendrobium SIMMCP TARP (Table 1), specifically:

It is important to note the relatively short baseline monitoring period and that the monitoring commenced during a period of high rainfall and that there were no impacts recorded when the soil moisture probes were within the respective Longwall 19 400m mining area, over one year ago. Rainfall in the period of 2023 to date is the driest year during the sites' monitored period and the third driest year-to-date in the 22 years of rainfall records from Cordeaux Colliery.

Graph 1: Average soil moisture levels at site S15a_12, logged hourly, date range: 13/09/2021 to 9/08/2023

- Continue monitoring program
- Submit an Impact Report to key stakeholders
- Seek advice on any other CMAs
- Report in the End of Panel Report
- Summarise actions and monitoring in AEMR

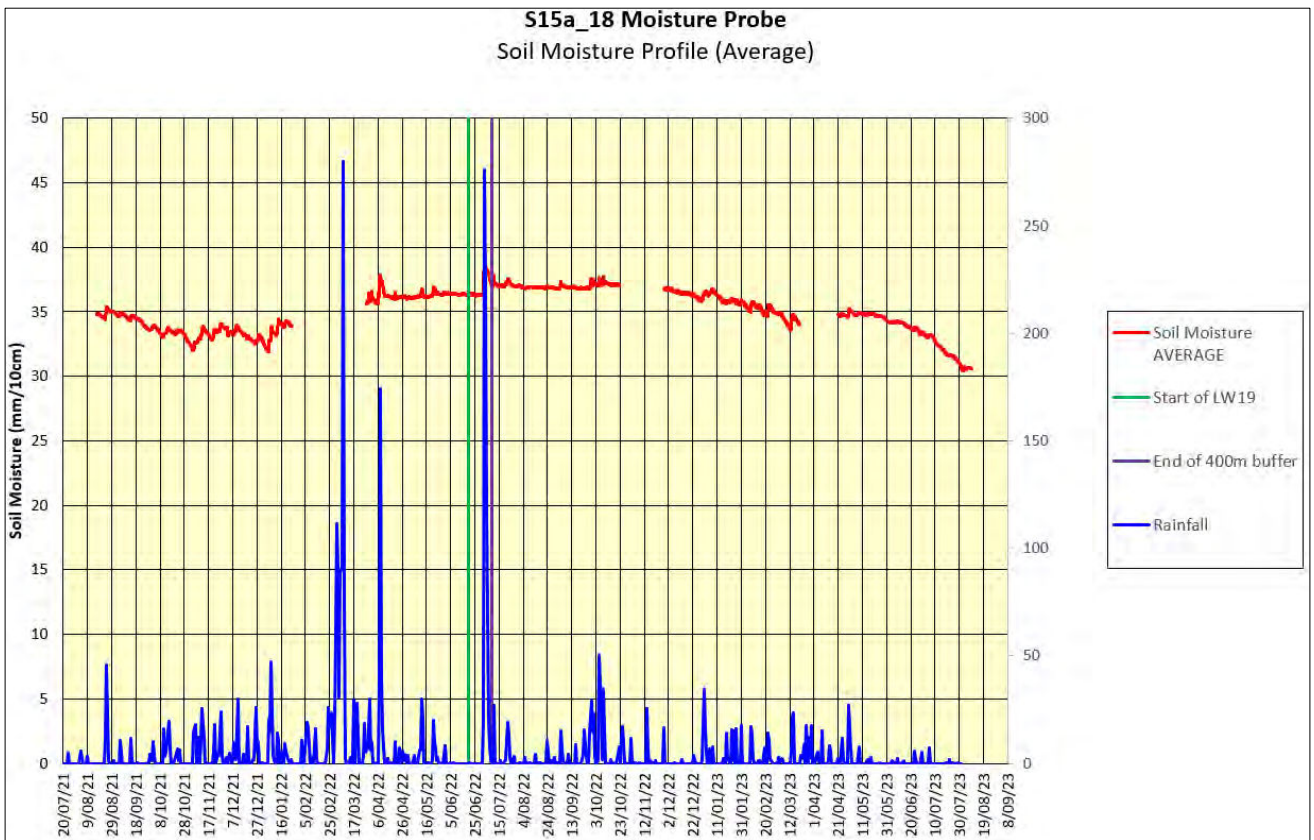
Graph 2: Average soil moisture levels at site S15a_18, logged hourly, date range: 16/08/2021 to 9/08/2023
