Figure 1: Map Showing latest swamp triggers in Swamp 15a. Inset shows frame in relation to Dendrobium mining operations.

Table 2: Impacts and triggers since June 2023. Highlighted row indicates observations featured in this report.

### **Subsidence Impact Reports - Swamps 144 and 15a**

**Re: Dendrobium Area 3A – Impact report – 18<sup>th</sup> August 2023**

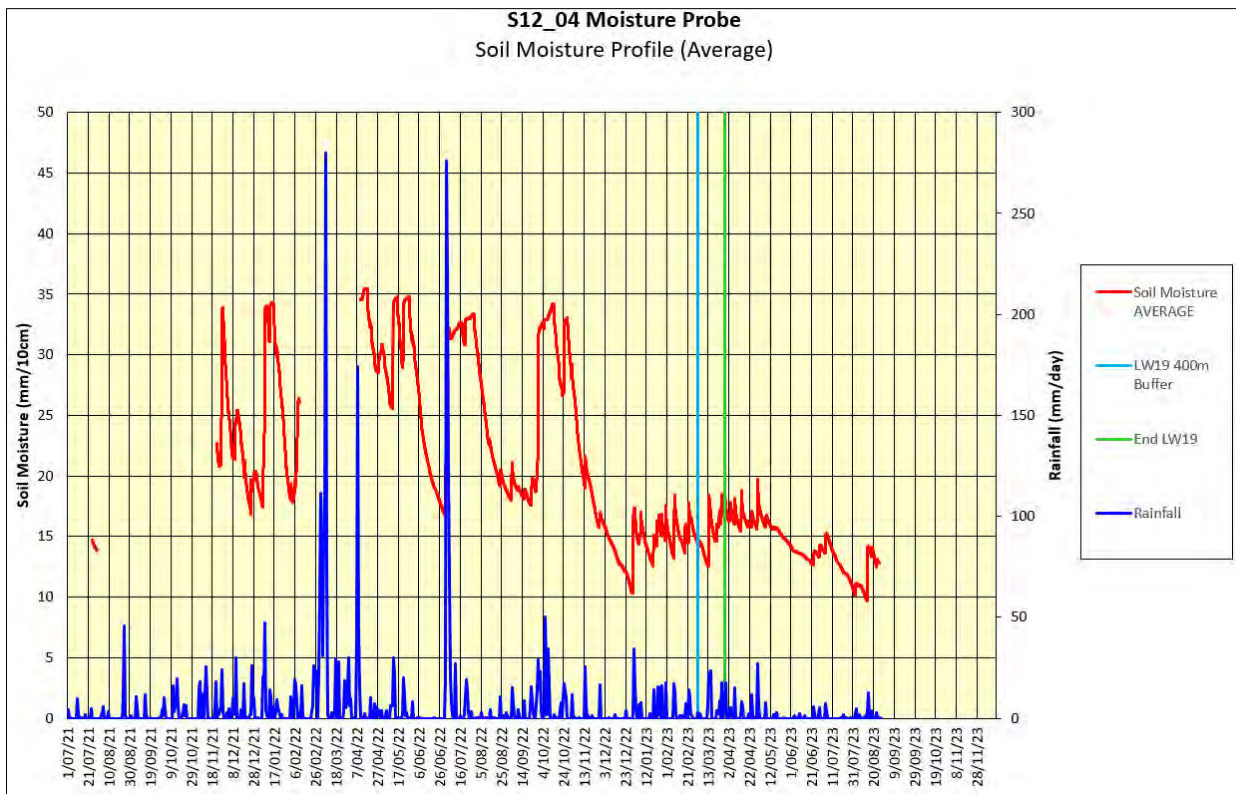
A soil moisture trigger was identified at monitoring site *S12\_04* in Swamp 12 during recent analysis of moisture data. *S12\_04* is located 395 m north from the western end of Longwall 19 (Figure 1). The site entered the Longwall 19, 400m active mining area on 3 March 2023 and remained within the active mining area until the end of extraction. On 1 August 2023 the average soil moisture value receded below the lowest level recorded during the baseline monitoring period (Graph 1).

As *S12\_04* is the only soil moisture site in Swamp 12 within 400 m of Longwall 19 mining, these results contribute to a Level 3 trigger according to the Dendrobium Swamps TARP (Table 1), specifically:

It is important to note that *S12\_04* has previously been within 400m of the active mining area during the extraction of Longwall 6, Longwall 7 and Longwall 8 (between 2010 and 2012). The baseline monitoring period for this site occurred during a period of unusually high rainfall in 2021 and 2022. In contrast, 2023 has been the driest year during the *S12\_04* monitored period and the third driest year-to-date in the 22 years of rainfall records from Cordeaux Colliery. There were no impacts recorded when the site was within the Longwall 19 active mining area.

Graph 1: Average soil moisture levels at site S12\_04, logged hourly, date range: 27/07/2021 to 25/08/2023

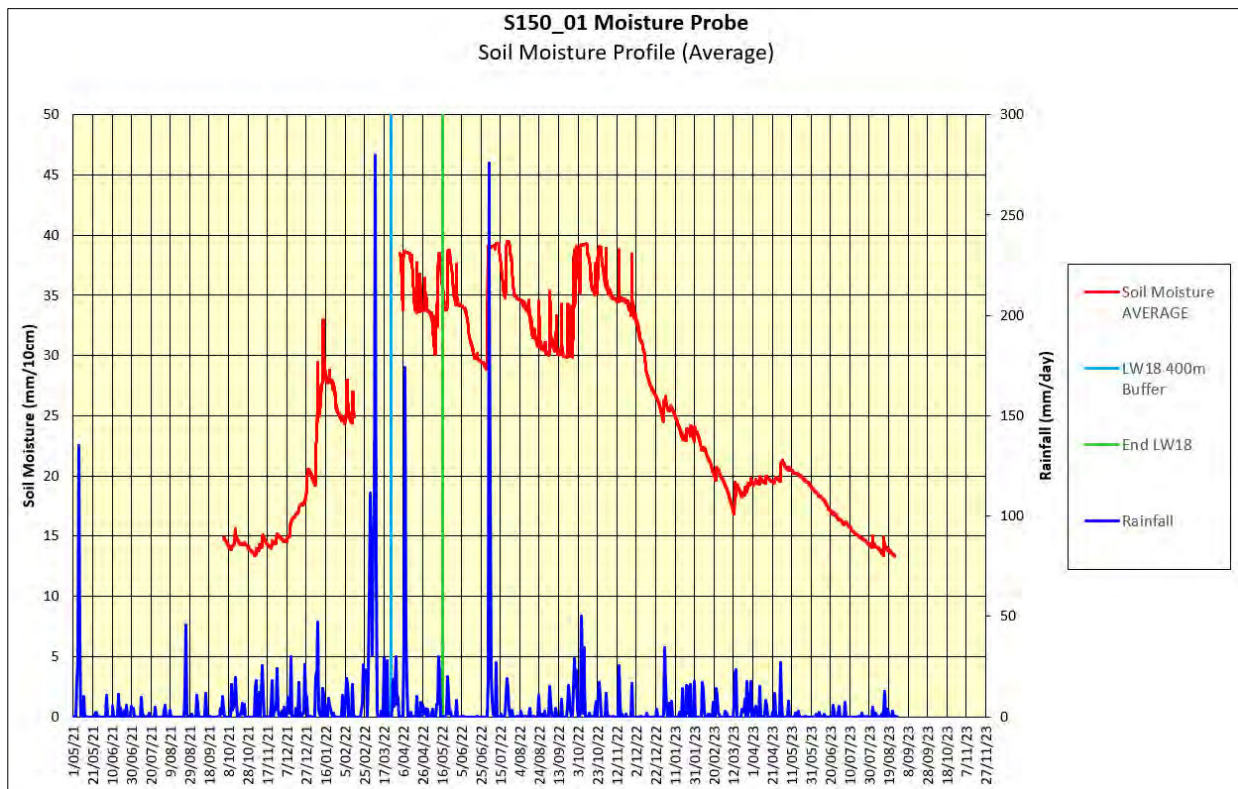
A soil moisture trigger was identified at monitoring site *S150\_01* in Swamp 150 during recent analysis of soil moisture data. *S150\_01* is located 280 m south of the eastern end of Longwall 18 (Figure 2). The site entered the Longwall 18, 400m active mining area on 24 March 2022 and remained in the active mining area until the end of extraction. On 24 August 2023, (one year and three months after completion of Longwall 18), the average soil moisture value receded below the lowest level recorded during the baseline monitoring period (Graph 2).

As the soil moisture probe *S150\_01* is the only one installed in Swamp 150, these results contribute to a Level 3 trigger according to the Dendrobium Swamps TARP (Table 1), specifically:

Monitoring for this site has predominately occurred during a period of unusually high rainfall in 2021 and 2022. In contrast, 2023 has been the driest year during the *S150\_01* monitored period and the third driest year-to-date in the 22 years of rainfall records from Cordeaux Colliery. There were no impacts recorded when the soil moisture probe was within the Longwall 18 active mining area.

Graph 2: Average soil moisture levels at site S150\_01, logged hourly, date range: 02/10/2021 to 25/08/2023

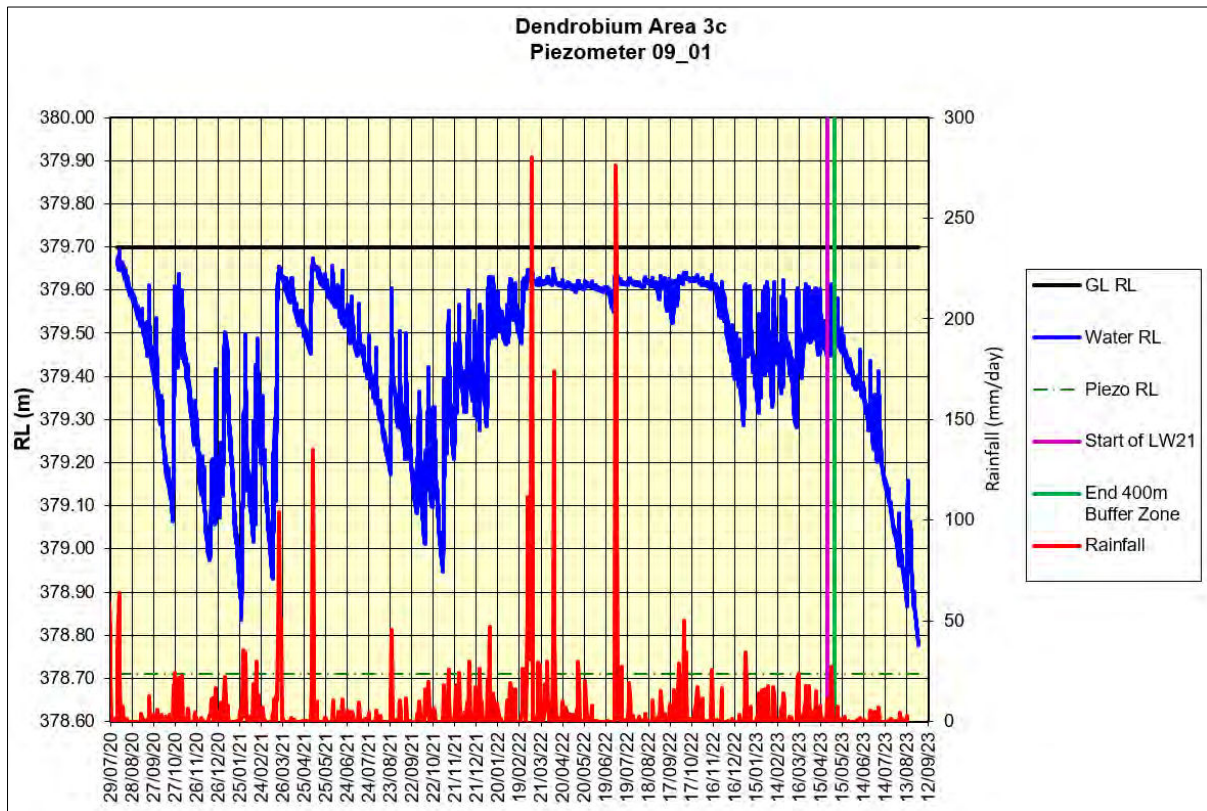
Site 09\_01 is located 368 m east of the eastern end of Longwall 21 (Figure 3). The site was within the 400m active mining area between 25 April 2023 and 2 May 2023. On 25 August 2023 the water level in the borehole 09\_01 receded below the lowest level recorded during the baseline monitoring period (Graph 3) and on 28 August 2023 the average soil moisture value at S09\_01 receded below the lowest level recorded before mining (Graph 4).

Graph 3: Shallow groundwater levels at 09\_01, logged hourly, date range: 07/08/2020 to 29/08/2023

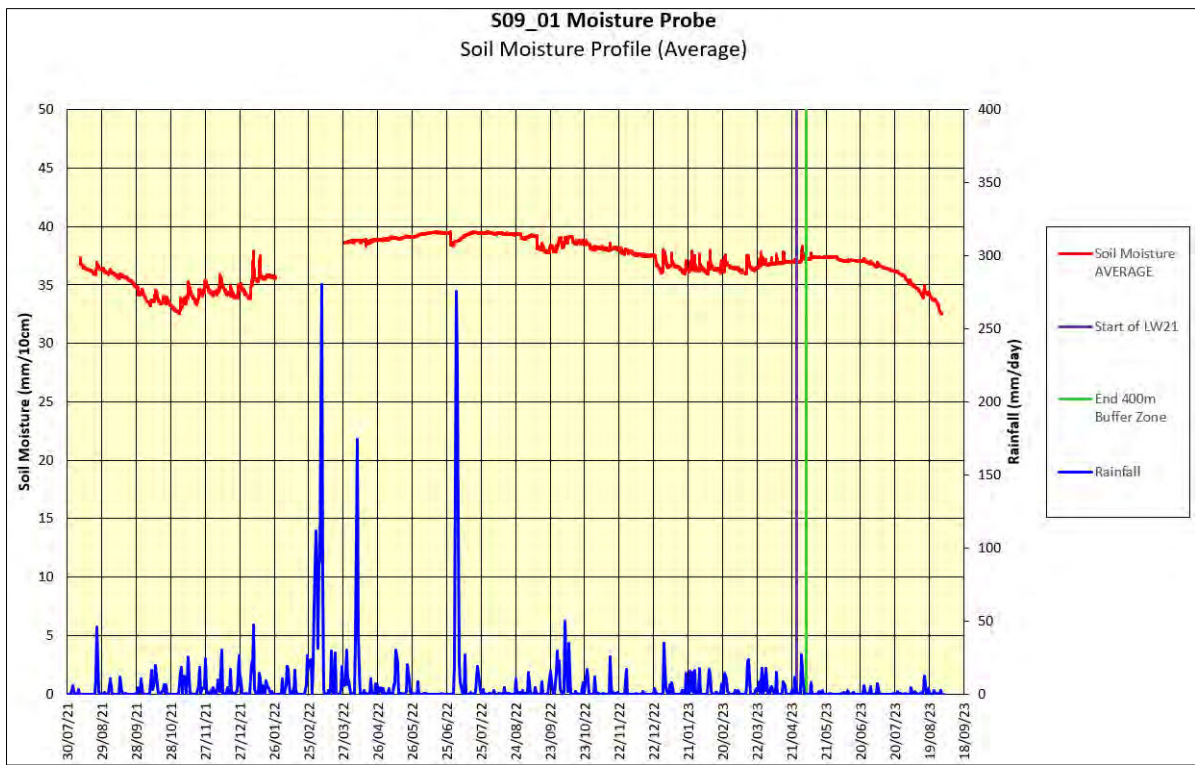
Graph 4: Average soil moisture levels at site S09\_01, logged hourly, date range: 10/08/2021 to 29/08/2023.

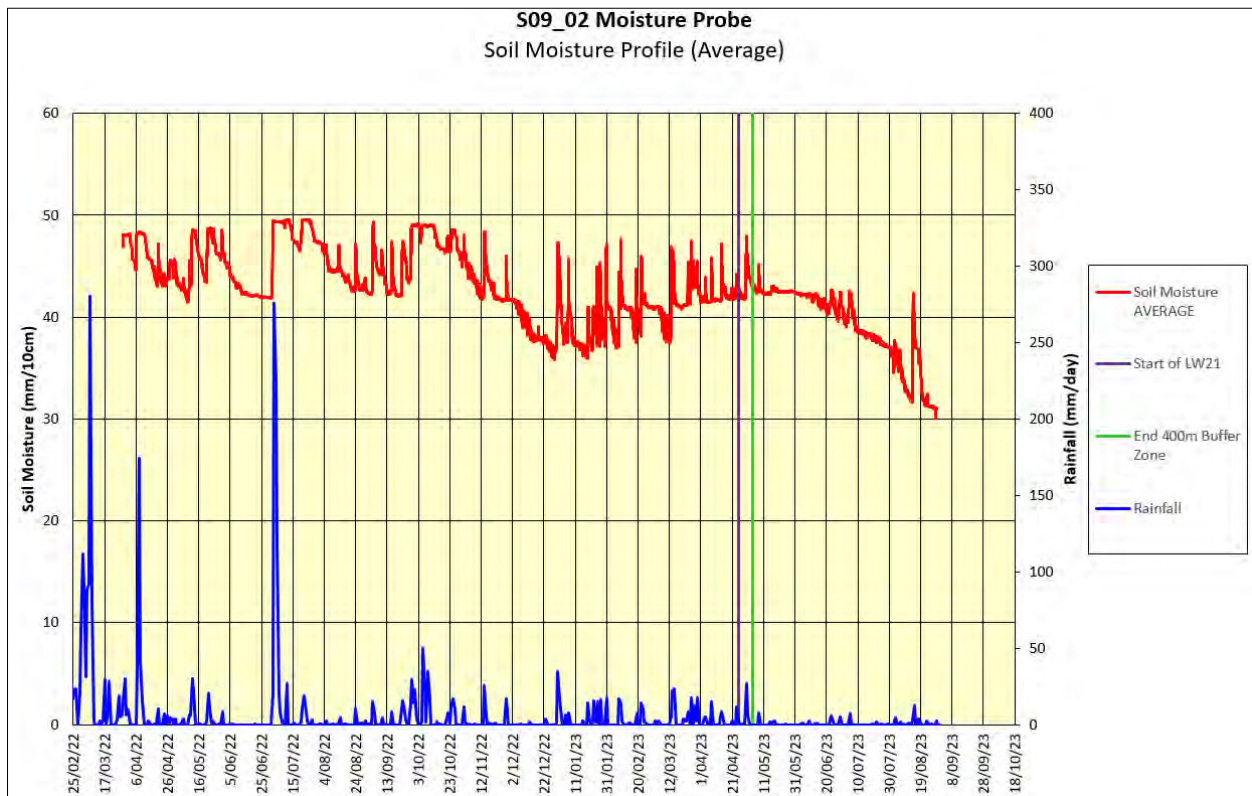
Site S09\_02 is located 350 m east of the eastern end of Longwall 21 (Figure 3). The site was within the 400m active mining area between 25 April 2023 and 4 May 2023. On 1 August 2023 the average soil moisture value in the probe S09\_02 receded below the lowest level recorded before mining (Graph 5). The groundwater trigger in site 09\_02 was reported on 9 August 2023.

Graph 5: Average soil moisture levels at site S09\_02, logged hourly, date range: 28/03/2022 to 29/08/2023

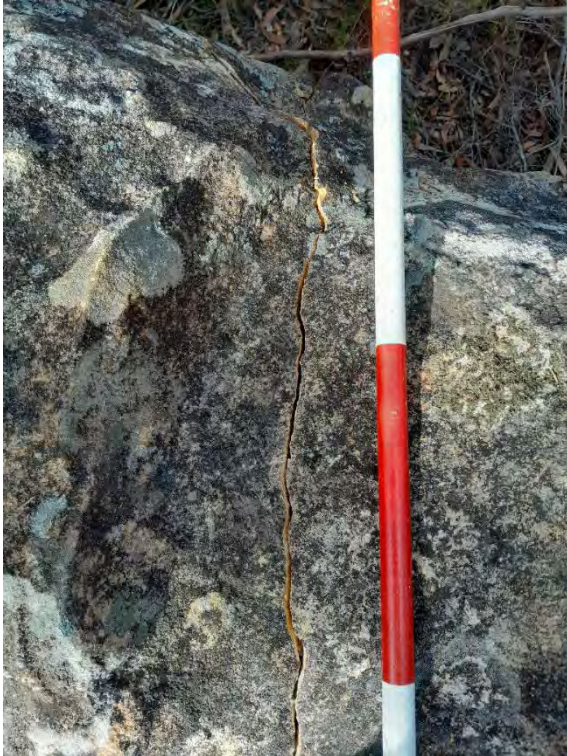
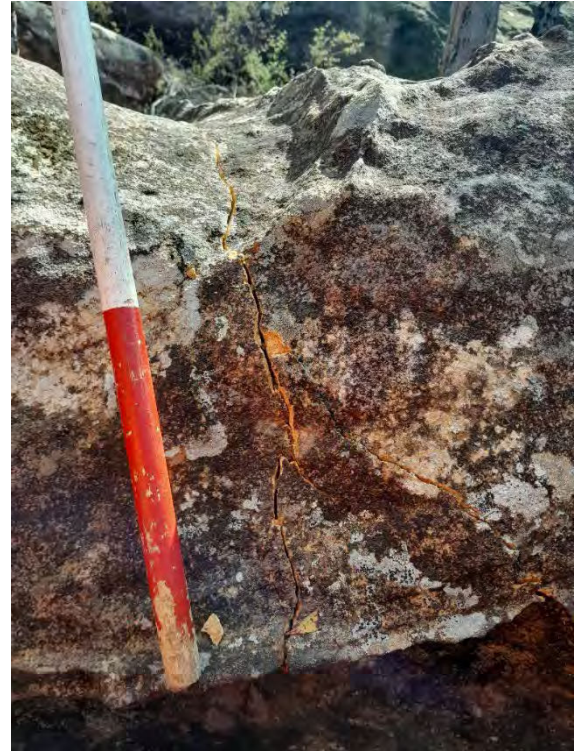
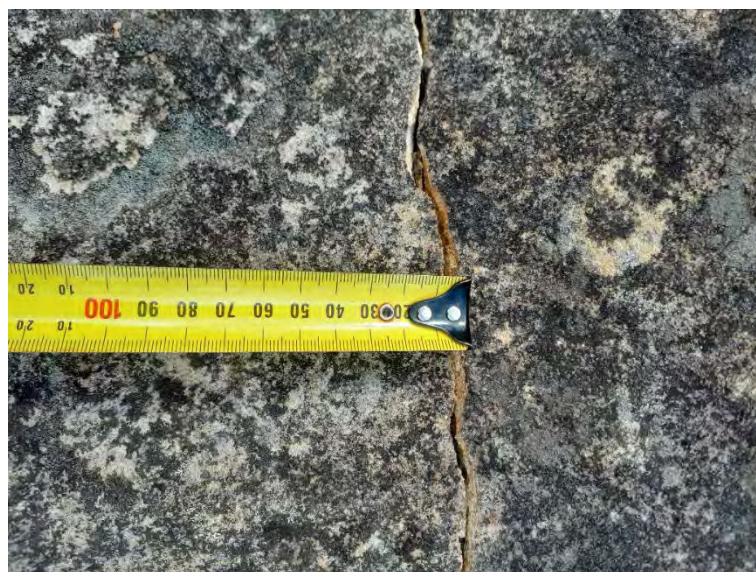
DA3C\_LW21\_023 is located approximately 100m north of tributary WC20 (Figure 3). The impact consists of a fracture to a rock outcrop (Photo 1 to Photo 3). The impact has a maximum continuous length of 2.10m, a maximum width of 0.004m and a maximum measurable depth of 1.30m.

DA3C\_LW21\_023 is a Level 1 trigger as per the Dendrobium Landscape TARP (Table 2), specifically:

- Crack or fracture up to 100mm width;
- Crack or fracture up to 10m length;

Photo 1: DA3C\_LW21\_023, section of the rock fracture. Taken: 31/08/2023.

Photo 2: DA3C\_LW21\_023, section of the rock fracture. Taken: 31/08/2023.

Photo 3: DA3C\_LW21\_023, maximum width of the rock fracture. Taken: 31/08/2023.

- Continue monitoring program
- Submit an Impact Report to key stakeholders
- Seek advice on any other CMAs
- Report in the End of Panel Report
- Summarise actions and monitoring in AEMR

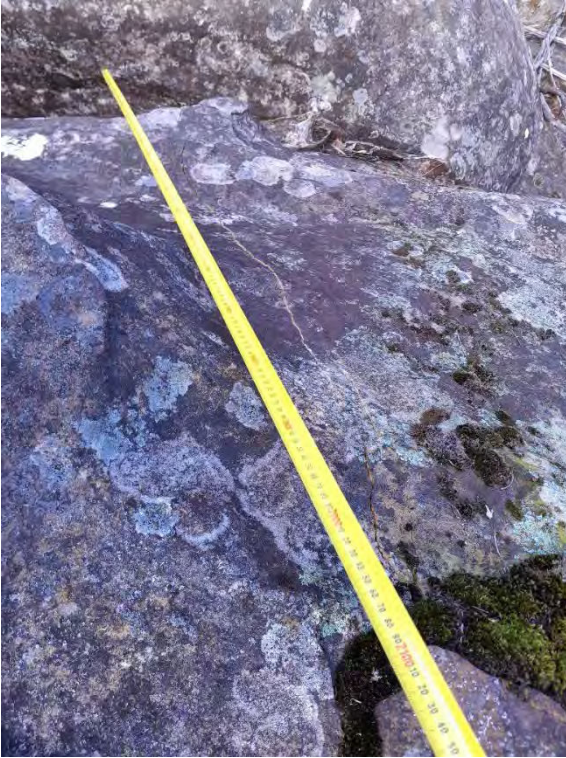
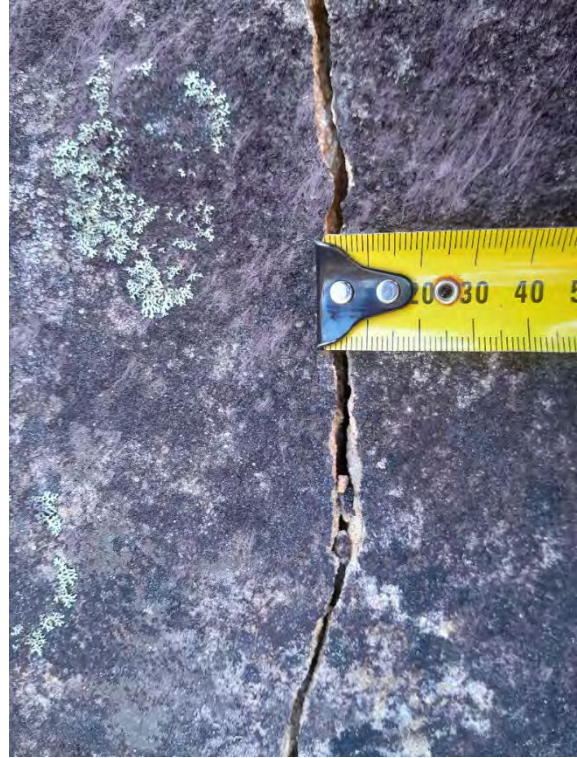
DA3C\_LW21\_024 is located approximately 100m north of WC20 (Figure 3). The impact consists of a fracture to a rock outcrop (Photo 4 and Photo 5). The impact has a maximum continuous length of 3.80m and a maximum width of 0.005m.

DA3C\_LW21\_024 is a Level 1 trigger as per the Dendrobium Landscape TARP (Table 2), specifically:

- Crack or fracture up to 100mm width;
- Crack or fracture up to 10m length;

Photo 4: DA3C\_LW21\_024, section of the rock fracture.  
Taken: 31/08/2023.

Photo 5: DA3C\_LW21\_024, maximum width of the rock fracture.  
Taken: 31/08/2023.

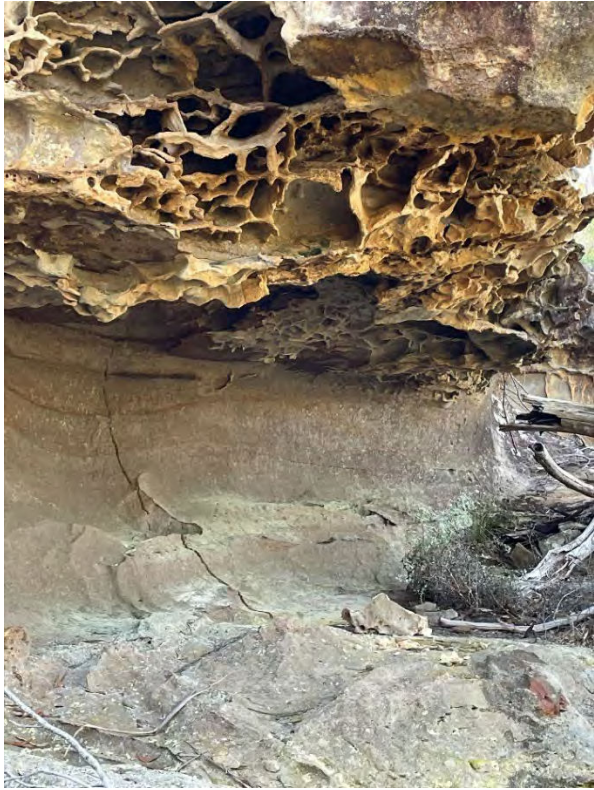
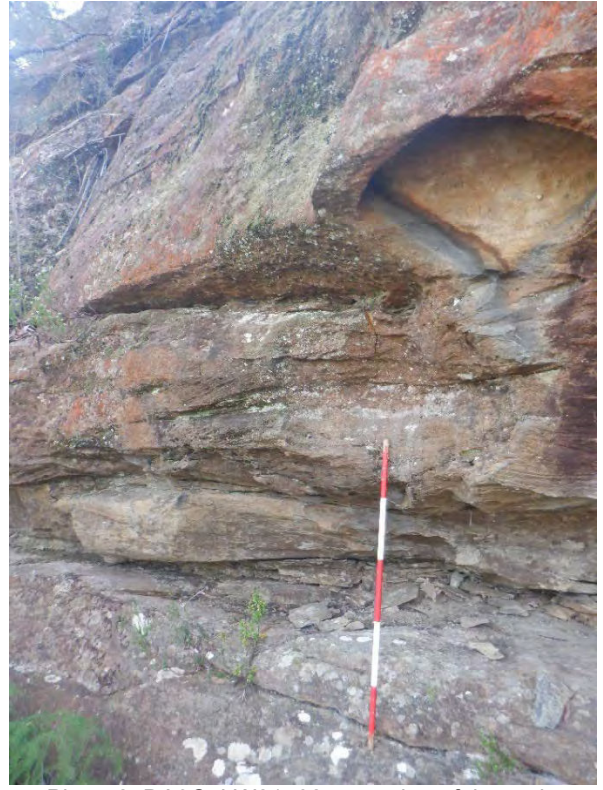
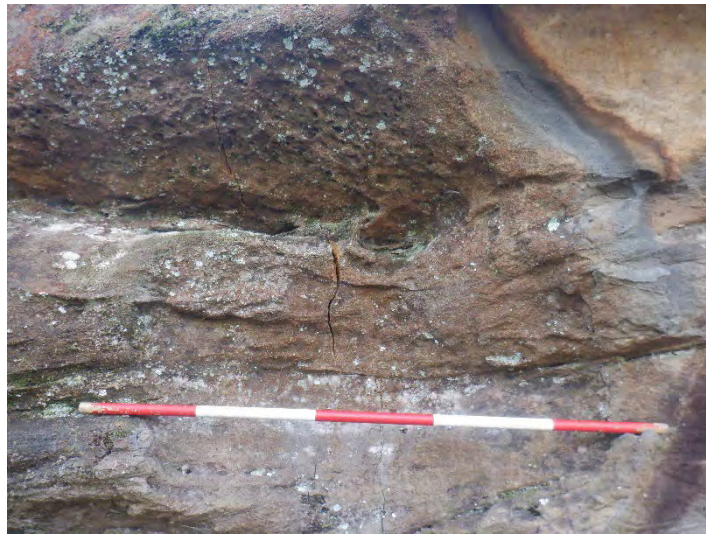
*DA3C\_LW21\_025* is located approximately 80m north of tributary WC20 (Figure 1). The impact consists of fracturing, rockfall and rock displacement to a rock overhang and outcrop (Photo 1 to Photo 3). Some of the measurements have been estimated due to safety concerns. The impact has a maximum continuous length of  $\approx 5$ m, a maximum width of  $\approx 0.03$ m. Total rockfall volume was estimated to be  $\approx 0.7$ m<sup>3</sup>. Caution tape barricading is in place at the site as a safety precaution.

*DA3C\_LW21\_025* is a Level 1 trigger as per the Dendrobium Landscape TARP (Table 1), specifically:

- Crack or fracture up to 100mm width;
- Crack or fracture up to 10m length;
- Rockfall from a cliff which is left mostly intact resulting in insignificant ground disturbance.

Photo 1: DA3C\_LW21\_025, section of the rock fracture in overhang. Taken: 06/09/2023.

Photo 2: DA3C\_LW21\_025, section of the rock fracture. Taken: 06/09/2023.

Photo 3: DA3C\_LW21\_025, section of the rock fracture. Taken: 06/09/2023.

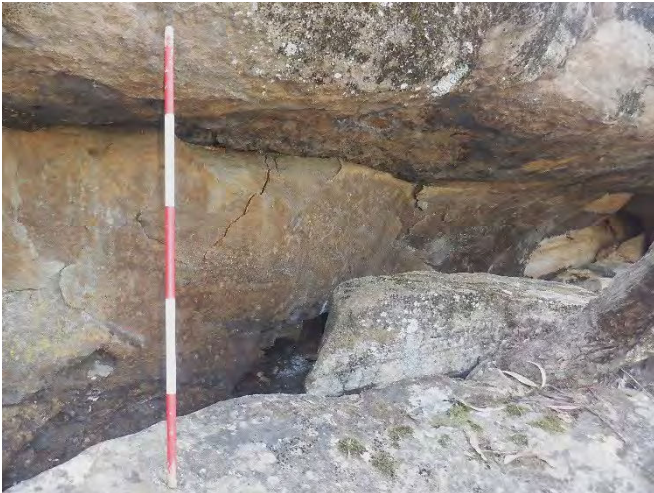
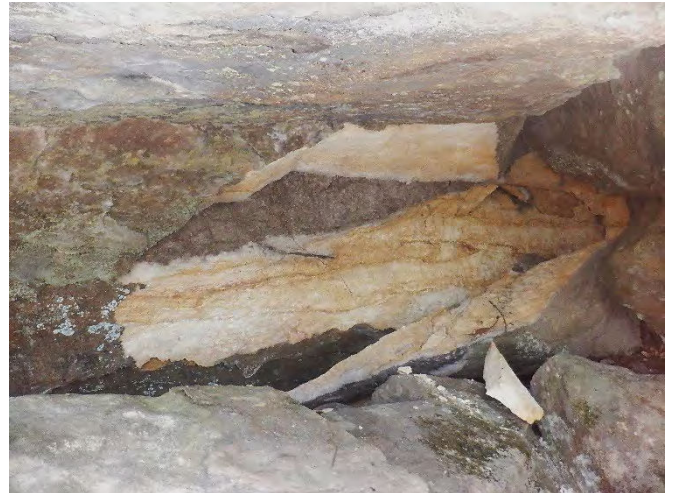
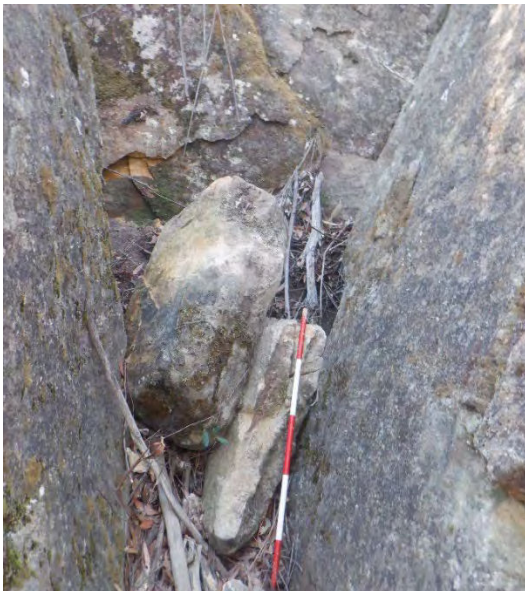
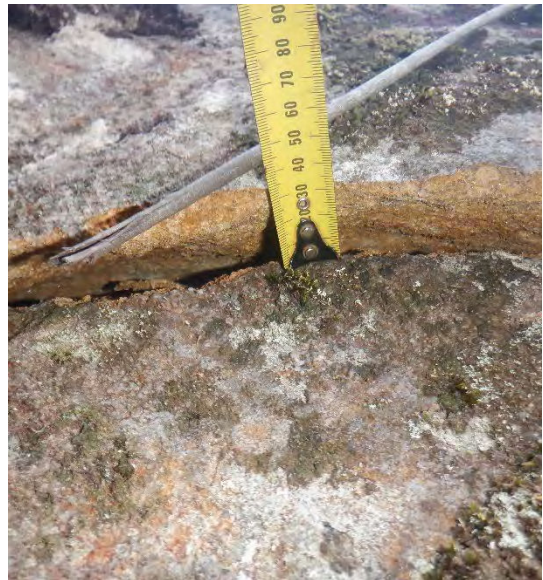
DA3C\_LW21\_026 is located approximately 50m north of tributary WC20 (Figure 1). The impact consists of a rockfall and rock fracturing to a rock overhang (Photo 4 to Photo 7). Some measurements were estimated due to safety concerns. The rockfall volume was estimated to be  $\approx 1\text{m}^3$  in total, the rock fracturing has a maximum length of 1.7m and maximum width of 0.032m.

DA3C\_LW21\_026 is a Level 1 trigger as per the Dendrobium Landscape TARP (Table 1), specifically:

- Crack or fracture up to 100mm width;
- Crack or fracture up to 10m length;
- Rockfall from a cliff which is left mostly intact resulting in insignificant ground disturbance.

Photo 4: DA3C\_LW21\_026, section of rock fracture and rockfall. Taken 06/09/2023

Photo 5: DA3C\_LW21\_026, close up section of rockfall. Taken 06/09/2023.

Photo 6: DA3C\_LW21\_026, section of rock fracture and rockfall. Taken 06/09/2023

Photo 7: DA3C\_LW21\_026, Width of rock fracture. Taken 06/09/2023
