**APPIN AREA 7  
LONGWALL 706 END OF  
PANEL REPORT**

**ATTACHMENT C2 –  
LW706 IMPACT  
REPORTS**

**APPIN AREA 7  
LONGWALL 706 END  
OF PANEL – IMPACT  
REPORTS**

## **Nepean River Impact Report – Gas Release**

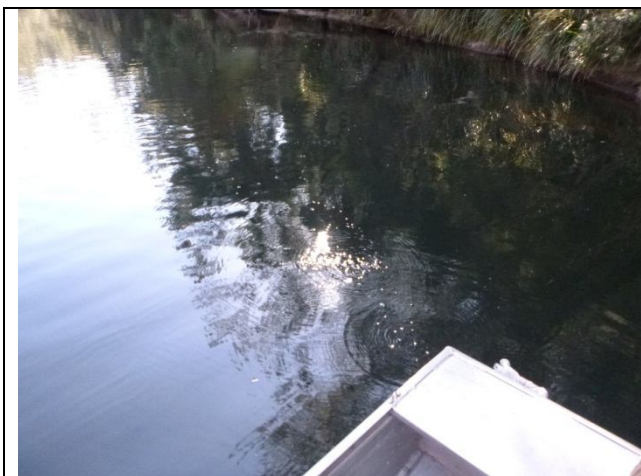
AA7\_LW706\_001 consists of 4 gas release sites in two 2m x 1m zones (Photos 1 & 2), approximately 6m apart. The releases are located over previously extracted Tower Mine Longwall 16, approximately 925 metres upstream of Gas Zone 15 (**Map 1**).

Longwall 16 commenced extraction on 28<sup>th</sup> October 1998 and completed extraction on 22<sup>nd</sup> August 1999. The impact is most likely a reactivated gas release from the mining of Longwall 16 due to its proximity to Appin Area 7 mining.

**Photo 1:** AA7\_LW706\_001 Gas Release 13<sup>th</sup> August 2014.

Gas releases have been observed during monitoring of the Nepean River. As the flow rate of the gas releases are each less than 3000L/min, they fall within a Level 1 trigger from the Longwall 705-706 SMP (**Appendix A, Table 1**), no Corrective Management Actions are required or recommended at this stage. Monitoring of active gas zones will continue and will be reported as required.

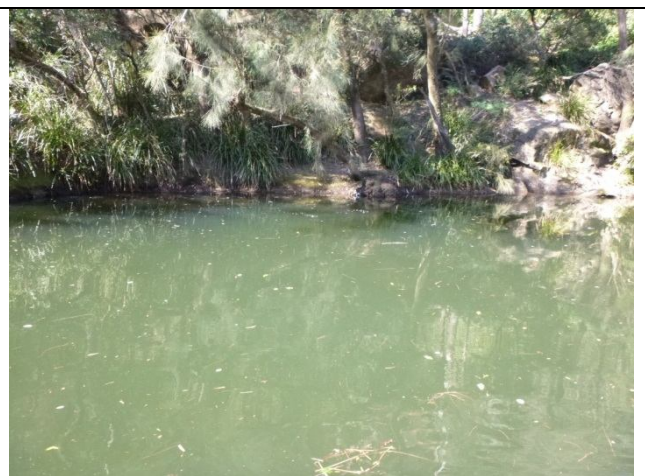
**Photo 2:** AA7\_LW706\_001 Gas Release 13<sup>th</sup> August 2014.

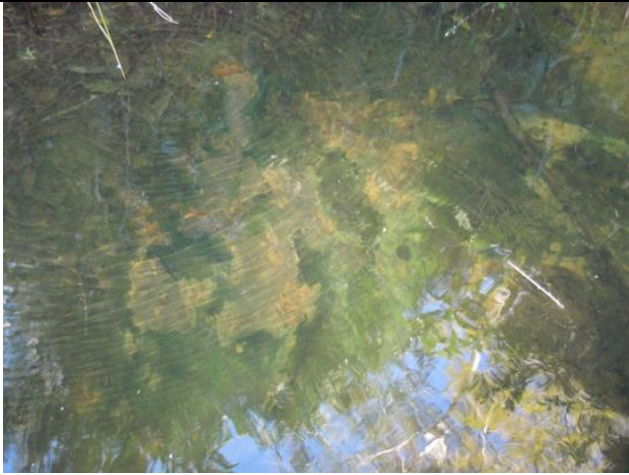
Gas Zone 5 was originally identified on 2<sup>nd</sup> February 2008. At last inspection on 12<sup>th</sup> August 2014 a low intensity intermittent single point release was recorded, over an area of 0.5m x 0.5m (Photo 3). Monitoring of AA7LW701\_Gas Zone 5 will continue.

**Photo 3:** Gas Zone 5, looking downstream. Gas releases and iron present. Taken on 2/07/2014.

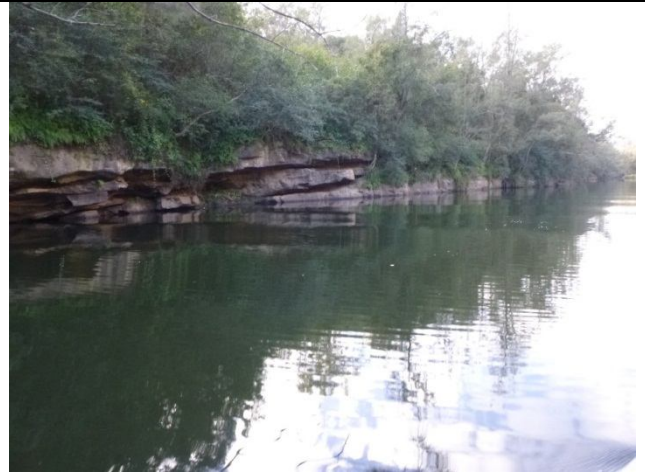
Gas Zone 14 was originally identified on 12<sup>th</sup> April 2012. As of 5<sup>th</sup> August 2014 a low intensity intermittent release was recorded, over an area of 2m x 2m (Photo 4). Monitoring of AA7LW704\_Gas Zone 14 will continue.

**Photo 4:** Gas Zone 14, looking downstream. Gas releases present. Taken on 4/08/2014.

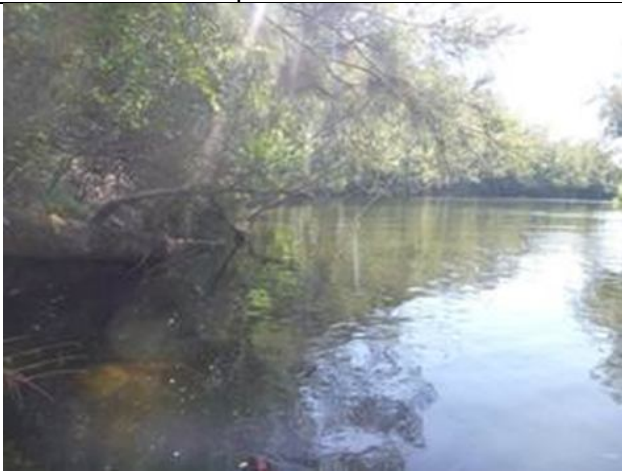
Gas Zone 16 was originally identified on 4<sup>th</sup> October 2012 and consisted of multiple releases in an approximate 60m x 5m area. The flow rate from Gas Zone 16 was estimated to be approximately 200L/min. This release has not been active since the 17<sup>th</sup> January 2014 (Photo 5).

**Photo 5:** AA7LW705 Gas Zone 16 looking downstream. Gas zone not active. Taken on 17/01/2014.

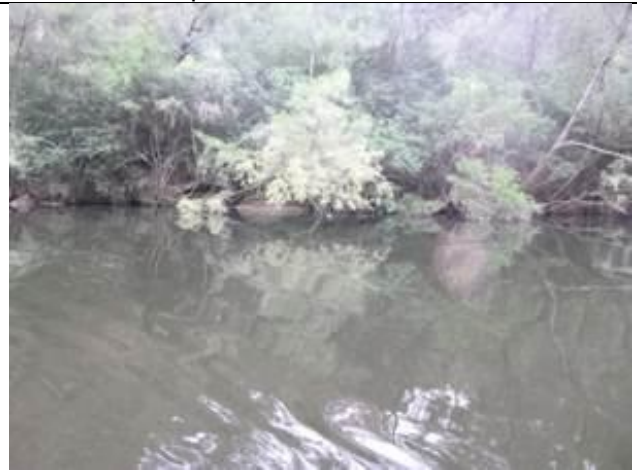
Gas Zone 17 was originally identified on 7<sup>th</sup> February 2013, consisting of up to seven releases at any one time. No activity has been identified since 19<sup>th</sup> February 2014 (Photo 6). Gas Zone 17 was too small to measure or estimate flow rates.

**Photo 6:** AA7LW705 Gas Zone 17 looking across stream. Gas zone not active. Taken on 19/02/2014.

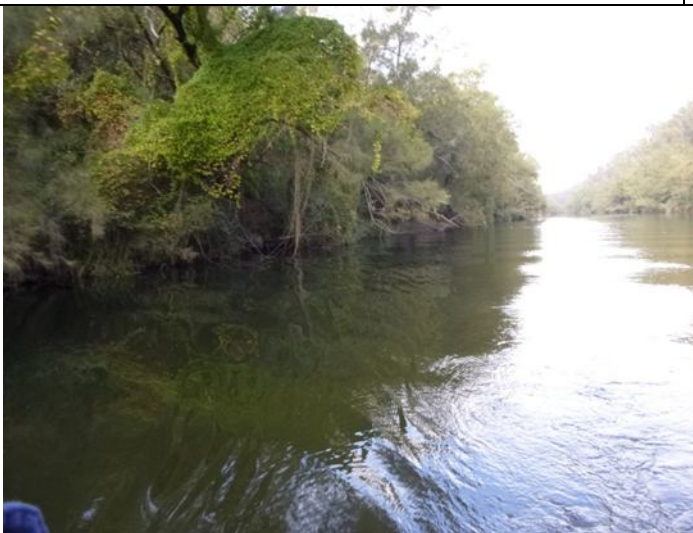
Gas Zone 18 was originally identified on 18<sup>th</sup> February 2013 and consisted of up to 20 releases. No activity has been identified since 2<sup>nd</sup> June 2014 (Photo 7). Gas Zone 18 was too small to measure or estimate flow rates.

**Photo 7:** Gas Zone 18, looking upstream. No gas releases present. Taken on 4/08/2014.

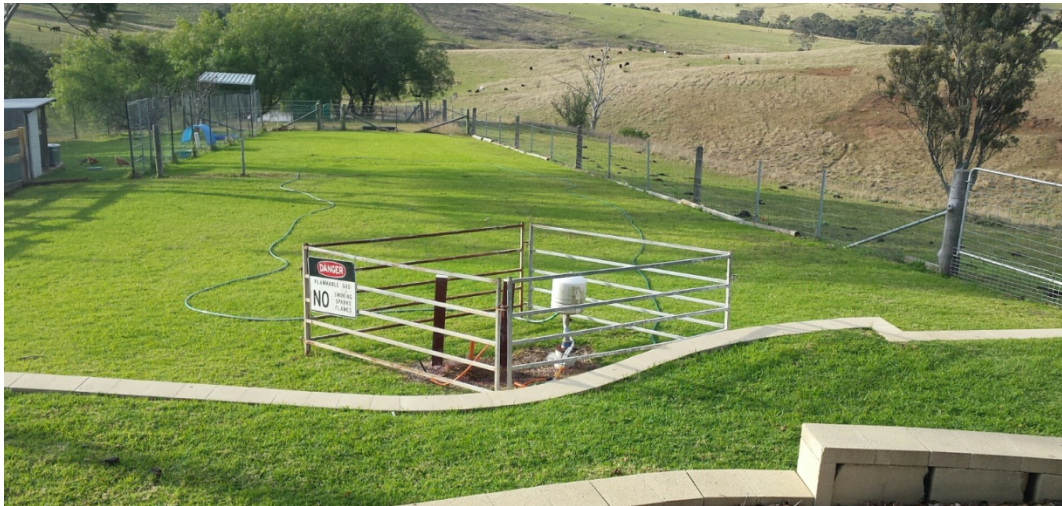
An inspection of the borehole was undertaken on the 15<sup>th</sup> July by Illawarra Coal (IC) representatives in response to feedback from the landholder in relation to water cloudiness and the smell of gas from the borehole. Strata gas was detected from the borehole. Gas and water samples were taken at the time of the inspection, with lab testing

confirming the presence of methane.

**Photo 1: Temporary fencing to existing borehole**

At the advice of IC representatives, the landholder has now ceased using the borehole and the area around the borehole has been restricted (refer Photo 1). A qualified electrician has isolated power supply to the pump to prevent use.

A 10,000 litre water tank has been provided by IC, in a location determined by the landholder for the purpose of providing water to livestock. Potable water from the water tank adjacent to the house will be used for the animals in the paddock closest to the house.

A work program is currently being developed by IC to grout the existing borehole.

A replacement borehole is anticipated to be drilled in a location determined in consultation with the landholder following the active subsidence period for Longwall 707 (unless an alternative water supply is provided at the agreement of the landholder).

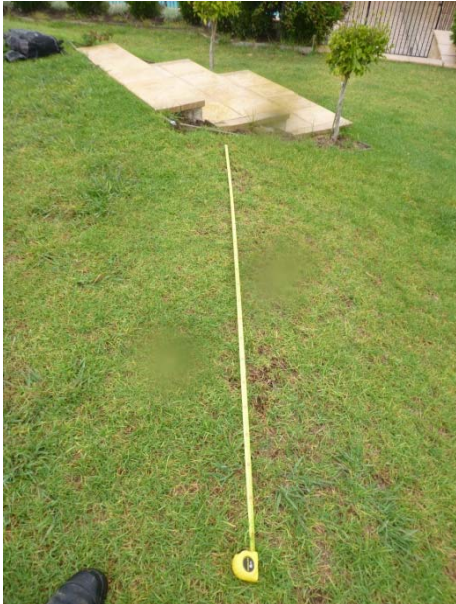
Multiple soil cracks were identified within a 30m x 35m area of the property. The approximate maximum dimensions were 2.4m long, 0.03m wide and 0.425m deep (Photos 1 and 2). The cracks do not appear to pose a safety hazard and with no further movements are expected to self-remediate. The landholders have been advised to report any changes to S32IC.

**Photo 1:** Longest identifiable soil crack on landholder's property. Taken on 04/01/2016.

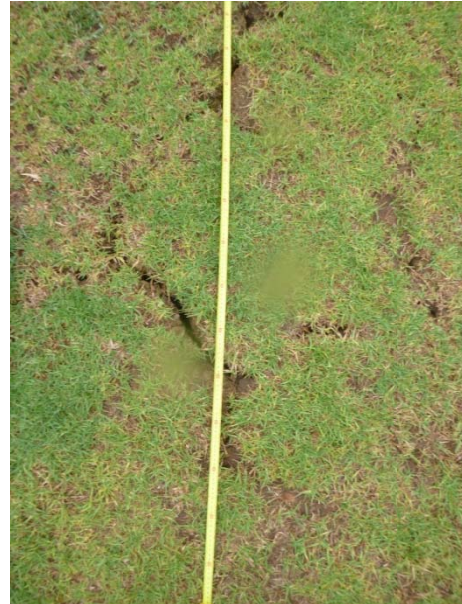
**Photo 2:** Widest identifiable crack on landholder's property. Taken on 04/01/2016.

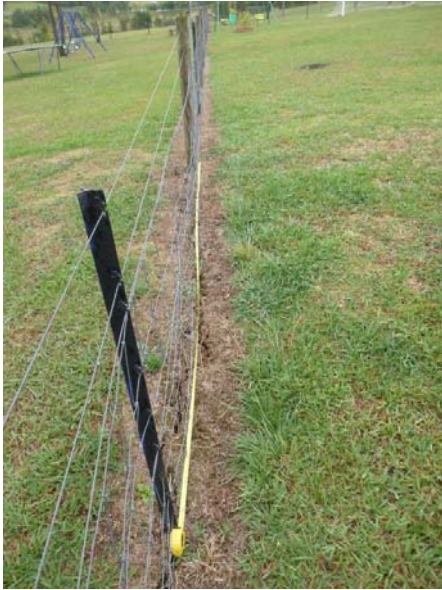
Cracking was identified along a fence line located within the property (Photo 3). Total length of cracking was approximately 65m, with a maximum width of 0.03m and depth of 0.1m. The cracks do not appear to pose a safety hazard and with no further movements are expected to self-remediate.

**Photo 3:** Cracking along fence line. Taken on 04/01/2016.

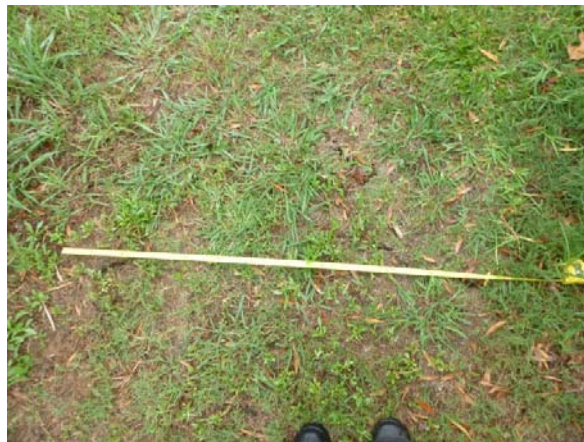
A soil crack was identified at the base of the north-western section of the Dam E16d01 wall (Photo 4). The crack was approximately 1.3m long, with a maximum width and depth of 0.02m and 0.03m respectively. The crack does not appear to pose a safety hazard and with no further movements is expected to self-remediate.

**Photo 4:** Cracking to base of dam wall. Taken on 04/01/2016.
