**WEST CLIFF AREA 5  
LONGWALL 38 END OF  
PANEL REPORT**

**31 May 2016**

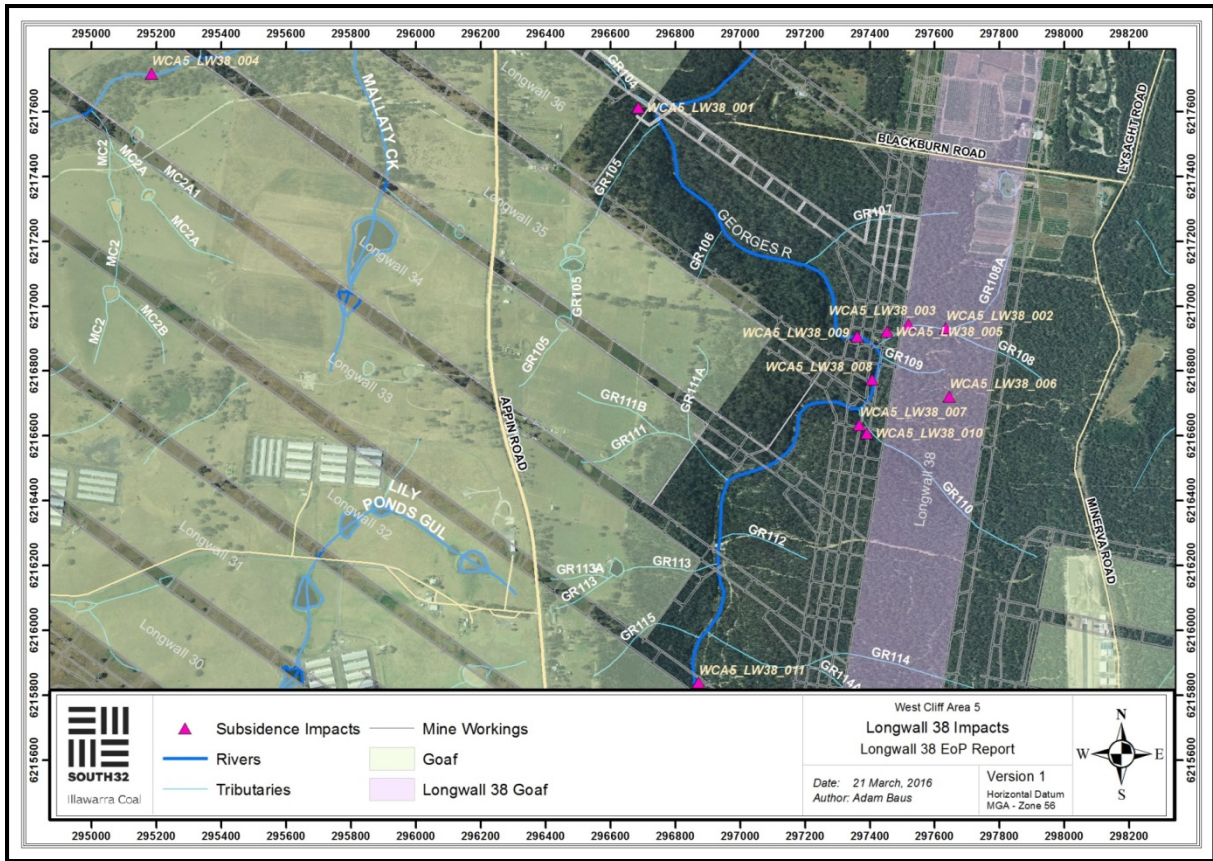
Figure 5-1: Georges River Impacts reported during Longwall 38 Extraction

Fracturing was identified in the Georges River at GR\_Rockbar\_49. The largest fracture at this site is 10m long and 0.04m wide. Flow diversion was observed and the impact is a Level 2 Trigger under the TARPs.

| Site ID | Impact Type | Date | Activating Longwall | Feature Affected | Impact Description | Trigger Level | Report/s Date |
|---|---|---|---|---|--|---|--|
| WCA5_L<br>W38_008 | Rock Fracturing | 10/12/2015 | LW38 | Georges River | Multiple fractures and dislodgment of rocks on GR_Rockbar 49. Fractures range from 1.3m to 10m long. Flow diversion evident. | Level 2 | 11 <sup>th</sup> December<br>2015 |
| WCA5_L<br>W38_009 | Iron Staining | 10/12/2015 | LW38 | Georges River | 20m section of iron staining downstream of GR_Pool 49. | Level 1 | 11 <sup>th</sup> December<br>2015 |
