Illawarra Coal

Dendrobium Area 3B Longwall 10 End of Panel Report

May 2015

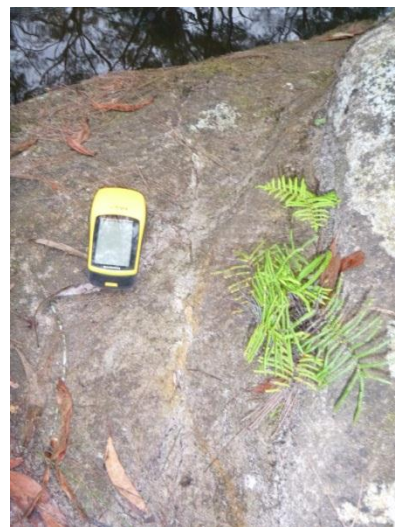
An extension of impact DA3B_LW9_017 was recorded during Longwall 10 extraction (Photo 1 and Photo 2). Due to the weathered nature of the fracture, it does not appear to have occurred recently and was likely hidden from view due to sand and debris that typically lines the banks of Wongawilli Creek.

Photo 2: Impact DA3B_LW9_017. Taken on 16/12/2014

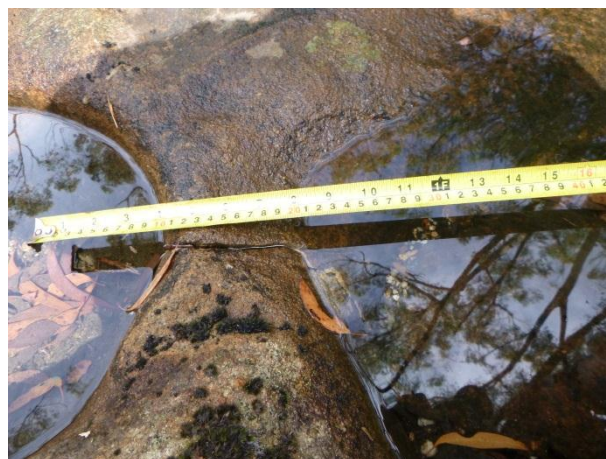
Three TARP Level 1 fractures have been observed in WC21 (Photo 3, Photo 4 and Photo 5) and have been identified as DA3B_LW10_010, 013 and 020 respectively (Figure 6). No water loss or flow diversion was observed from these impacts.

Photo 5: Impact DA3B_LW10_020 Fracturing to WC21_Rockbar 24. Taken on 02/02/2015

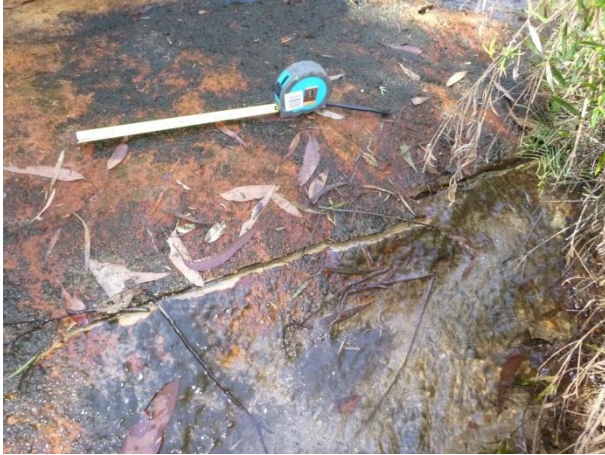
Thirteen TARP Level 2 fractures have been identified in WC21 (Figure 6), resulting in an observable diversion of surface water (Photo 6 and Photo 7). Two of these fractures were identified during Longwall 10 extraction as extensions of existing Longwall 9 impacts DA3B_LW9_014 and 016 (Photo 12 and Photo 13).

Photo 6: Impact DA3B_LW10_007 – rock fracture with reappearance of localised flow diversion. Taken on 18/11/2014

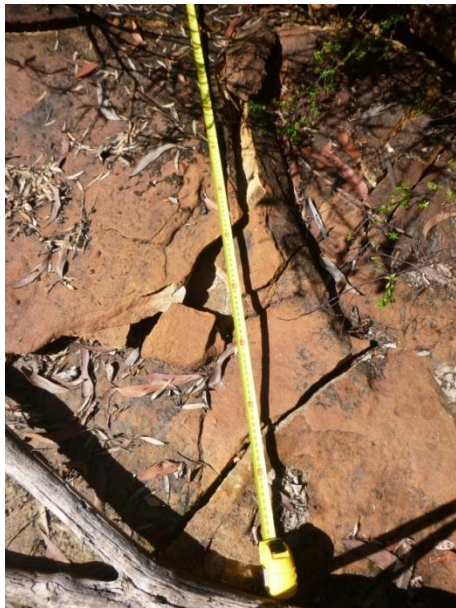
Additionally, during the inspection carried out on the 3rd of March 2015, an extension of an existing impact was observed. Within impact DA3B_LW10_009 a zone of fracturing and uplift was identified below the lip of WC21 Rockbar 23 (Photo 10 and Photo 11). The impact remains as a Level 2 trigger according to the WIMMCP TARPs dated June 2014.

Photo 10: Impact DA3B_LW10_009 – Length of longest fracture with uplift. Taken on 03/03/2015

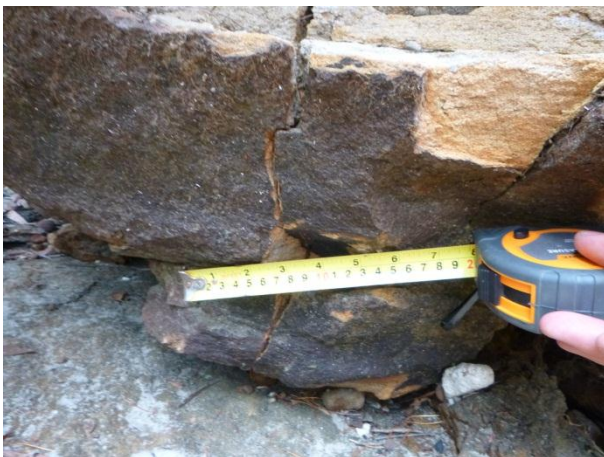
During Longwall 10 extraction, two extensions of existing Longwall 9 impacts were identified within WC21. Extensions of fractures were observed to impacts DA3B_LW9_014 and 016 (Photo 12 and Photo 13). The fractures ranged from 0.5m to 3.1m long and hairline to 0.03m in width. These impacts are Level 2 Triggers according to the WIMMCP TARPs dated December 2013.

Photo 12: Impact DA3B_LW9_014 – Widest point of vertical fracture. Taken on 04/05/2015

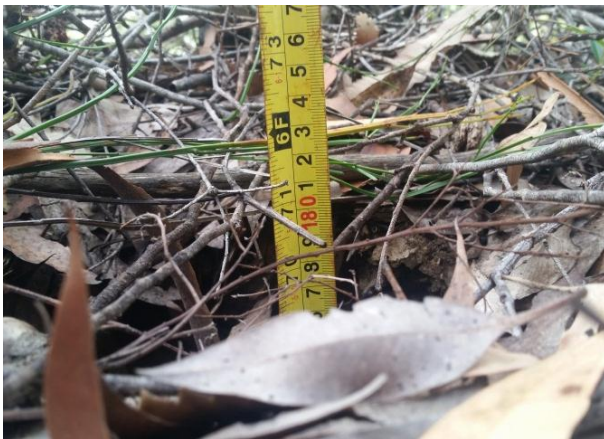
This impact is a Level 2 trigger under the TARPs set out in Table 1.2 of the DA3B SMP, Volume 2 (November 2012), as shown in Table 11, Specifically:

- Crack or fracture between 100 and 300mm width,
- Crack or fracture between 10 and 50m length, and
- A crack at the surface with the potential risk to safety and/or fauna entrapment.

Photo 14: Impact DA3B_LW10_024. Depth of crack. Taken on 18/02/2015

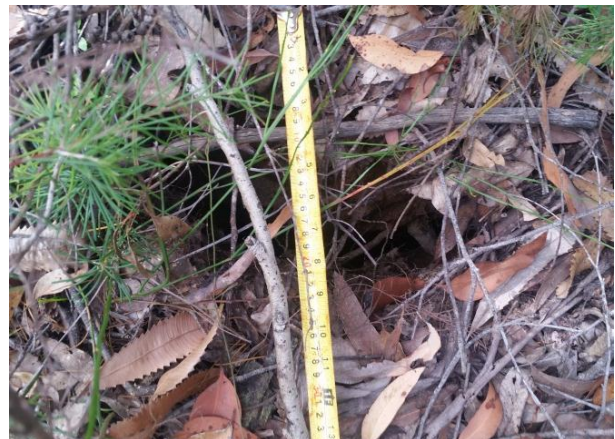
Photo 15: Impact DA3B_LW10_024. Width of crack. Taken on 18/02/2015

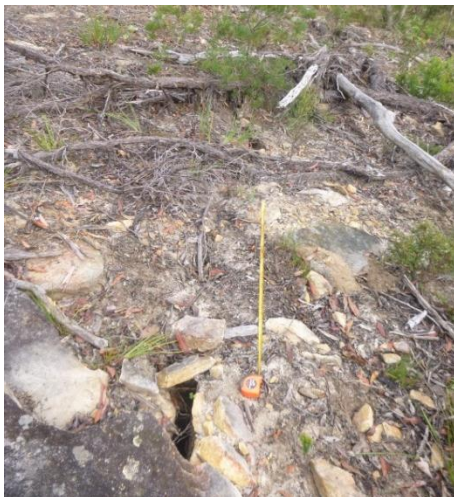
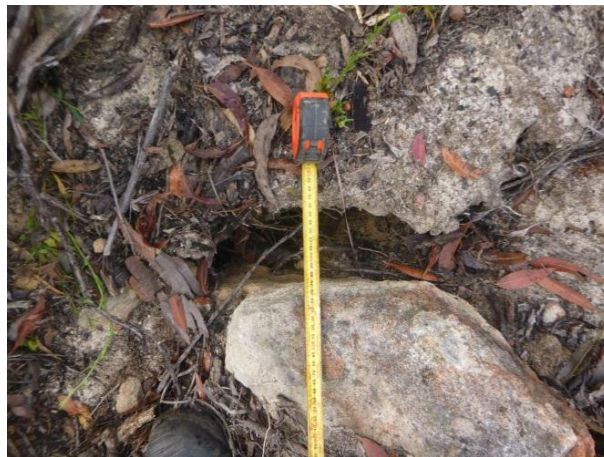
Impact DA3B_LW10_025 consisted of a single soil crack to a seismic track adjacent to Access Track 6000. The crack measured approximately 14m long, 0.1m wide and 1.4m deep (Photo 16 and Photo 17). At the time of identification, the crack was in the process of infilling and will most likely self-remediate.

This impact is a Level 2 Trigger under the TARPs set out in Table 1.2 of the Dendrobium Area 3B SMP, Volume 2 (November, 2012), specifically:

- Crack or fracture between 100 and 300mm width, and
- Crack or fracture between 10 and 50m length

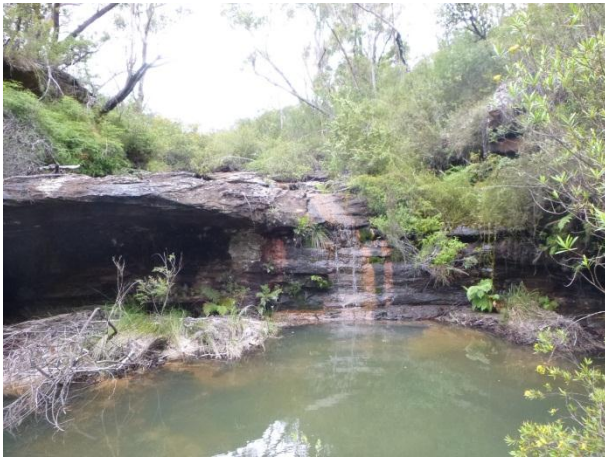
Iron staining and water cloudiness have been previously observed in WC21 (DA3B_LW9_019, Photo 24). During Longwall 10 extraction the iron staining and cloudiness has extended from WC21_Pool 10 downstream to WC21_Pool 4 (Photo 25 and Photo 26). An inspection of the confluence of WC21 and Wongawilli Creek indicated that the iron staining and water cloudiness is no longer visible at that point (Photo 27).

Photo 24: Impact DA3B_LW9_019 – WC21_Pool 10 looking upstream. Taken on 24/12/2013

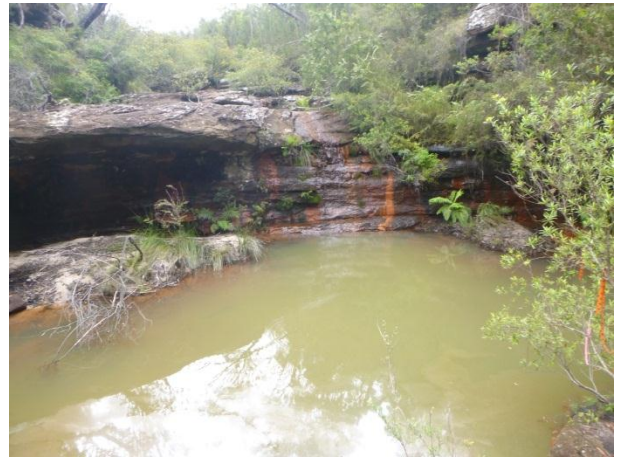
Photo 25: Impact DA3B_LW9_019 – WC21_Pool 10 looking upstream. Taken on 18/12/2014

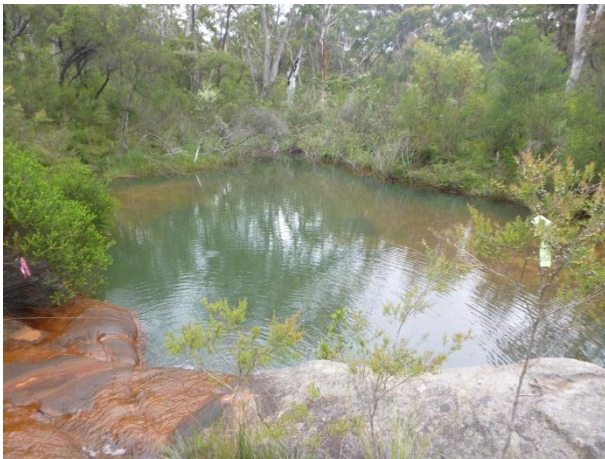
Photo 26: Impact DA3B_LW10_019 – WC21_Pool 4 looking downstream. Taken on 18/12/2014

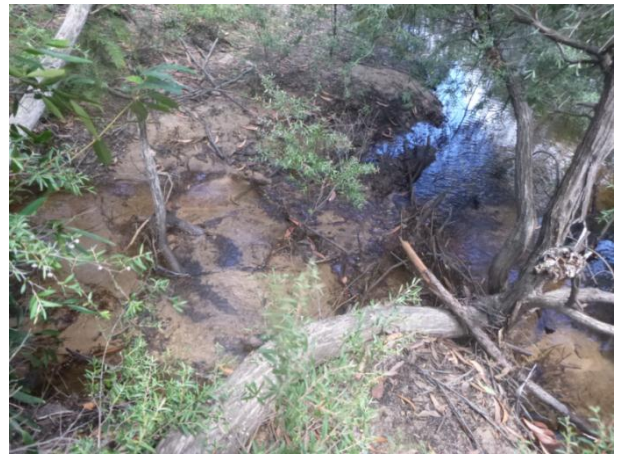
Photo 27: Confluence of WC21 and Wongawilli Creek. Taken on 16/01/2015
