SIMEC Mining – Tahmoor Coal

Management Plan for extraction of Tahmoor South LW S4A-S7A adjacent to Wellers Road Overbridge

Revision A

Prepared by Mine Subsidence Engineering Consultants
on behalf of
Transport for NSW (Country Regional Network) and Tahmoor Coal and the Rail Management Group

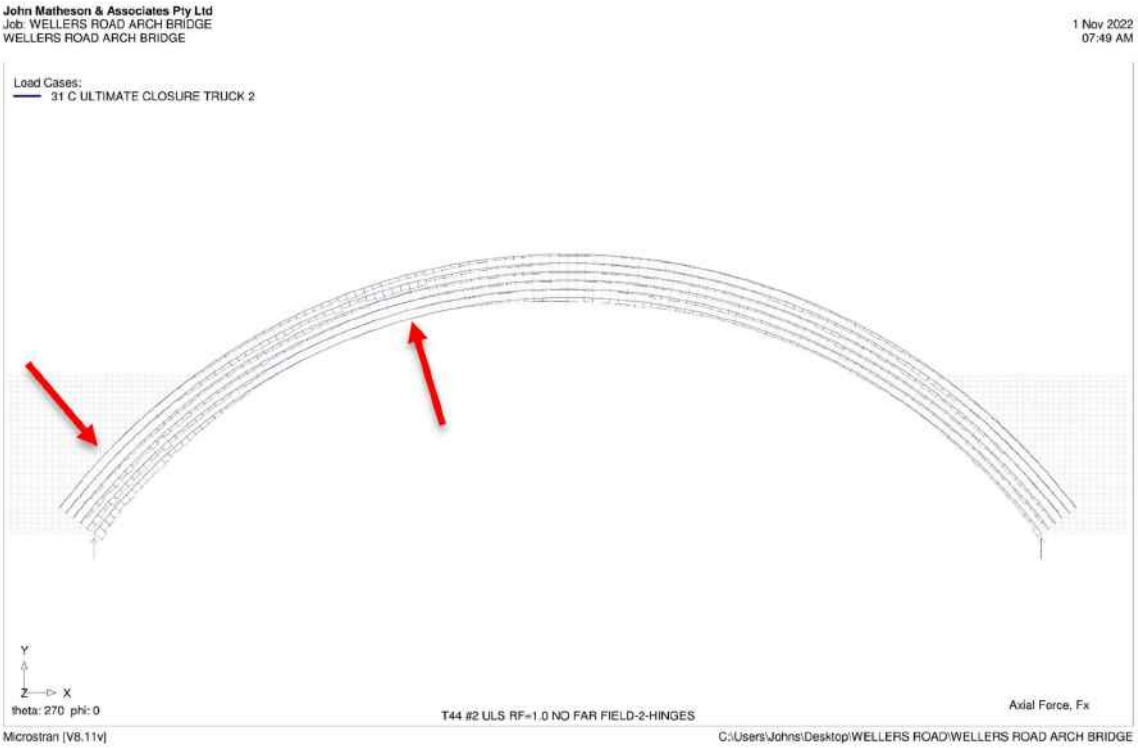
The simulation predicts a maximum compressive stress of around 8.6MPa in the concrete arch at ULS with a rating factor of RF=1.0, see **Figure 11**. The analysis predicts that two hinges could develop at ULS, indicated by the red arrows, see **Figure 10**.

Figure 10 The numerical model predicts that two (2) hinges will develop for T44 #2 truck load (centred at ¼ span) at ULS with a rating factor RF=1, red arrows indicate the hinge locations.

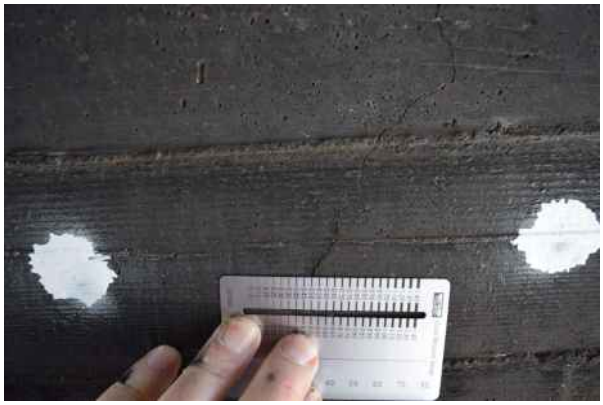
Figure 17: DSC_2871 Crack 2, gauge G2 upside

Figure 16: DSC_2870 Crack 2, gauge G2 upside

Wellers Road Overbridge at 101.152km						
Structure Element	**22 February 2014**			**14 May 2022**		
	Observed Damage	**Image**	**Damage Classification**	**Observed Damage**	**Image**	**Damage Classification**
External face of Sydney spandrel wall	i. Fine stepped cracking rising from the concrete arch in line with the vertical face of the downside abutment, stepping upwards before running horizontally eastward through the brick buttress approximately 5-courses below the spandrel corbel. Water staining is evident on the brick surface. ii. A fine stepped crack on the upside brick corbel where the concrete arch bears on the corbel. The crack extends horizontally across the nearby brick buttress. iii. A vertical crack on the upside end of the Sydney parapet beyond the upside abutment. iv. Bricks are missing from the parapet header-course.		Cracking generally up to Category 1 cracking (0.1mm<w<1.0mm) observed but could slightly exceed Category 1, reaching Category 2 in some locations.	i. Fine stepped cracking rising from the concrete arch in line with the vertical face of the downside abutment, stepping upwards before running horizontally eastward through the brick buttress 7-courses below the spandrel corbel. Water staining is evident on the brick surface. ii. A fine stepped crack in the upside brick corbel where the concrete arch bears on the corbel. The crack extends horizontally across the nearby brick buttress. iii. A vertical crack in the upside end of the Sydney parapet beyond the upside abutment. iv. Bricks are missing from the parapet header-course.	**Figures 37-48, 61**	Cracking generally up to Category 1 (0.1mm<w<1.0mm) observed but could slightly exceed Category 1, reaching Category 2 in some locations towards the cutting, which was not accessible.

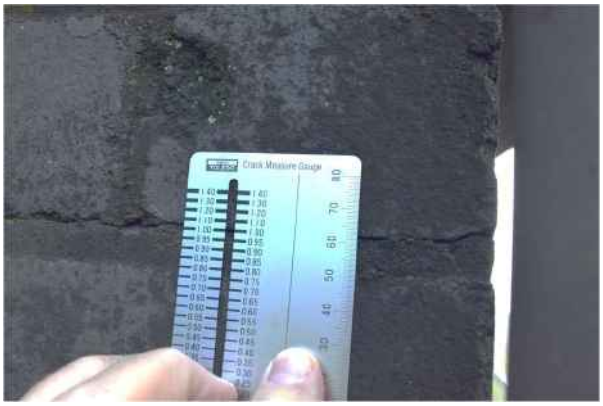
Figure 53: DSC_2837 Underlying crack width < 1mm

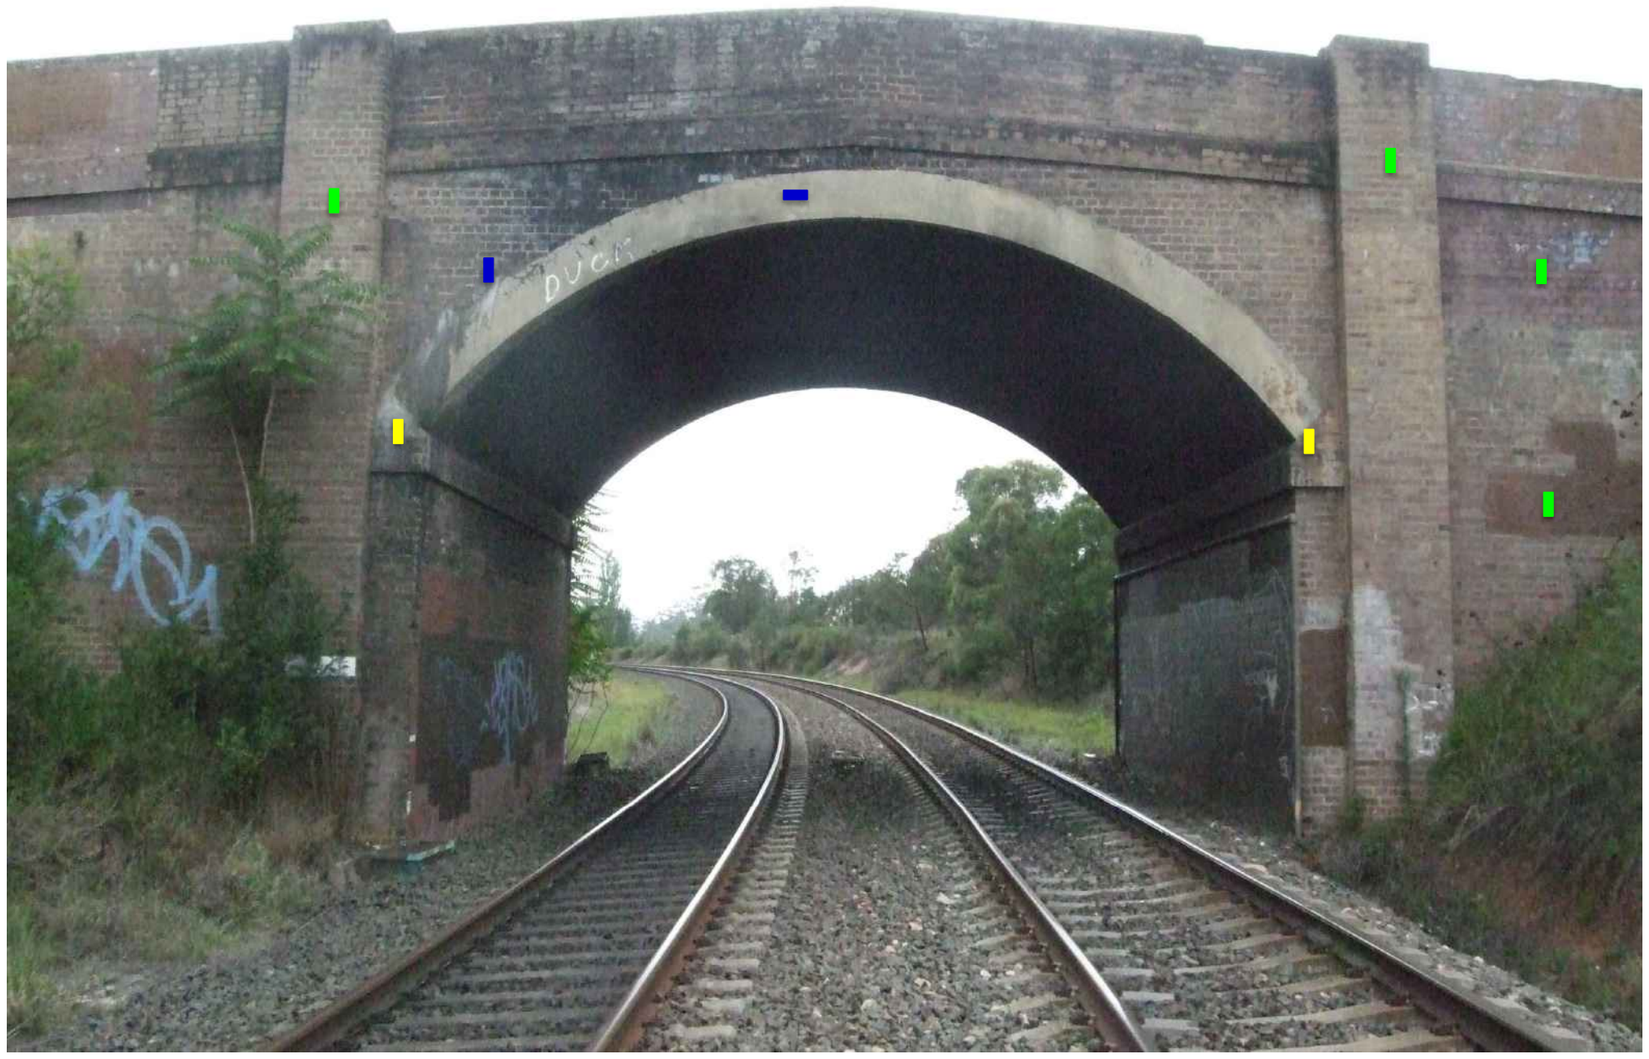
Figure 61 Sydney spandrel wall elevation showing location of 4# Type 1 (lime-green) & 2# Type 2 (dark blue) crack gauges and 2# tell-tale marks, yellow.

Figure 62 Country spandrel wall elevation showing location of 2# Type 1 (lime-green) & 2# Type 2 (dark blue) crack gauges and 2# tell-tale marks, yellow.

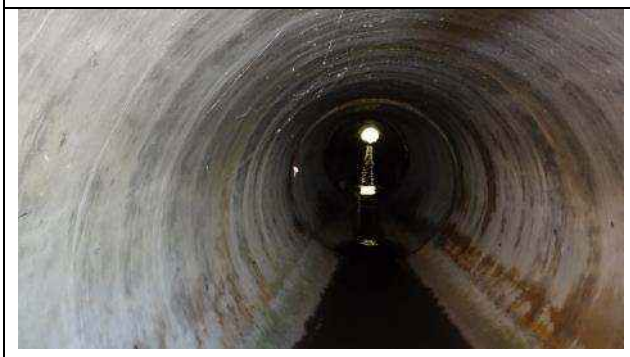
98.739km downside culvert RCP extension

- No evidence of current or past embankment instability observed.
- No evidence of culvert piping erosion observed.
- No requirement for any remedial works identified.

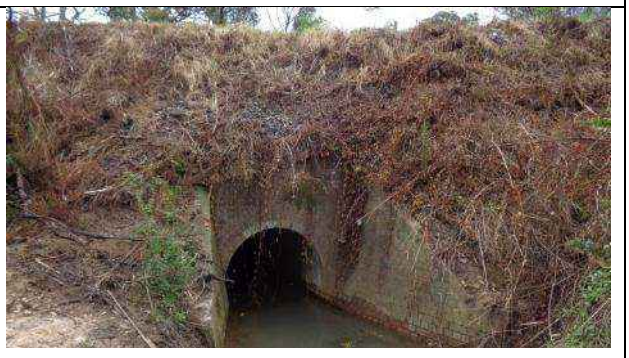
100.430km upside culvert (upstream)

Based on the existing embankment profile and the performance of similar embankments on the main line subject to subsidence; the impact of the predicted subsidence at this location on batter stability is expected to be minimal. The embankment is located near the centreline of LWS5A.

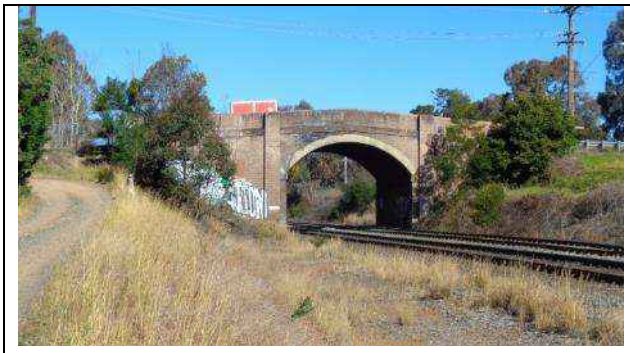
101.162km Wellers Road overbridge view from city

Brief geotechnical assessment of the cutting at 101.162km did not note any evidence of current or past cutting instability or fault structures.
