Tahmoor Coal Pty Ltd

SIX MONTHLY SUBSIDENCE IMPACT REPORT

Tahmoor North, Western Domain Longwalls West 1 and West 2

Report 3 – May 2021

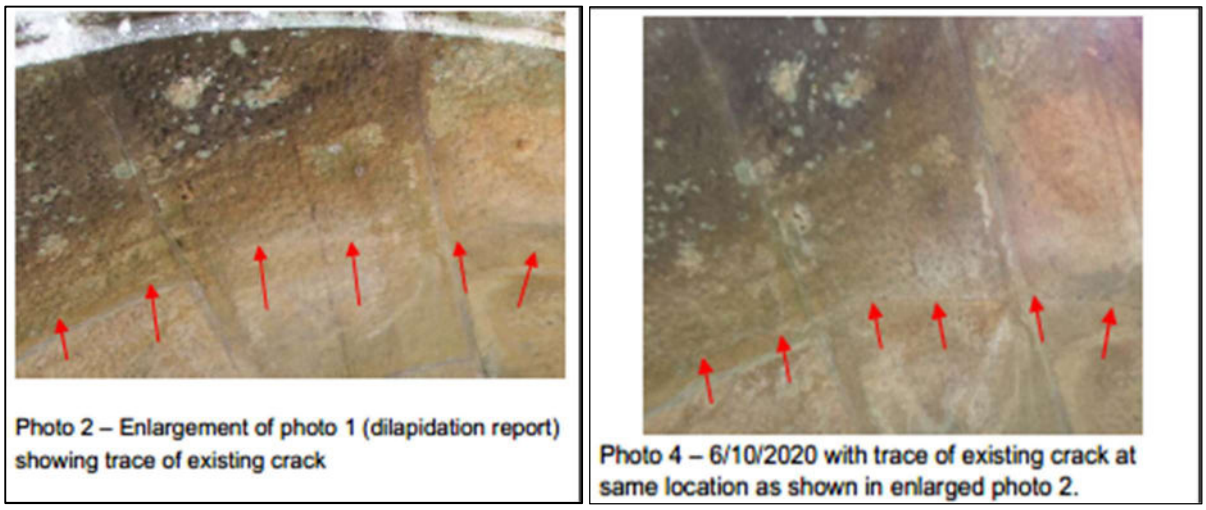
- Historical Heritage TARP – Level 2 Trigger for Sandstone Culvert impacts at 89.629km as a result of a small traverse crack up to 2mm. This cracking is related to the minor

opening of an existing crack (previously reported and not adversely affecting the structural integrity of the culvert);

The impact to the sandstone culvert at 89.629 km was discussed in detail during the previous Six-Monthly Subsidence Impact Report. A small traverse crack up to 1 mm in width was observed in late August to early September 2020 (refer **Figure 2-1**), and was noted to be a minor pre-existing crack that was likely formed due to lateral loading from the retaining wall and steep batter slope. It is possible that the recent minor subsidence effect may have resulted in slight opening of the crack.

The crack was noted to have slightly opened up to 2 mm during subsidence effects on 17 November 2020 (refer to PMLL Detailed Monitoring Report 53; **Appendix E**). No further changes were noted for the remainder of the reporting period.

Figure 2-1 Pre-mining and current photos of the crack at culvert 89.629 km (source: PMLL Detailed Monitoring Report 47, **Appendix E**).

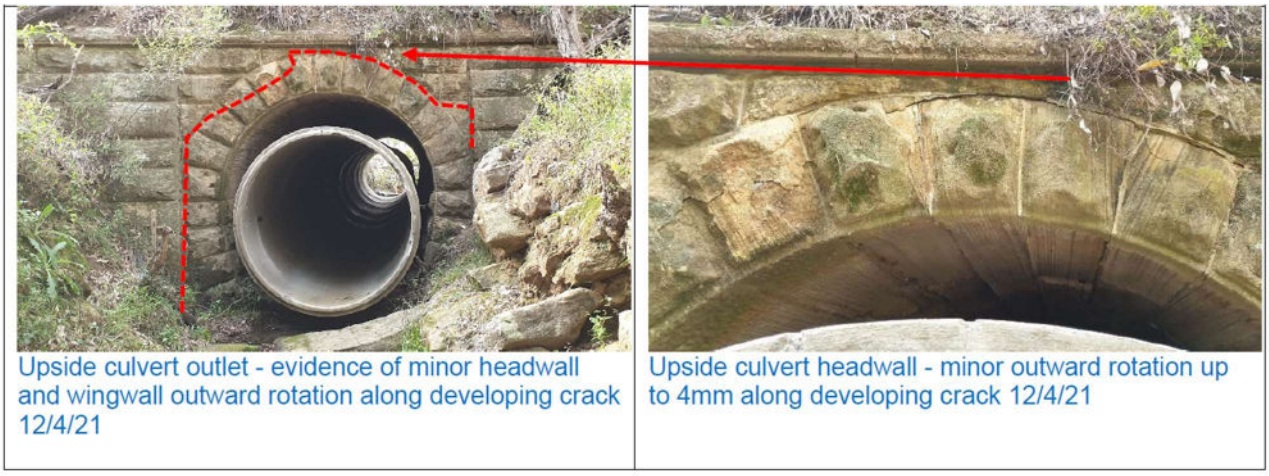
- Historical Heritage TARP – Level 2 Trigger for Sandstone Culvert Impacts at 88.980 km – minor separation and circumferential cracking. These cracks are noted to be minor and are not adversely affecting the structural integrity of the culvert;

- Minor separation and circumferential cracking of the sandstone block arch obvert predominantly along mortar bed indicative of outward rotation of the headwall up to 4mm with some associated spalling of sandstone block facing.
- Vertical crack along mortar up to 4mm at city side junction between wingwall and headwall with outward rotation of the wingwall up to 4mm.

These changes were noted in the PMLL Detailed Monitoring Report 19 (**Appendix E**) and are illustrated in **Figure 2-3**. No further movement was noted during the reporting period.

Figure 2-3 Cracking at culvert 88.980 km (source: PMLL Detailed Monitoring Report 19, **Appendix E**).

These cracks are noted to be minor and are not adversely affecting the structural integrity of the culverts. However, these observations triggered a Level 2 TARP trigger for historical heritage in October 2020, November 2020, February 2021, March 2021 and April 2021.

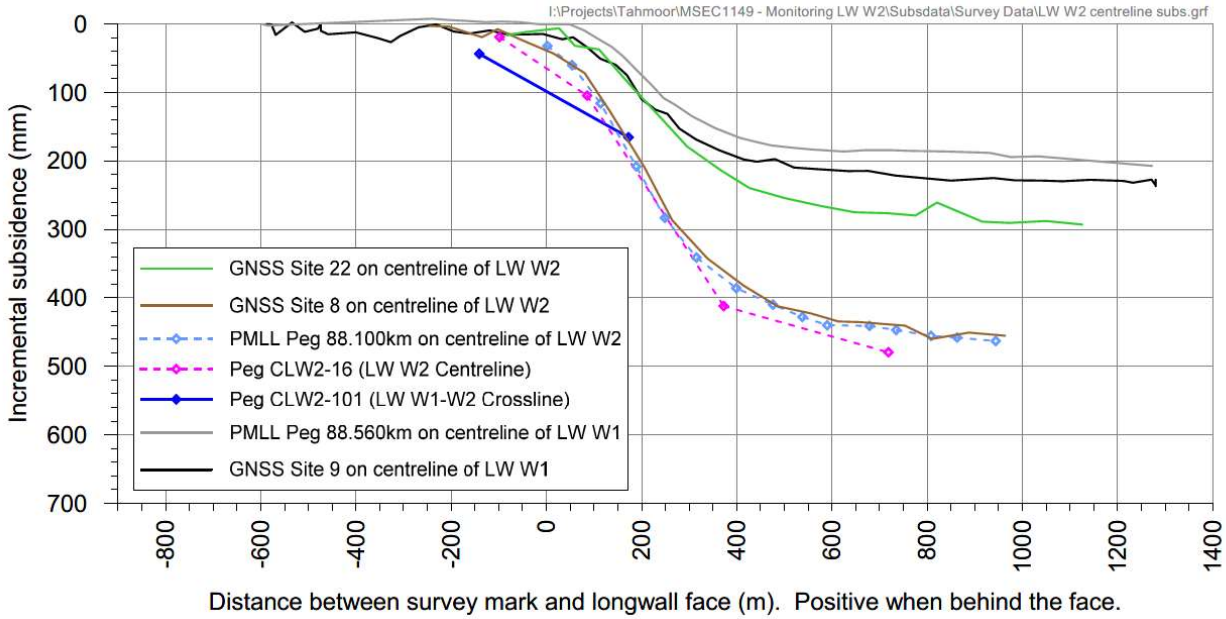
The development of subsidence at pegs and GNSS units located on the LW W2 centreline that have been mined directly beneath by LW W2 are illustrated in **Figure 4-2**. This figure shows that subsidence currently observed along the centreline of LW W2 is greater than LWW1 but current trends indicate that observed subsidence will be less than predicted subsidence.

Figure 4-2 Development of subsidence along centreline of LW W2 compared to previously extracted single panels (source: MSEC, Subsidence Monitoring Report 15, Appendix A).

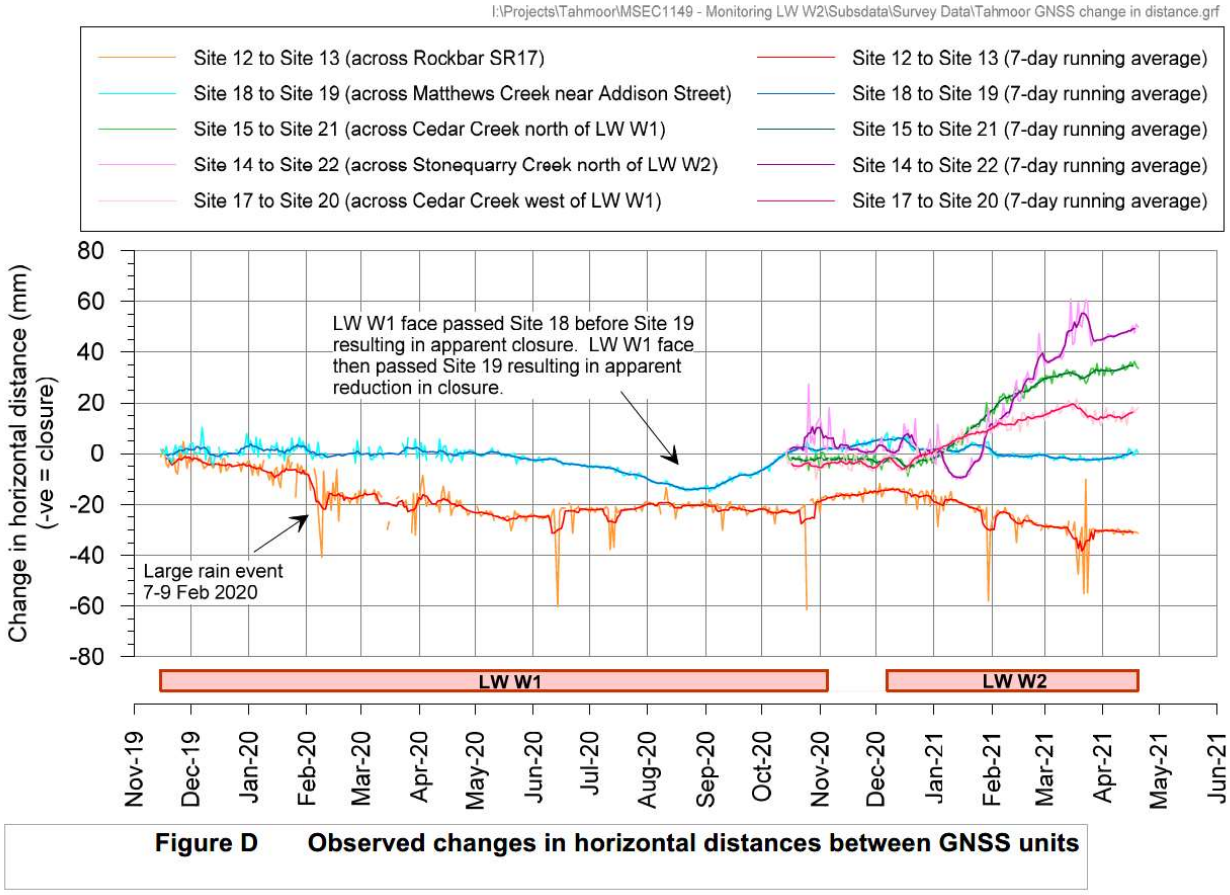
Site 13 moved south more than Site 12, resulting in closure of approximately 15 mm since the commencement of LW W2. Very little change is, however, measured across the rockbar itself and rates of change have reduced. Site 12 was observed to rise in height in response to the heavy rainfall event in late March and has stopped rising (refer **Figure 4-3**).

The LW W1 face passed Site 18 in early August 2020 and passed Site 19 in late August 2020, resulting in Site 18 moving towards LW W1 earlier than Site 19. This resulted in an apparent closure between the two sites between June and late August 2020, and an apparent reduction in closure between September to mid-October 2020 (refer **Figure 4-3**).

Figure 4-3 Observed changes in horizontal distances between GNSS units (source: MSEC, Subsidence Monitoring Report 15, Appendix A).
