# DENDROBIUM MINE – LW11 EOP REPORT

# LW11 EOP REPORT

**ILLAWARRA COAL**  
 DENDROBIUM COLLIERY - AREA 3B  
 LONGWALL 11 END OF PANEL REPORT  
 GENERAL LAYOUT & MONITORING LINES

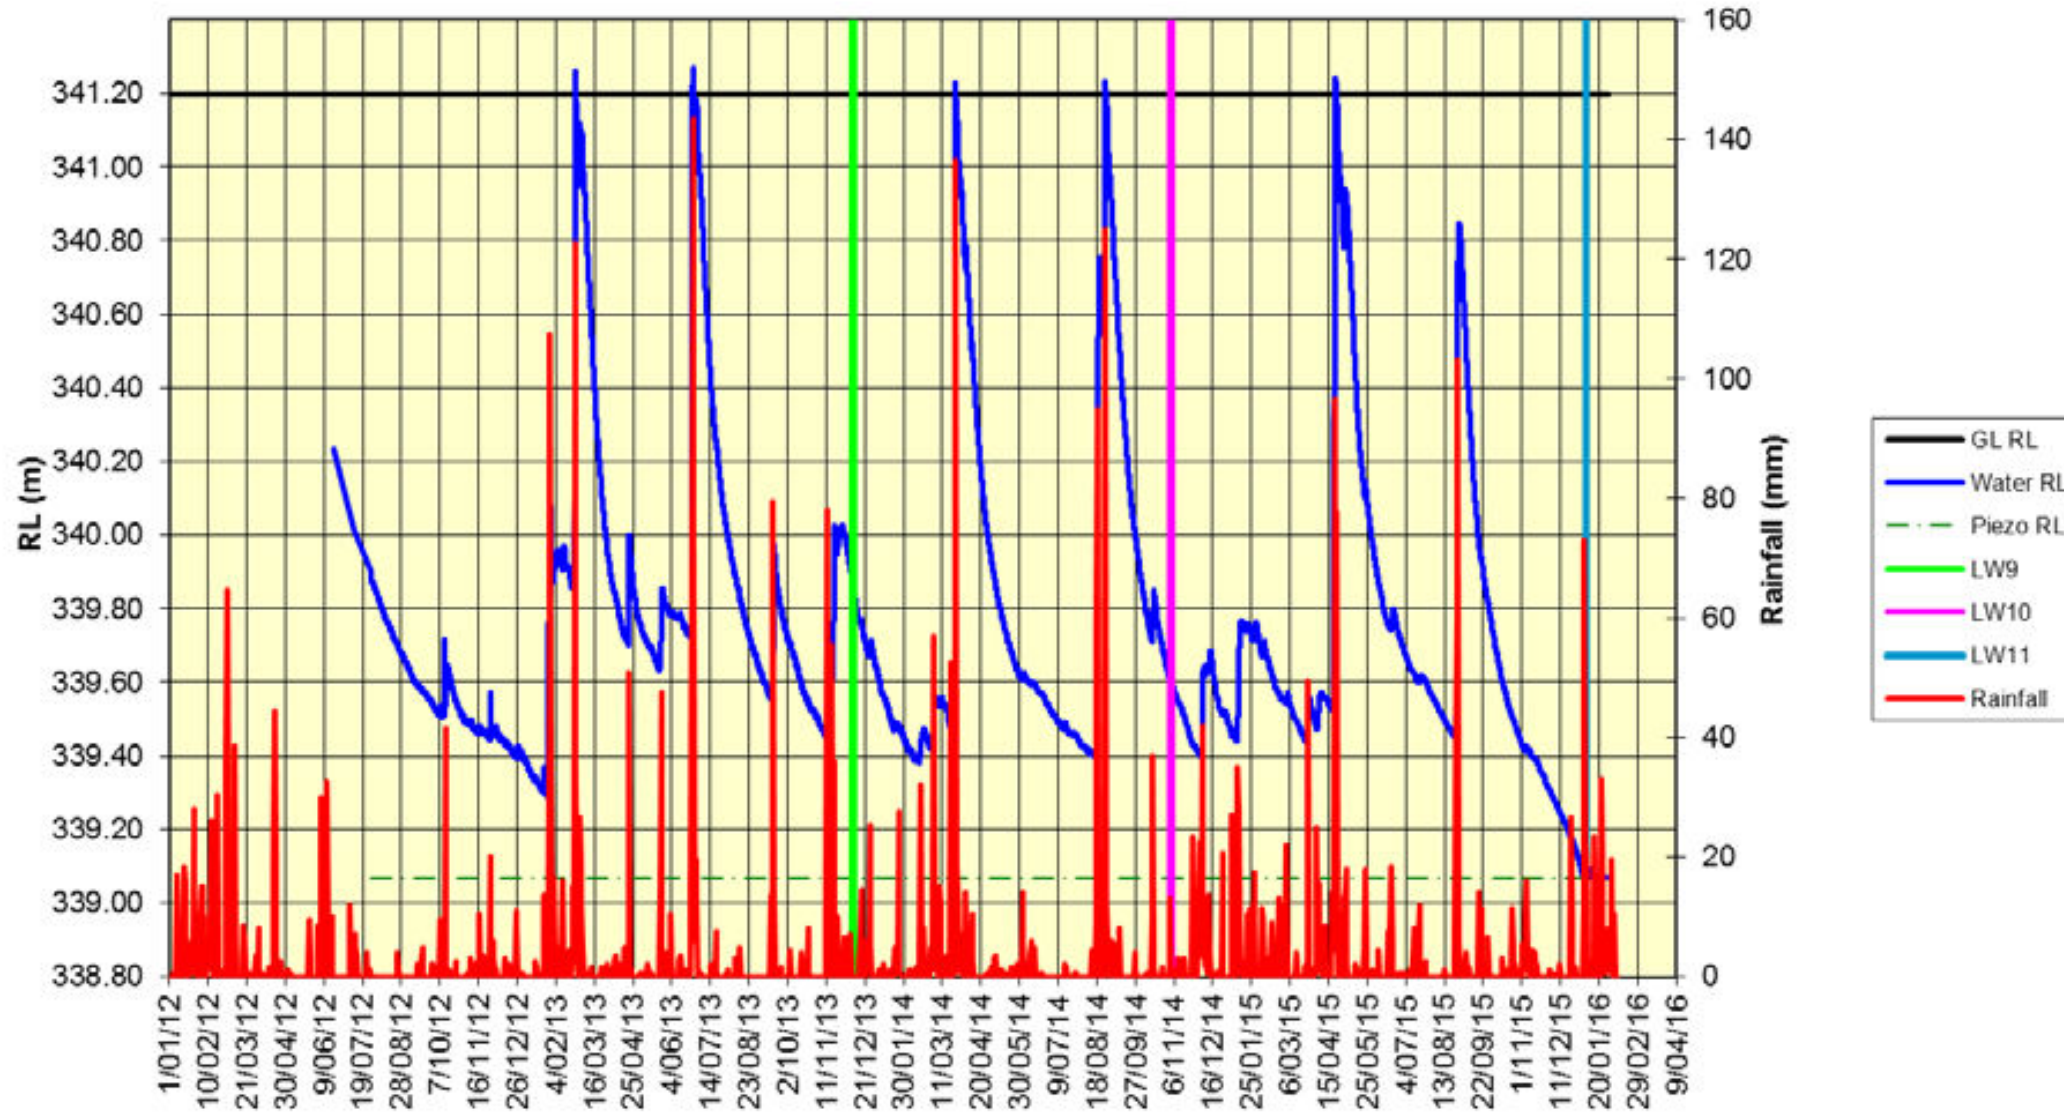
Figure 5.1: Groundwater levels measured borehole site 08\_01.

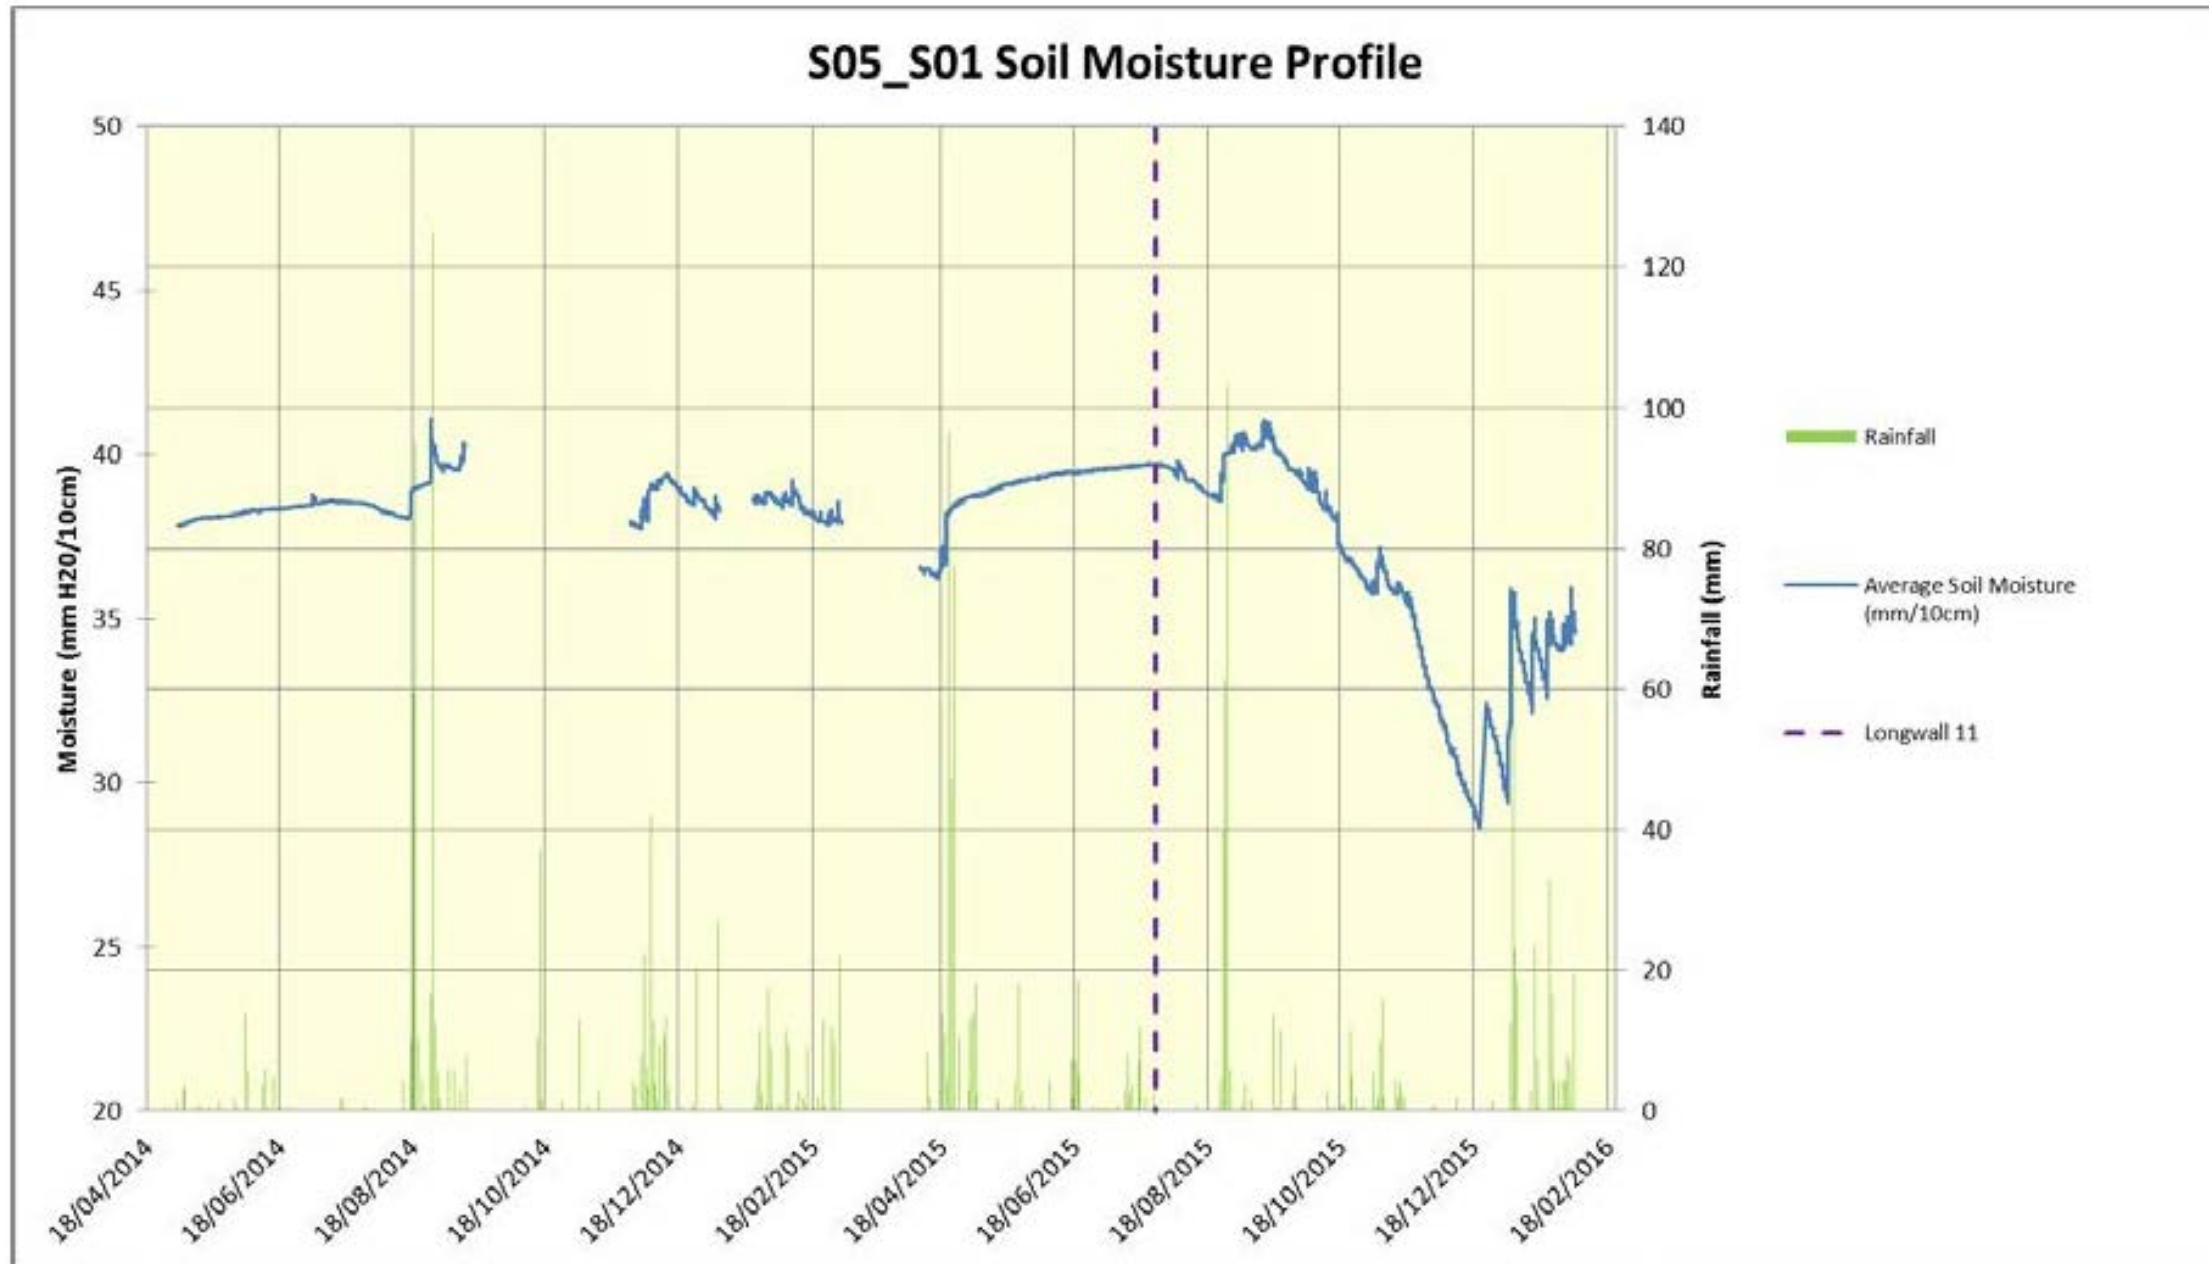
Figure 5.2: Soil moisture levels recorded at S05\_S01.

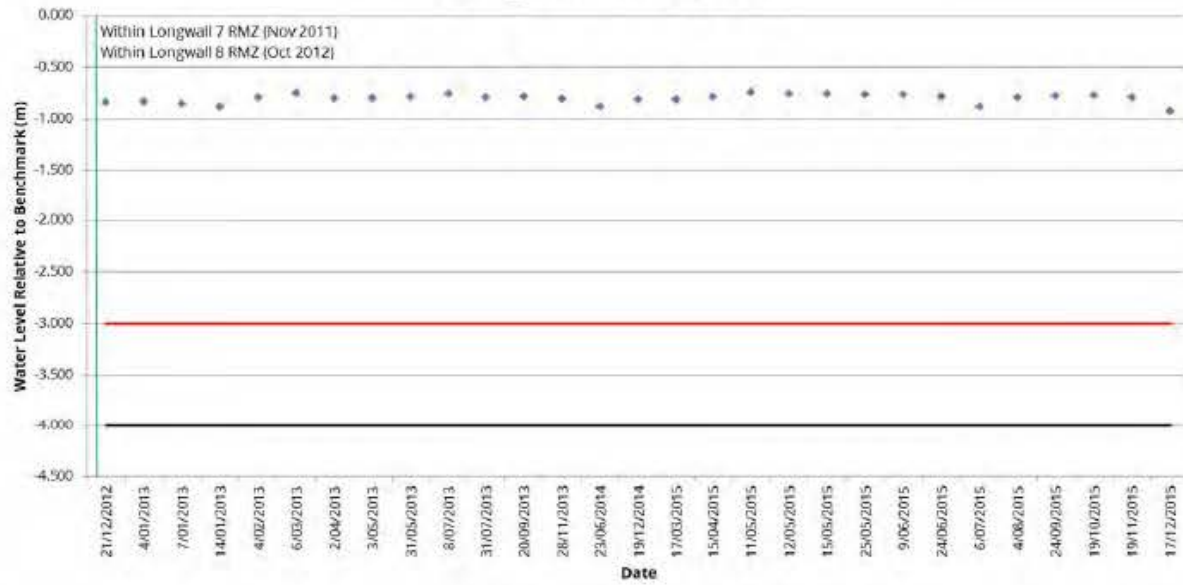
**SC10C\_Pool 1 Water Level**

**Graph 1** Water level at four pools along SC10C including three known breeding pools for Littlejohn's Tree Frog; Pool 1, Pool 3 and Pool 5 (data provided by Illawarra Coal Environmental Field Team). Red lines represent water levels below nail and black lines represent dry pool.

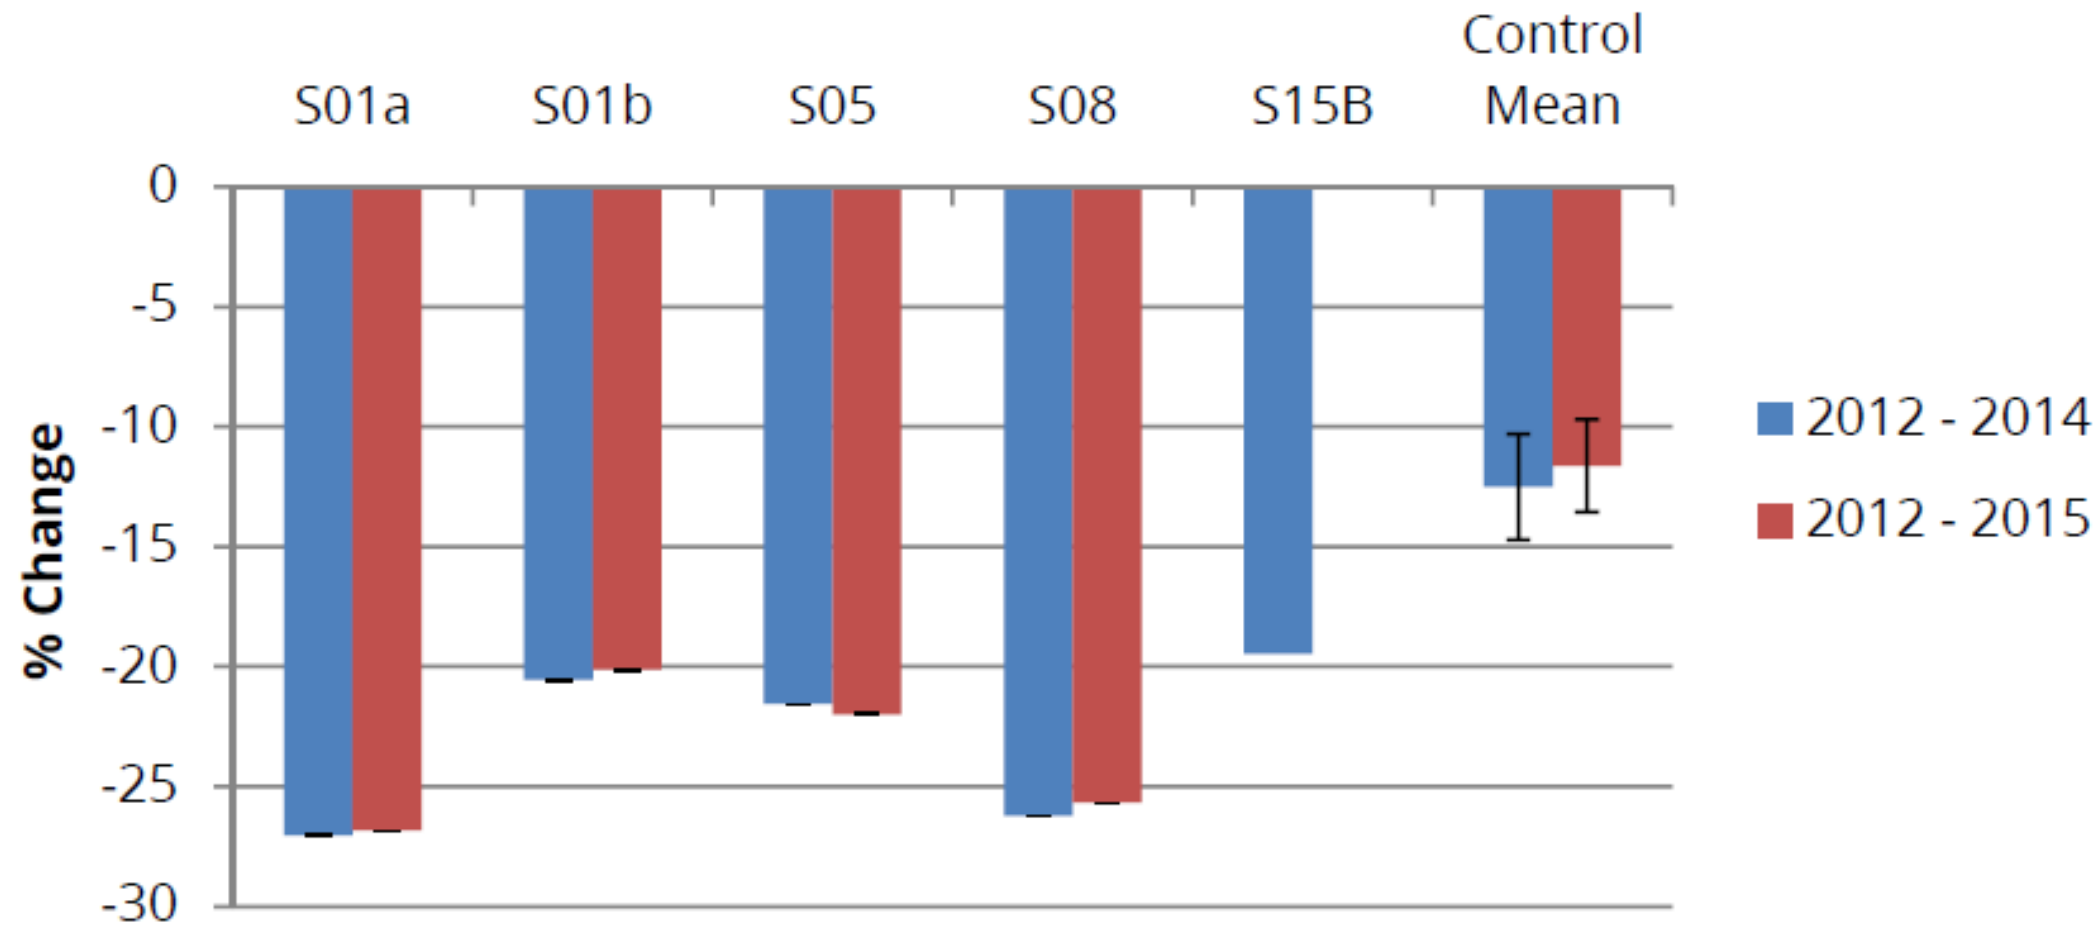
**Percent change in swamp extent from 2012 - 2014 and 2012 - 2015 at impacted swamps and mean ( $\pm$ SE) change in swamp extent from 2012 - 2014 and 2012 - 2015 at control sites.**

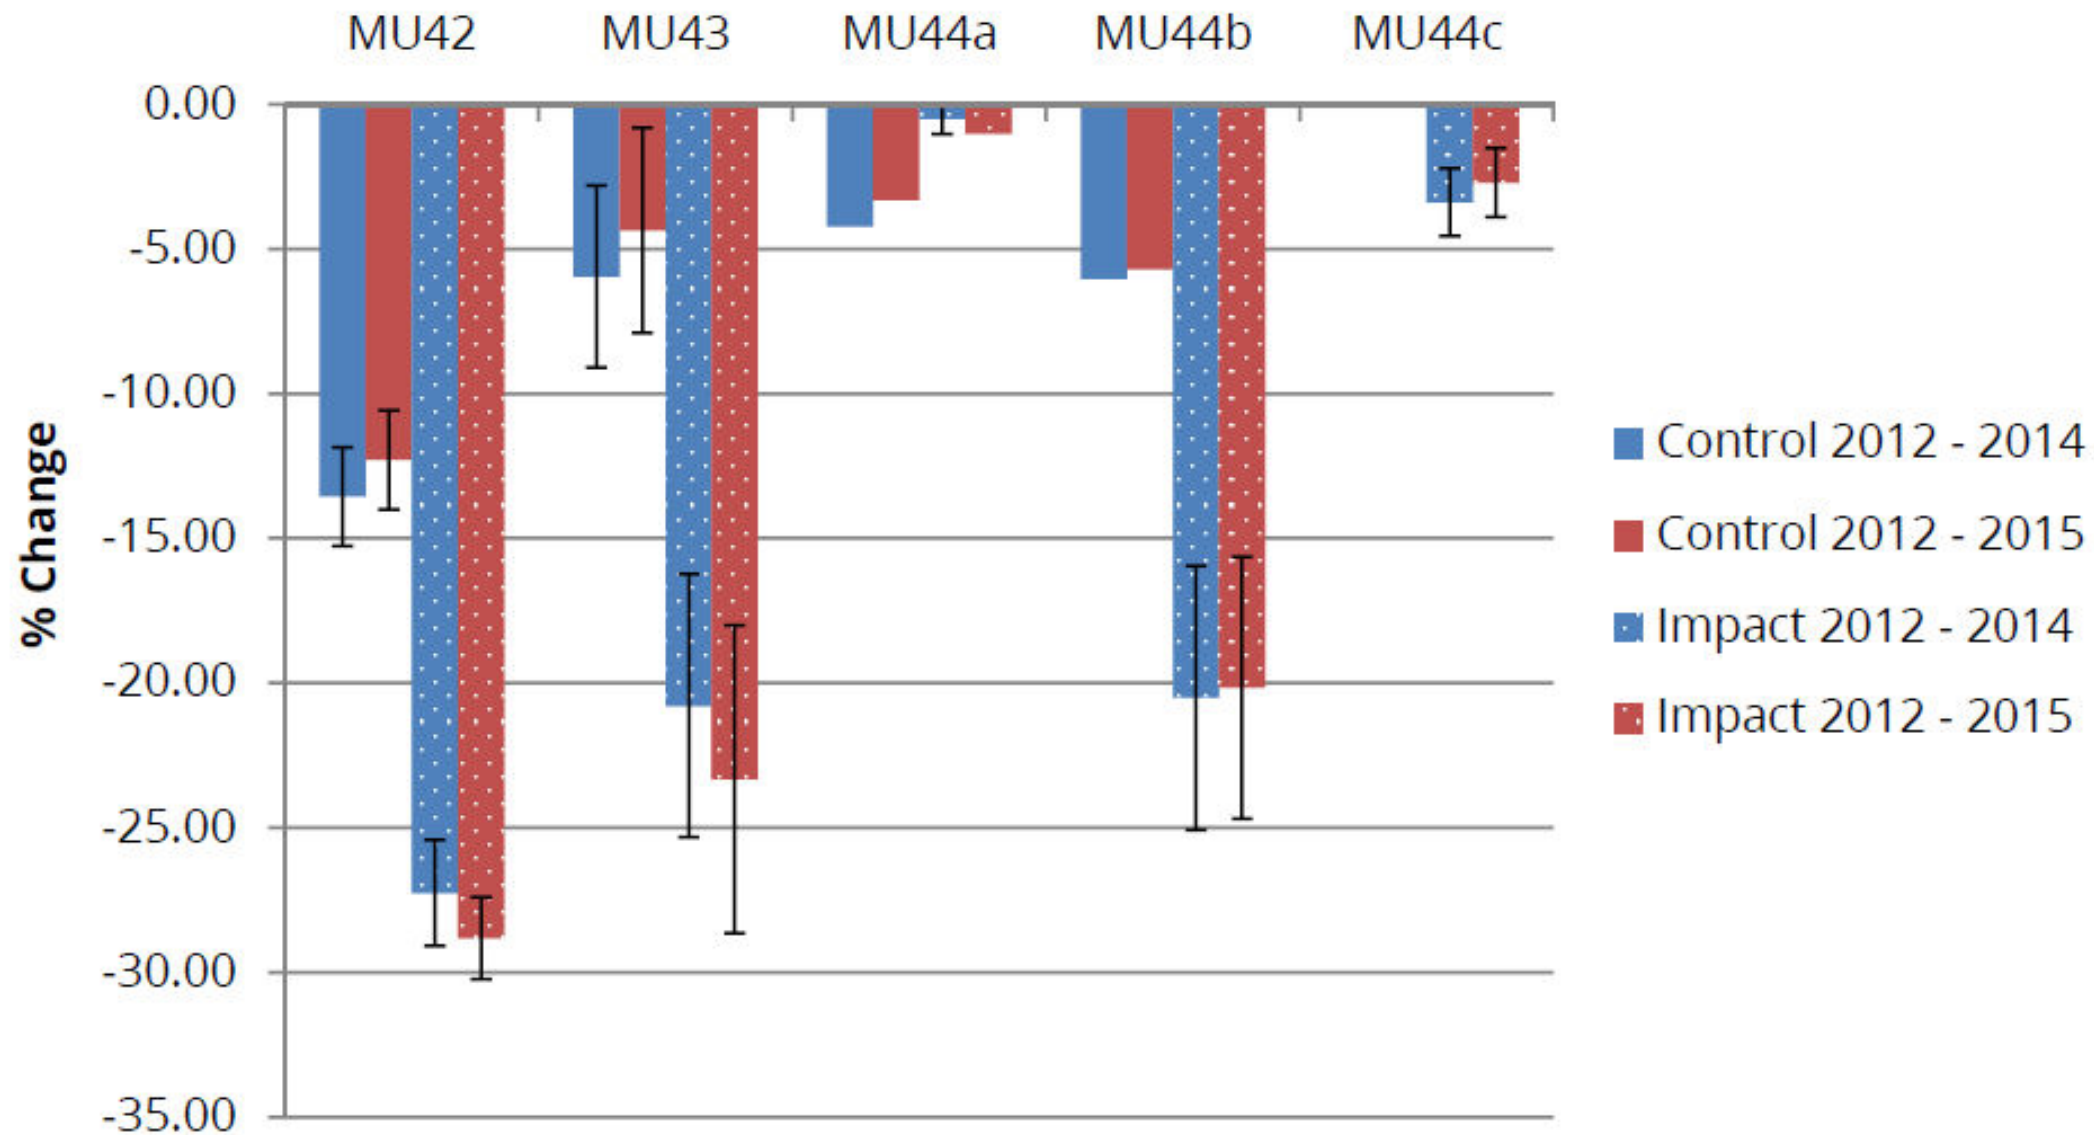
**Graph 8** Mean ( $\pm$ SE) decrease in swamp sub-community extent at impacted and control swamps across the Dendrobium 3A and 3B Areas during the periods 2012 - 2014 and 2012 - 2015.

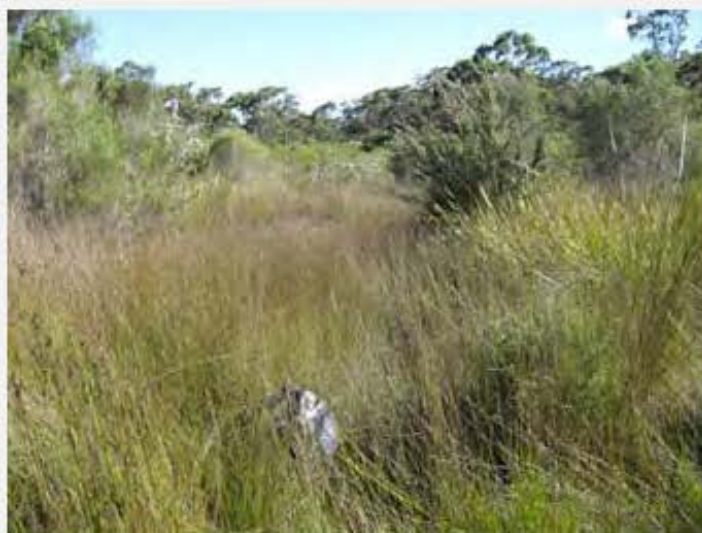
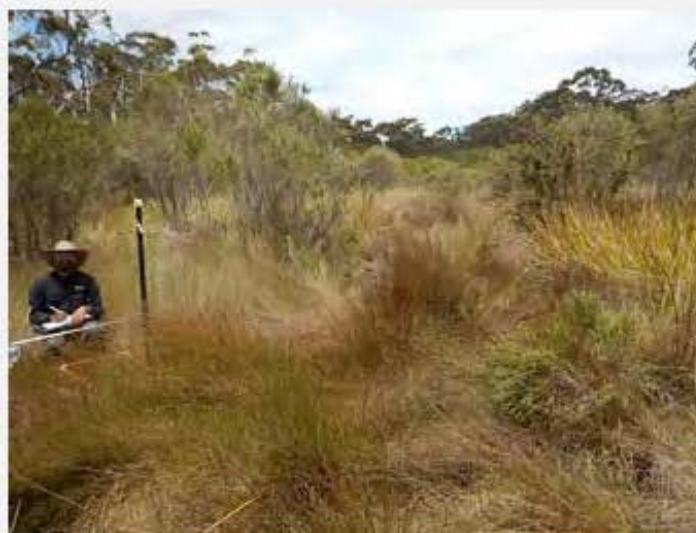
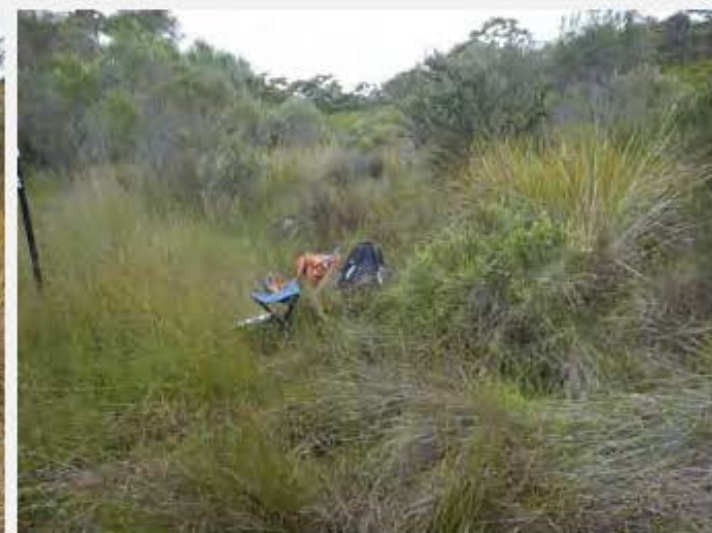
**Plate 3 Comparison of vegetation colouration at S1B-F2 South between spring 2009, spring 2014 and spring 2015.**
