Figure 1: Map Showing latest swamp triggers in Swamp 15a. Inset shows frame in relation to Dendrobium mining operations.

Table 2: Impacts and triggers since June 2023. Highlighted row indicates observations featured in this report.

### **Subsidence Impact Reports - Swamps 144 and 15a**

**Re: Dendrobium Area 3A – Impact report – 18<sup>th</sup> August 2023**

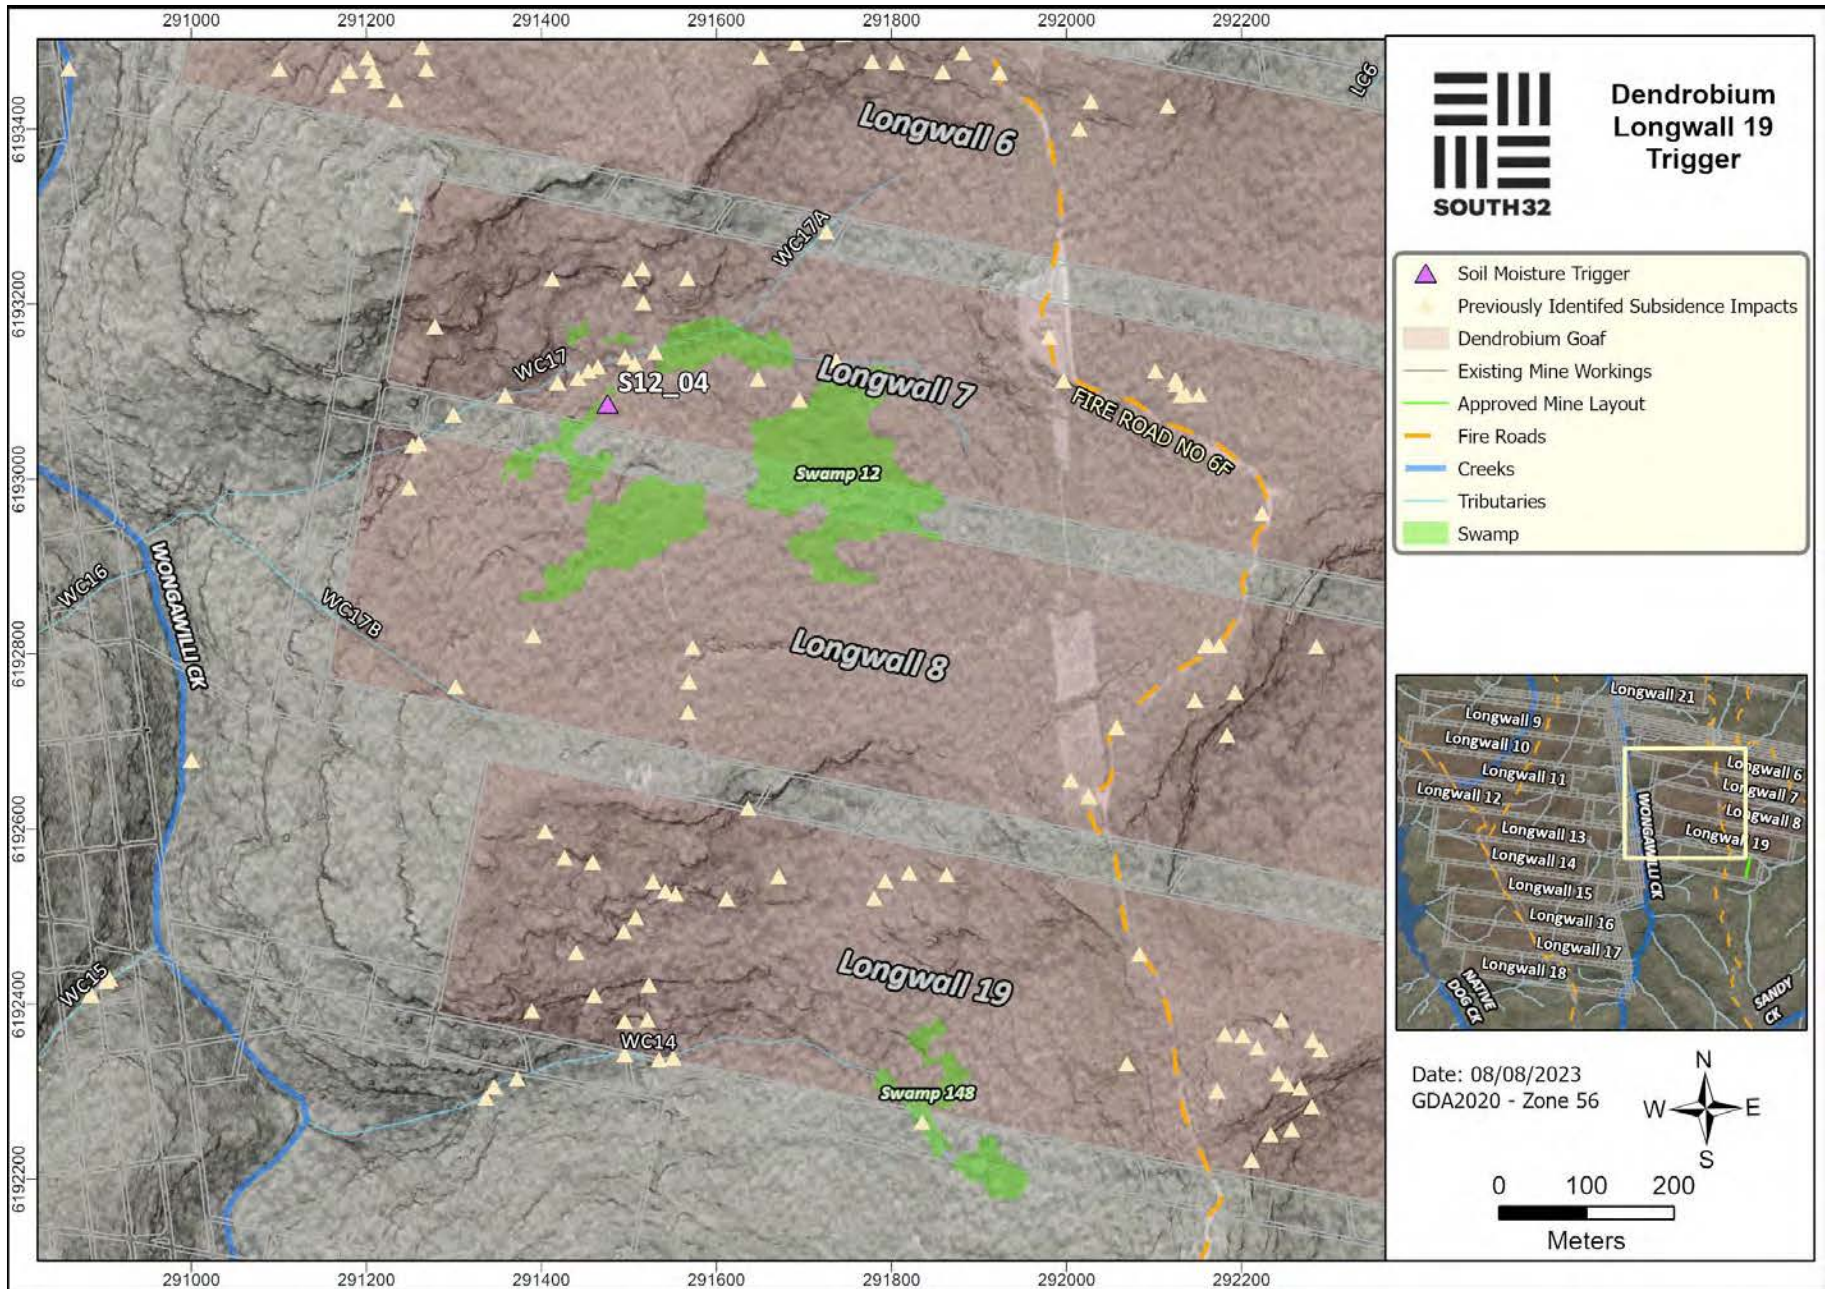
A soil moisture trigger was identified at monitoring site *S12\_04* in Swamp 12 during recent analysis of moisture data. *S12\_04* is located 395 m north from the western end of Longwall 19 (Figure 1). The site entered the Longwall 19, 400m active mining area on 3 March 2023 and remained within the active mining area until the end of extraction. On 1 August 2023 the average soil moisture value receded below the lowest level recorded during the baseline monitoring period (Graph 1).

Figure 1: Map showing latest swamp triggers in Swamp 12. Inset shows frame in relation to Dendrobium mining operations.

- Continue monitoring program
- Submit an Impact Report to key stakeholders
- Seek advice on any other CMAs
- Report in the End of Panel Report
- Summarise actions and monitoring in AEMR

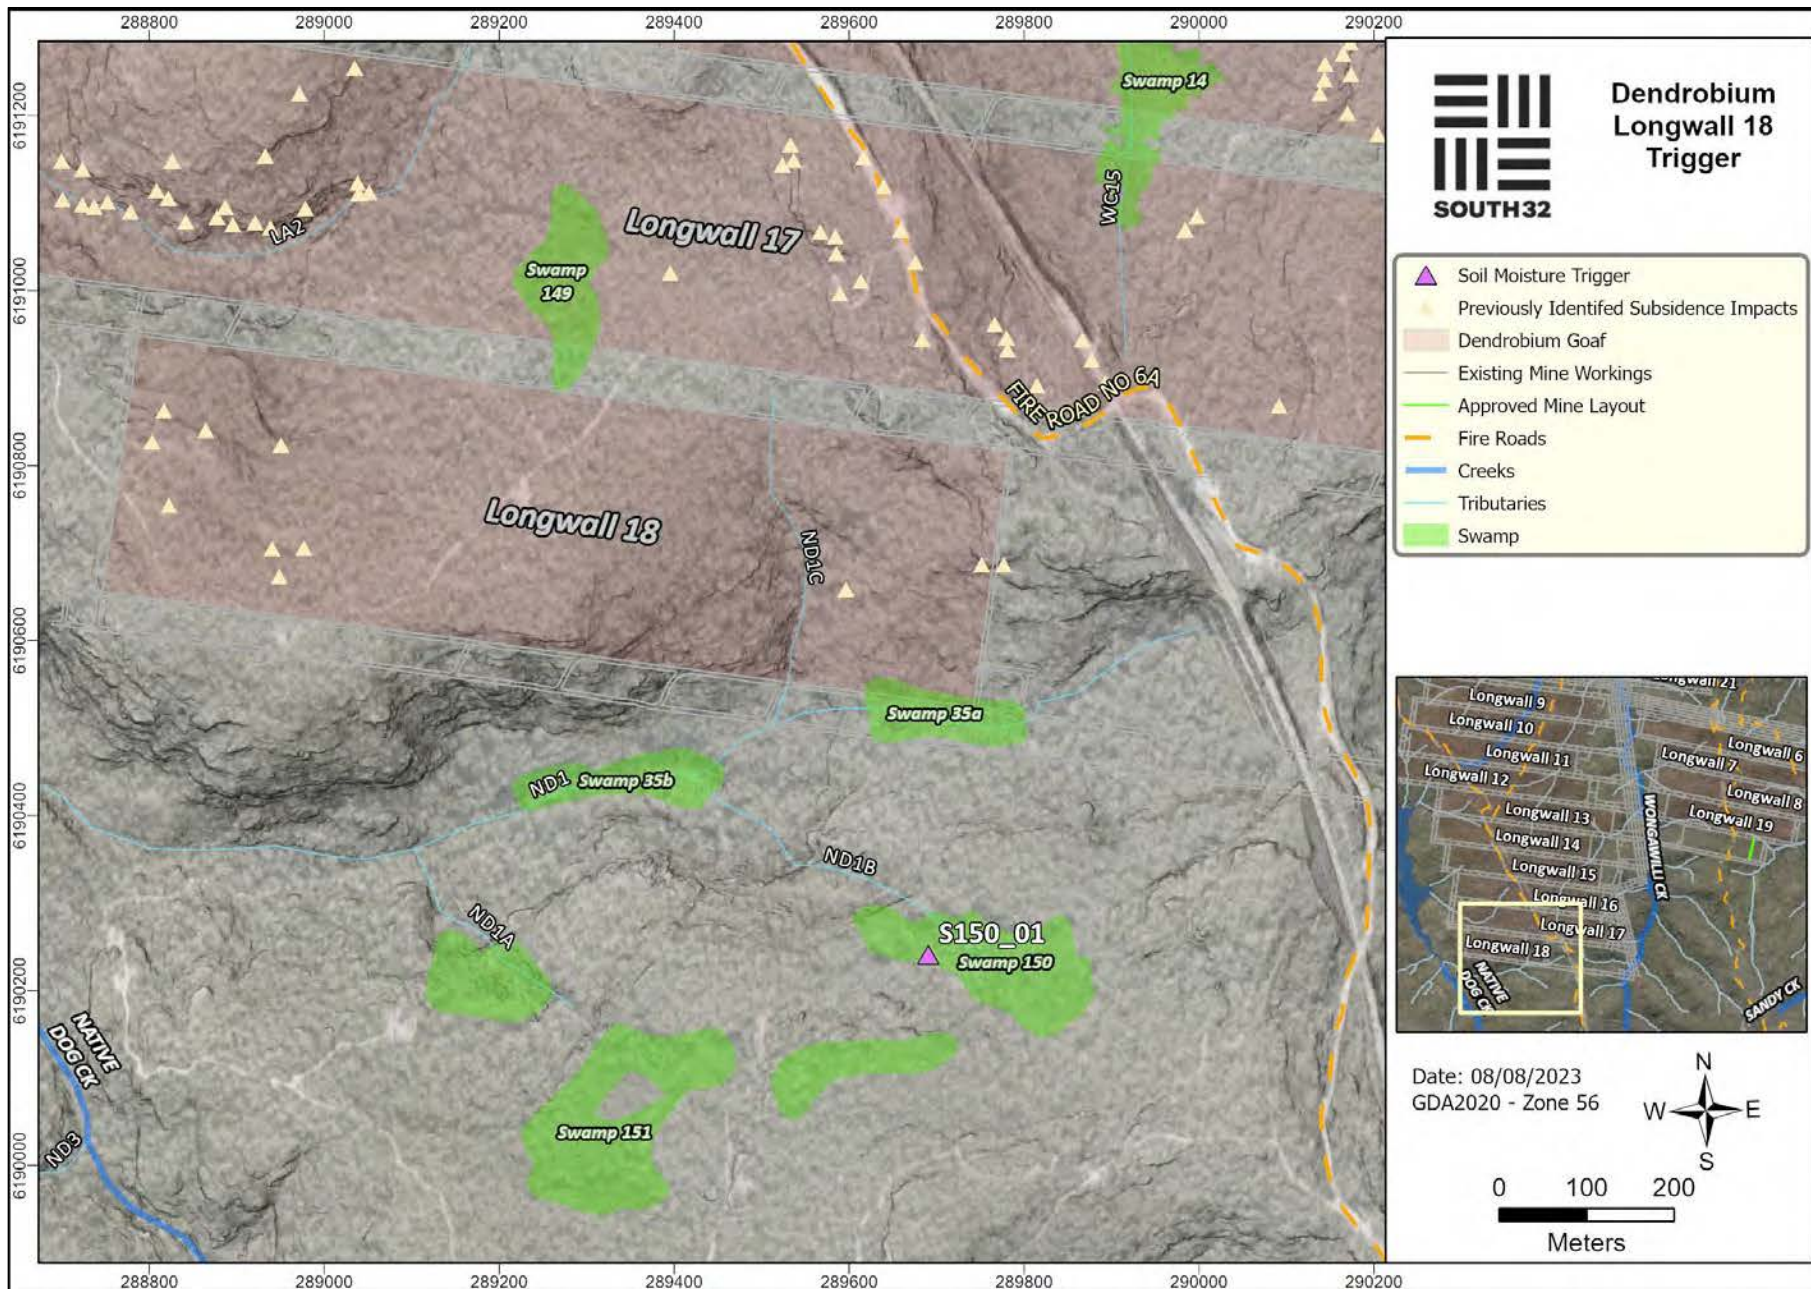
A soil moisture trigger was identified at monitoring site *S150\_01* in Swamp 150 during recent analysis of soil moisture data. *S150\_01* is located 280 m south of the eastern end of Longwall 18 (Figure 2). The site entered the Longwall 18, 400m active mining area on 24 March 2022 and remained in the active mining area until the end of extraction. On 24 August 2023, (one year and three months after completion of Longwall 18), the average soil moisture value receded below the lowest level recorded during the baseline monitoring period (Graph 2).

Figure 2: Map showing latest swamp triggers in Swamp 150. Inset shows frame in relation to Dendrobium mining operations.

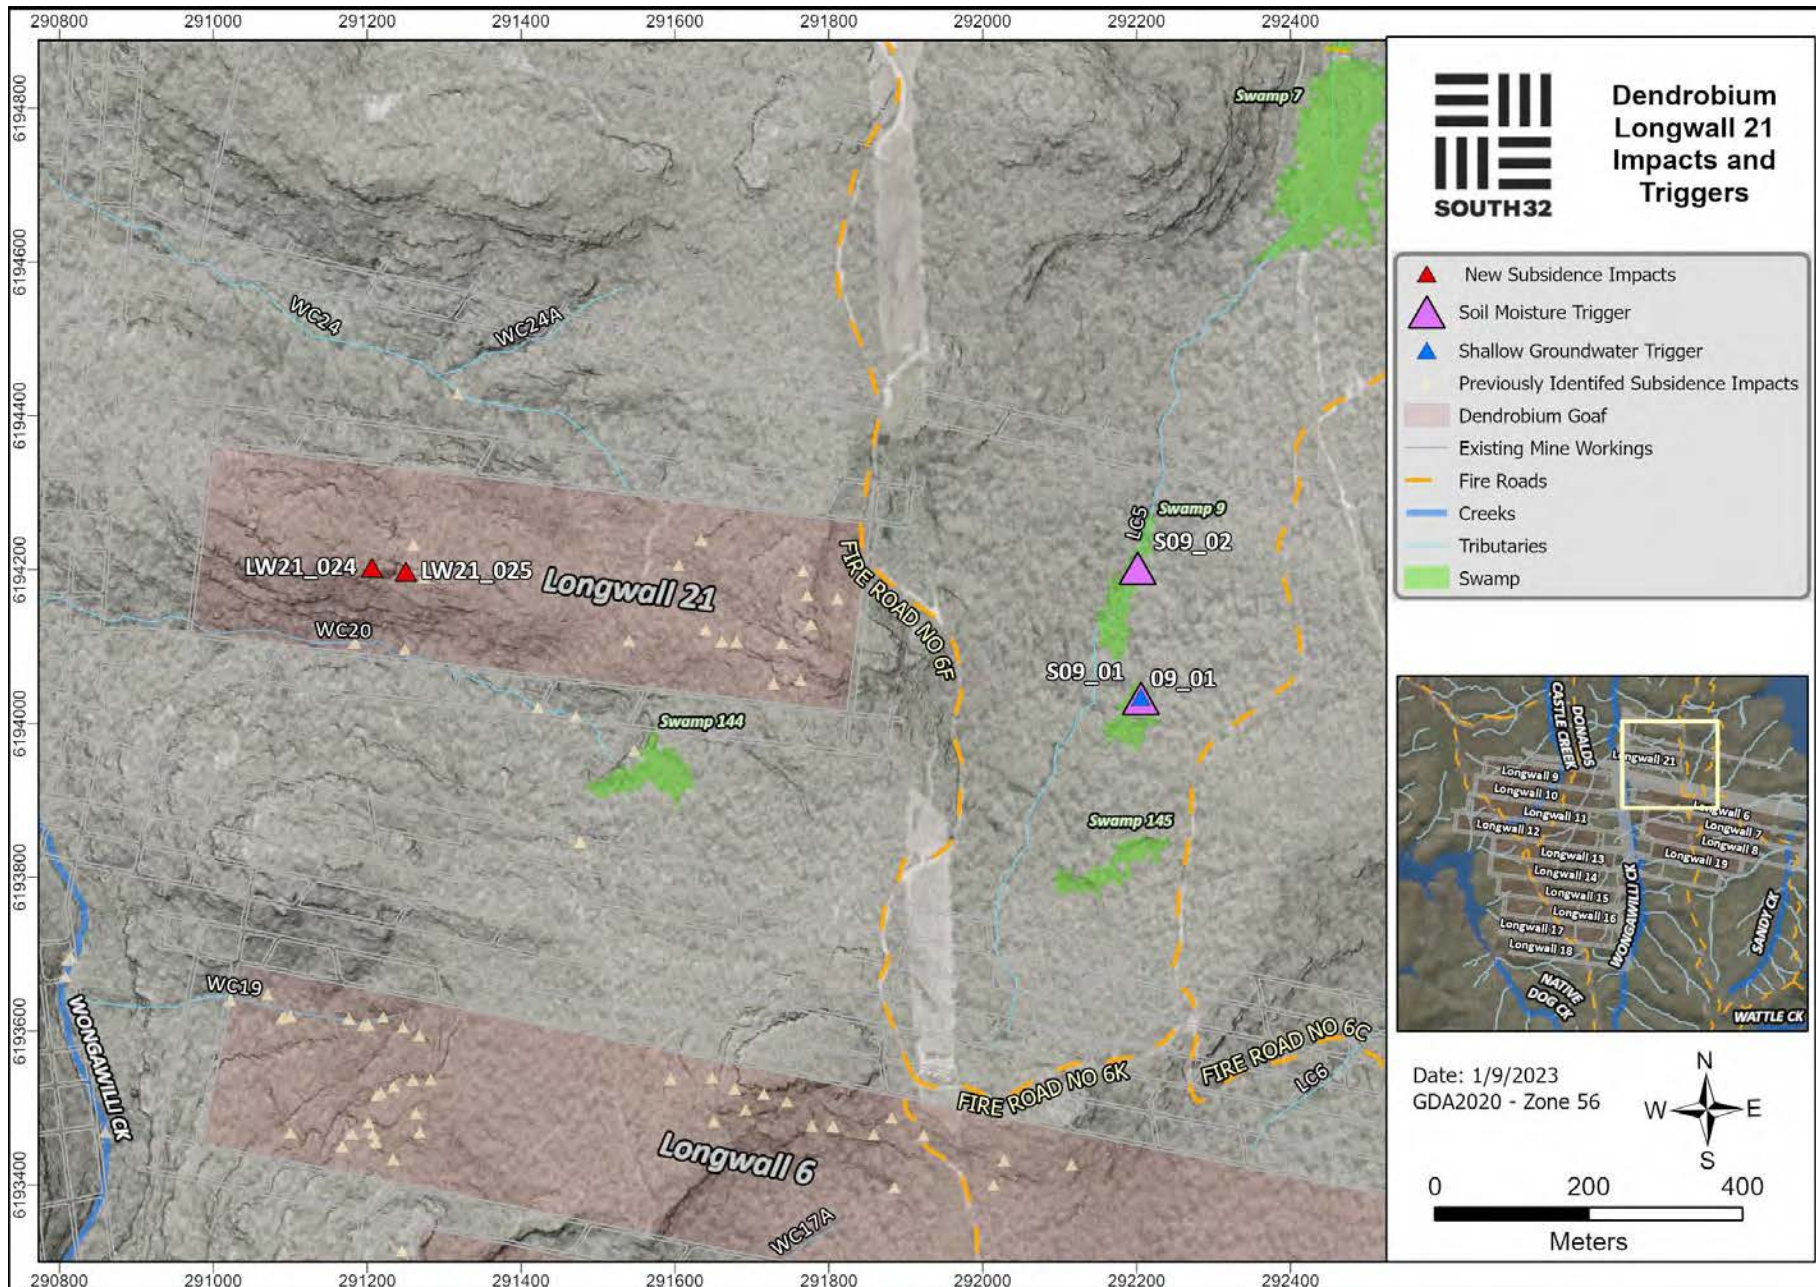
Site 09\_01 is located 368 m east of the eastern end of Longwall 21 (Figure 3). The site was within the 400m active mining area between 25 April 2023 and 2 May 2023. On 25 August 2023 the water level in the borehole 09\_01 receded below the lowest level recorded during the baseline monitoring period (Graph 3) and on 28 August 2023 the average soil moisture value at S09\_01 receded below the lowest level recorded before mining (Graph 4).

Site S09\_02 is located 350 m east of the eastern end of Longwall 21 (Figure 3). The site was within the 400m active mining area between 25 April 2023 and 4 May 2023. On 1 August 2023 the average soil moisture value in the probe S09\_02 receded below the lowest level recorded before mining (Graph 5). The groundwater trigger in site 09\_02 was reported on 9 August 2023.

Figure 3: Map showing latest swamp triggers in Swamp 09. Inset shows frame in relation to Dendrobium mining operations.
