**APPIN AREA 7  
LONGWALL 706 END OF  
PANEL REPORT**

**ATTACHMENT C2 –  
LW706 IMPACT  
REPORTS**

**APPIN AREA 7  
LONGWALL 706 END  
OF PANEL – IMPACT  
REPORTS**

## **Nepean River Impact Report – Gas Release**

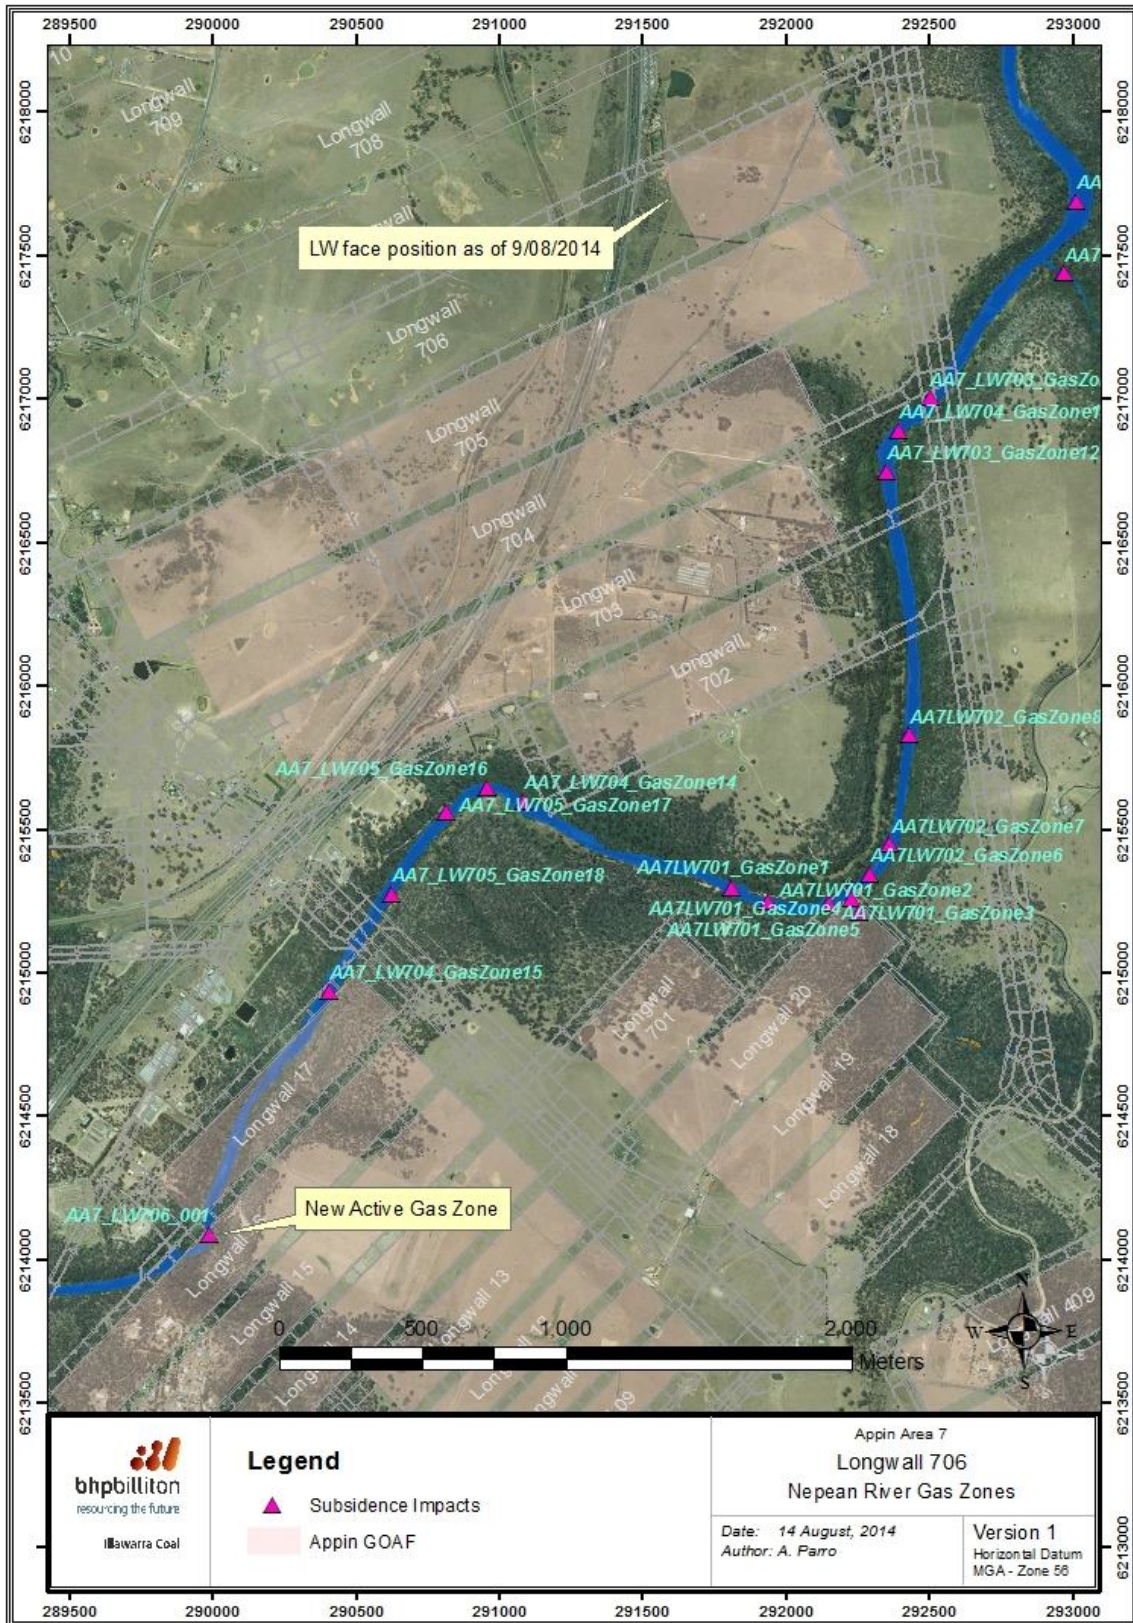
**Map 1:** Location of Gas Zones relative to Appin Mine Longwalls

AA7\_LW706\_001 consists of 4 gas release sites in two 2m x 1m zones (Photos 1 & 2), approximately 6m apart. The releases are located over previously extracted Tower Mine Longwall 16, approximately 925 metres upstream of Gas Zone 15 (**Map 1**).

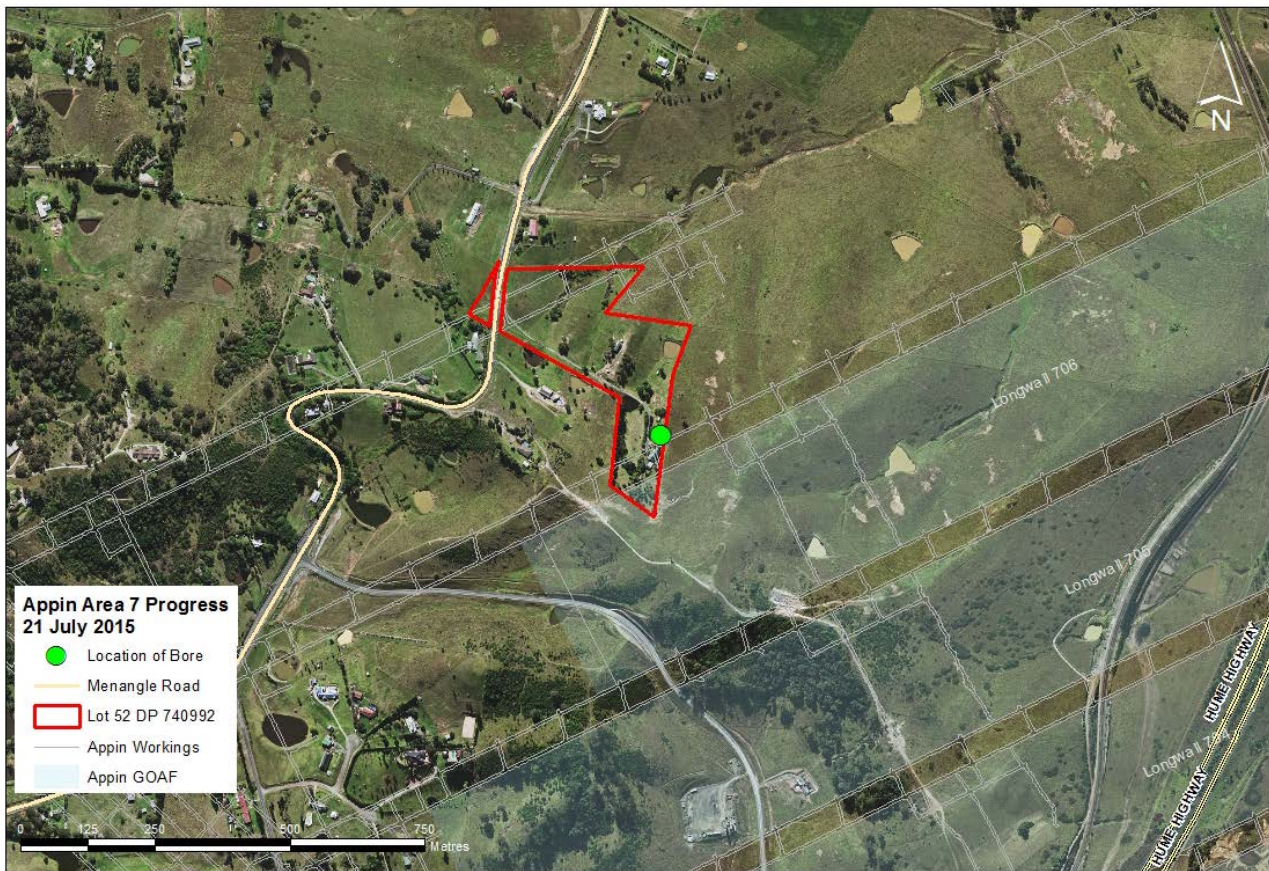
**Figure 1: Location of subject property in context of LW706**

Lot 52 DP 740992 (575 Menangle Road, Douglas Park) is partially located within Longwall 706 and Longwall 707 (refer Figure 1). The property contains a dwelling, ancillary structures and a private borehole.

The borehole (GW112441) is registered with NSW Office of Water. Department records indicate the borehole is authorised for domestic and stock use, and the bore was drilled to a depth of 294 metres. The indicative location of the borehole is shown in Figure 1.

Appin Mine is currently mining Longwall 706, with the subject property being within the 20mm subsidence zone for Longwall 706. The active subsidence period associated with Longwall 706 for this property has commenced.

A replacement borehole is anticipated to be drilled in a location determined in consultation with the landholder following the active subsidence period for Longwall 707 (unless an alternative water supply is provided at the agreement of the landholder).

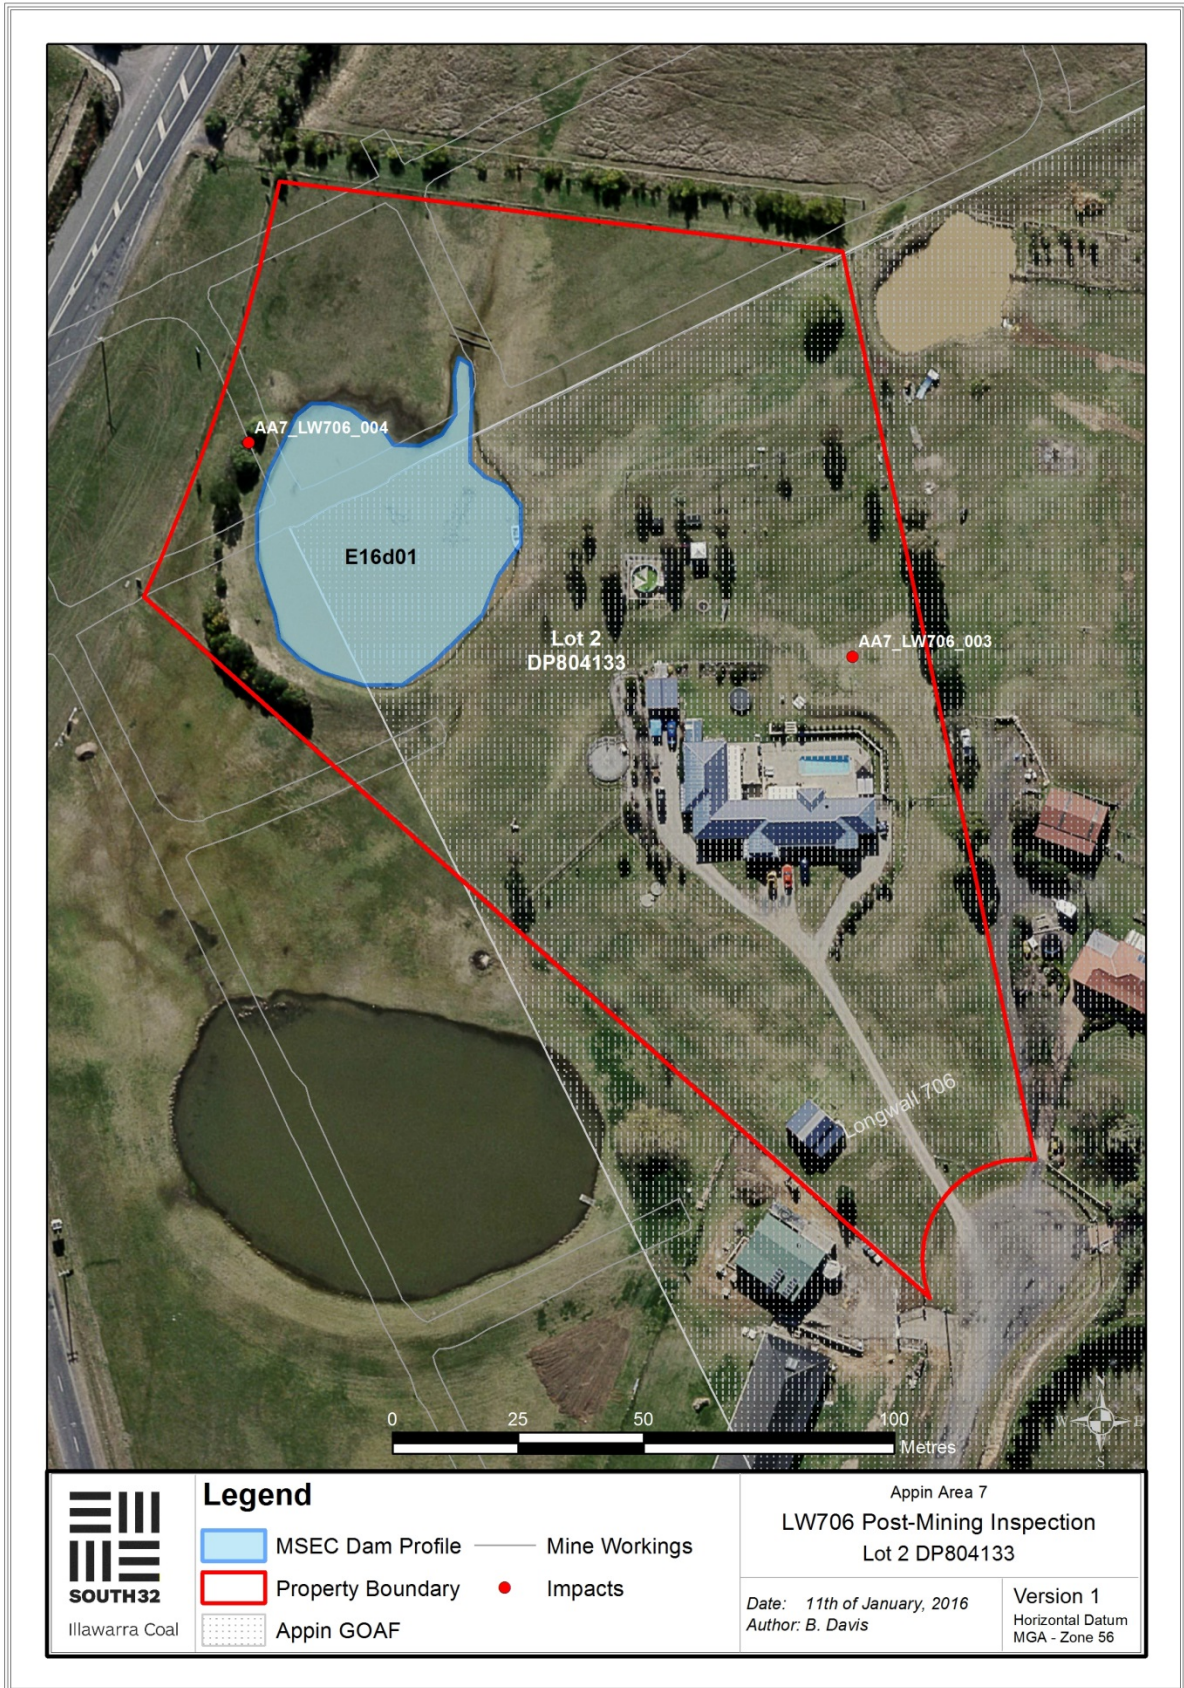
**Figure 1:** Location of impacts relative to Longwall 706, Appin Area 7.

A post-mining inspection on the property Lot 2 DP804133 was completed on the 4<sup>th</sup> of January 2016. Soil cracking was identified at two locations on the property (Figure 1) and are described below.
