Illawarra Coal

Dendrobium Area 3B Longwall 10 End of Panel Report

May 2015

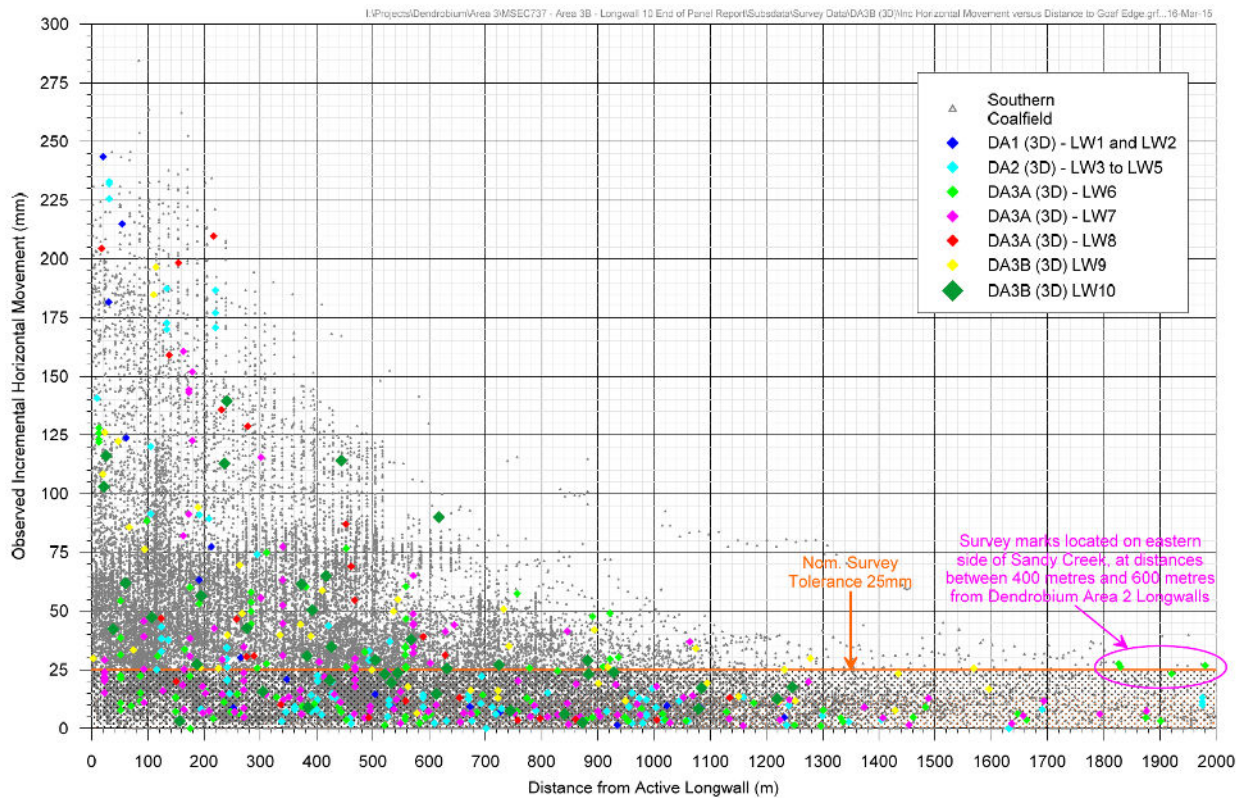
Figure 1: Observed Incremental Horizontal Movement for DA3B 3D Monitoring Points

The horizontal movement vectors for the marks located outside the extents of Longwall 10 were generally orientated towards the extracted goaf, but slightly orientated towards the longwall finishing end. The horizontal movement vectors for the marks located above the longwall were also generally oriented towards the finishing end.

The observed incremental horizontal movements at the DA3B 3D monitoring points, resulting from the extraction of Longwall 10 were within the range of those measured at similar distances from previously extracted longwalls at Dendrobium Mine and elsewhere in the Southern Coalfield. This is shown in Figure 1, Dendrobium longwalls are represented by colour.

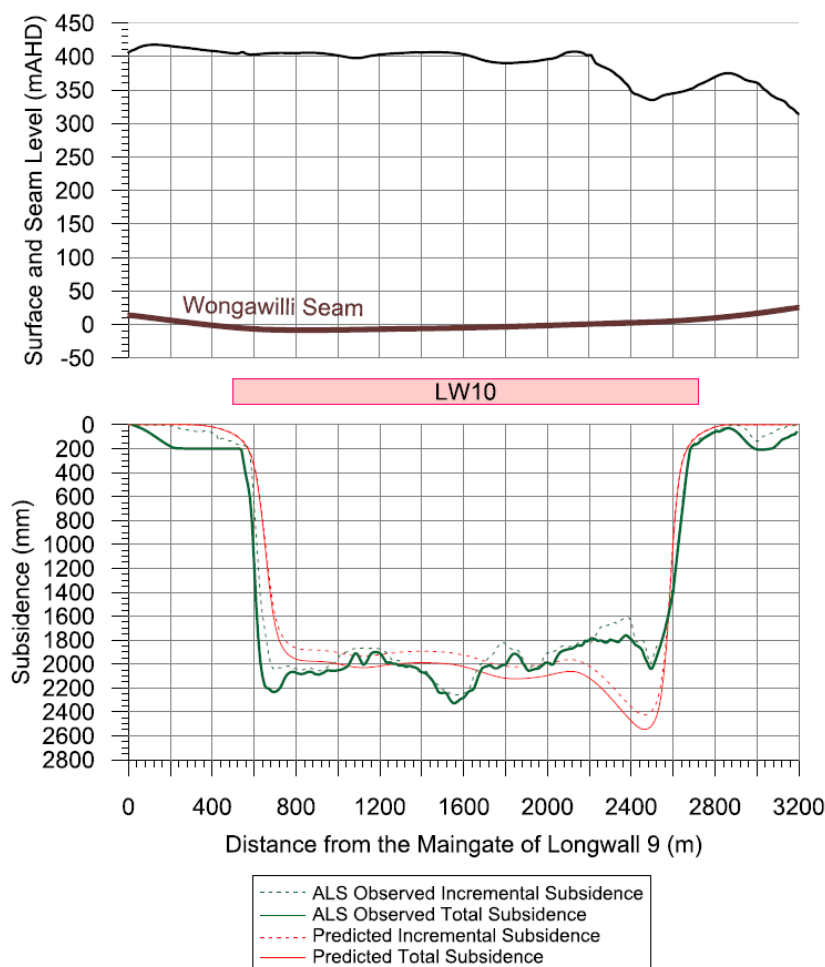
Figure 2: Observed Changes in Surface Level and Predicted Subsidence along Long-Section 1

The changes in surface level were determined by taking the differences between the surface levels measured before and after the extraction of Longwalls 9 and 10. The profile of predicted incremental and total subsidence is shown in Figure 2.

The observed incremental and total subsidence along Long-section 1 are reasonably similar to those predicted along the centreline of Longwall 10. There are two locations along the base of the subsidence trough that are greater than predicted but are within the accuracy of modelling predictions of $\pm 15\%$ and the expected tolerance of the ALS / LiDAR for absolute vertical position of ± 300 mm. The observed subsidence has also exceeded predicted subsidence at the commencing and finishing ends of Longwall 10 with the observed subsidence profiles at the ends of the subsidence trough being closer to the commencing end and finishing end of Longwall 10. The profile at the commencing end is slightly steeper than predicted. It is noted that the largest predicted maximum subsidence along the long-section was not exceeded by the largest observed subsidence along the long-section.

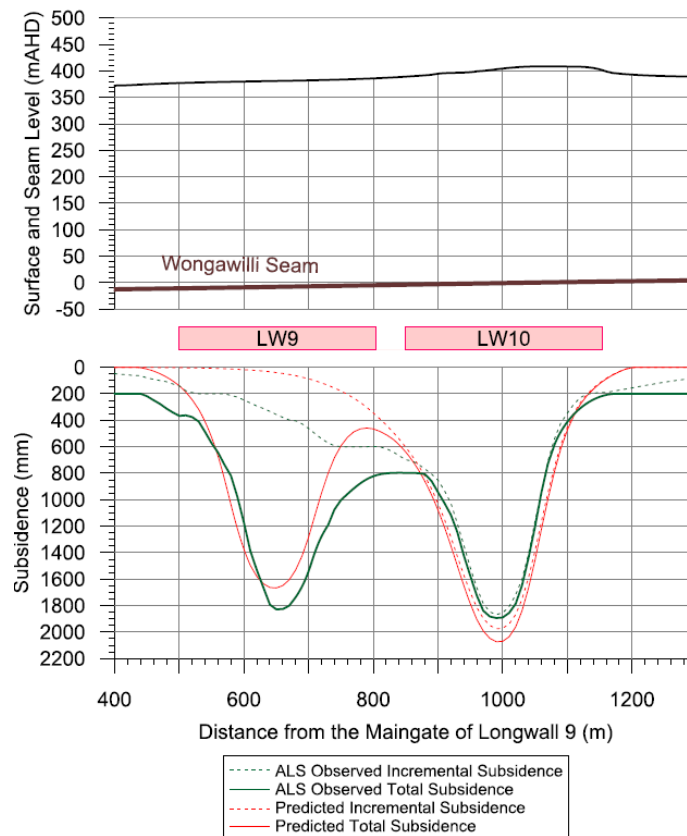
Figure 4: Observed Changes in Surface Level and Predicted Subsidence along Cross-section 2

The profiles of the observed incremental and total subsidence along Cross-sections 1 and 2, after the extraction of Longwall 10, are shown by the green lines in Figure 3 and Figure 4 respectively. The profiles of predicted incremental subsidence are also shown in these figures as red lines for comparison.

It can be seen from the above figures, that the shapes of the observed profiles are reasonably similar to those predicted. The maximum observed incremental and total subsidence exceeded that predicted above Longwall 9 in Cross-section 1 and Cross-section 2. The maximum observed incremental and total subsidence slightly exceeded that above Longwall 10 in Cross-Section 1. The observed subsidence profiles in Cross-section 1 and Cross-section 2 also show greater subsidence and a flatter subsidence profile above the chain pillar between Longwall 9 and Longwall 10 indicating significant pillar compression.

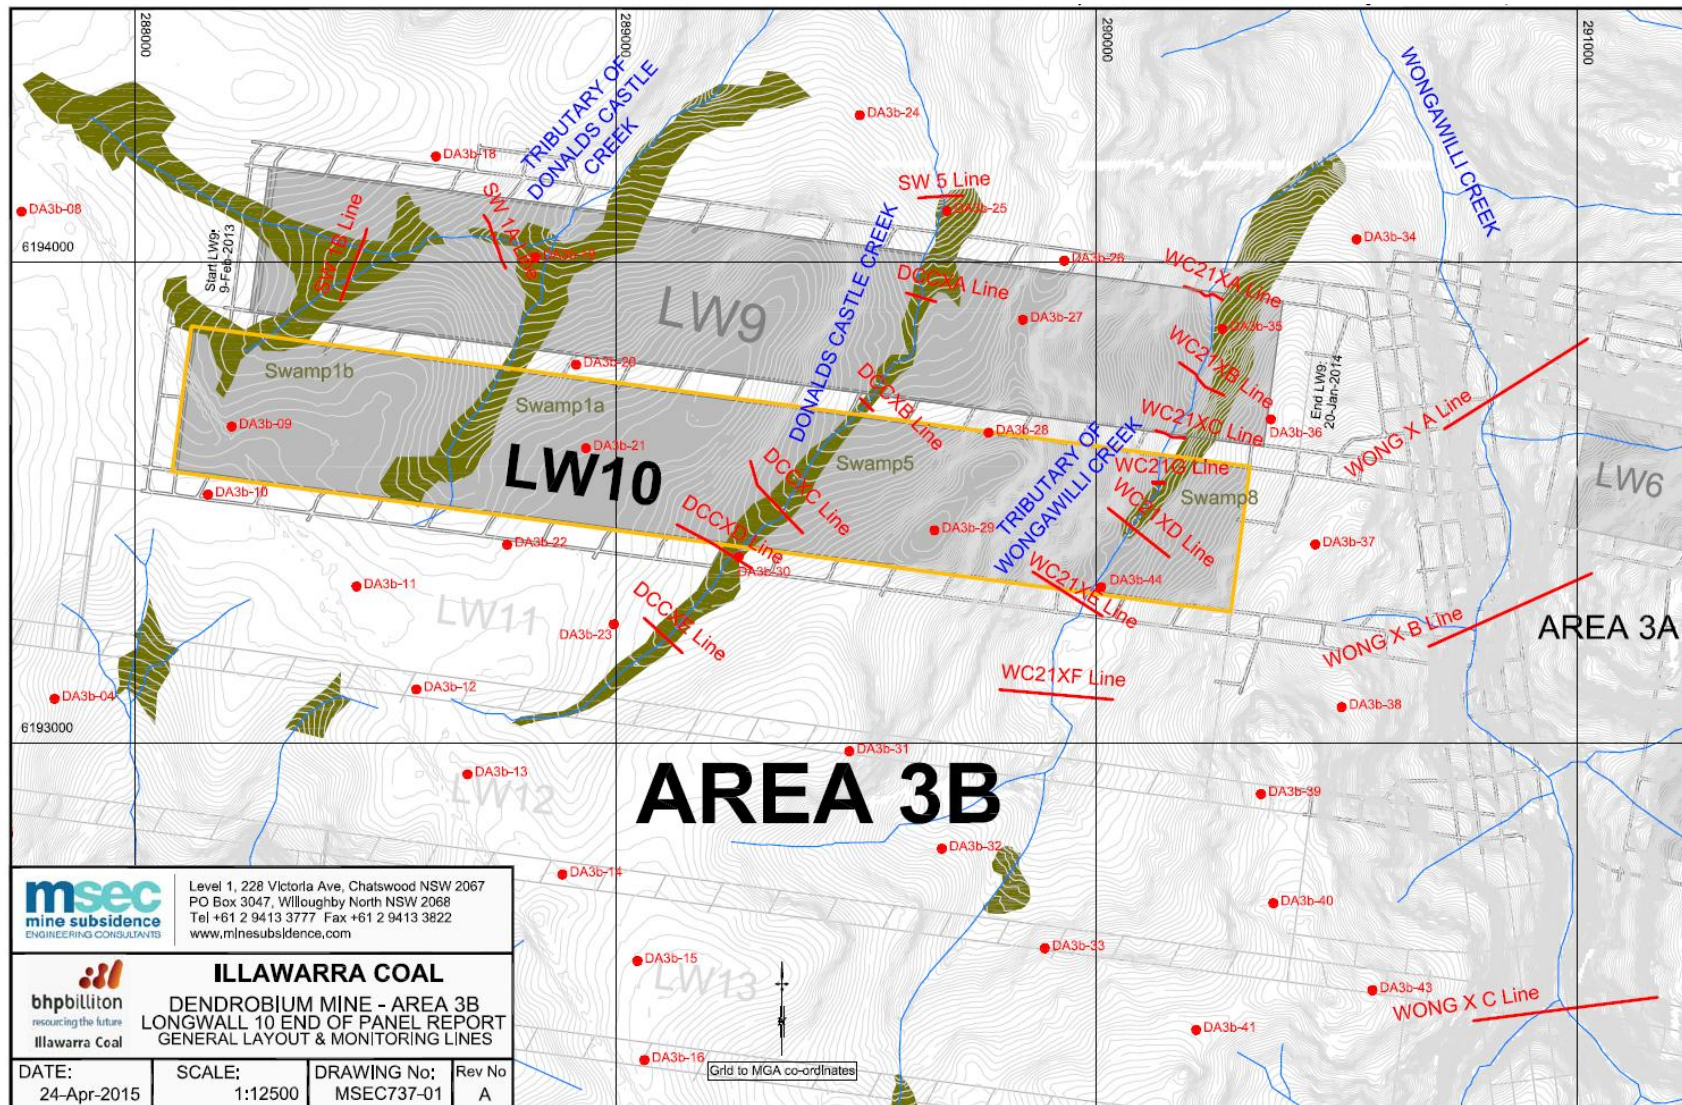
Figure 5: Location of monitoring points and lines in relation to Dendrobium Mine Area 3B Longwall 10

Closure movements across Wongawilli Creek were measured using 2D survey techniques at the Wong X A-Line, Wong X B-Line and Wong X C-Line. The location of these monitoring lines is shown in Figure 5 (MSEC737, 2015). The maximum observed closures at each of the Wongawilli cross lines were less than predictions.

The mine subsidence movements across the Swamp Cross Lines were measured using 2D survey techniques using the SW5 Line, SW 1A Line and the SW 1B Line. The locations of the swamp cross lines are shown in Figure 5. Observed subsidence at the Swamp Cross Lines was greater than predictions. Maximum observed subsidence was 1911mm at SW 1B Line, compared to the predicted subsidence of 1325mm.

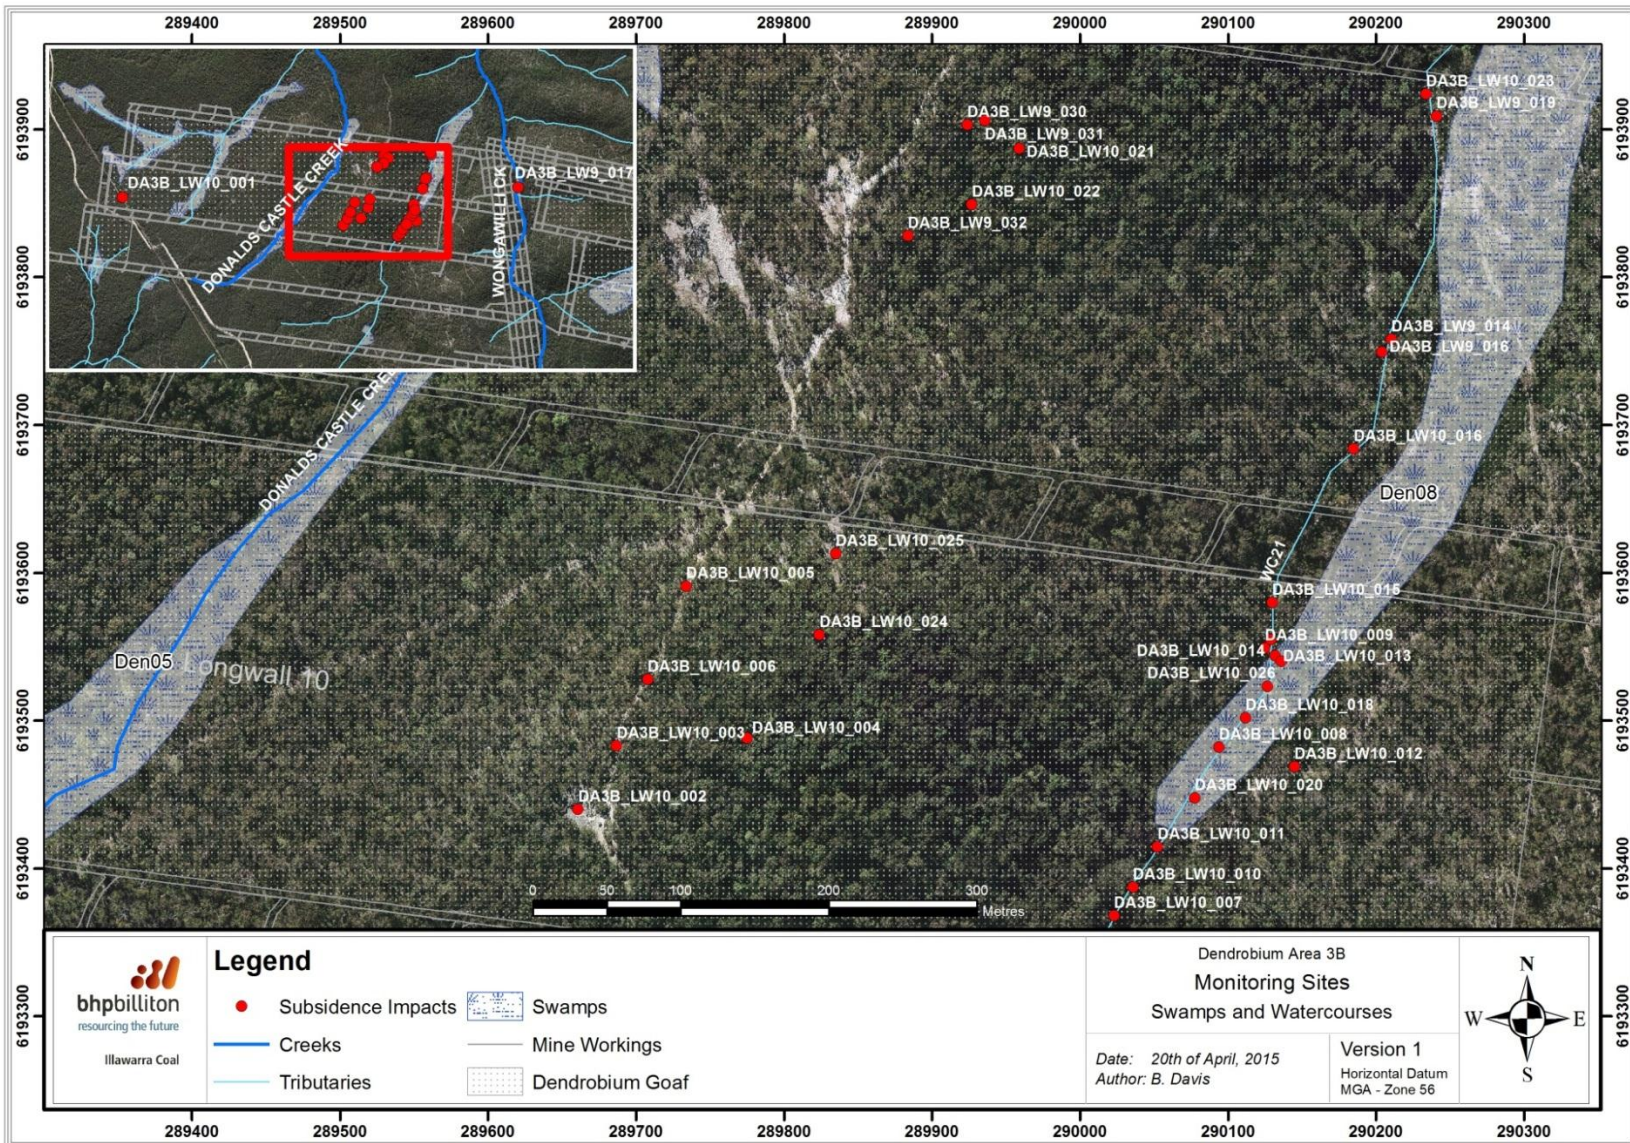
Figure 6: Location of Longwall 10 Surface Impacts

Three TARP Level 1 fractures have been observed in WC21 (Photo 3, Photo 4 and Photo 5) and have been identified as DA3B_LW10_010, 013 and 020 respectively (Figure 6). No water loss or flow diversion was observed from these impacts.

Thirteen TARP Level 2 fractures have been identified in WC21 (Figure 6), resulting in an observable diversion of surface water (Photo 6 and Photo 7). Two of these fractures were identified during Longwall 10 extraction as extensions of existing Longwall 9 impacts DA3B_LW9_014 and 016 (Photo 12 and Photo 13).
