# Avon and Cordeaux Reservoirs DSC Notification Area Management Plan

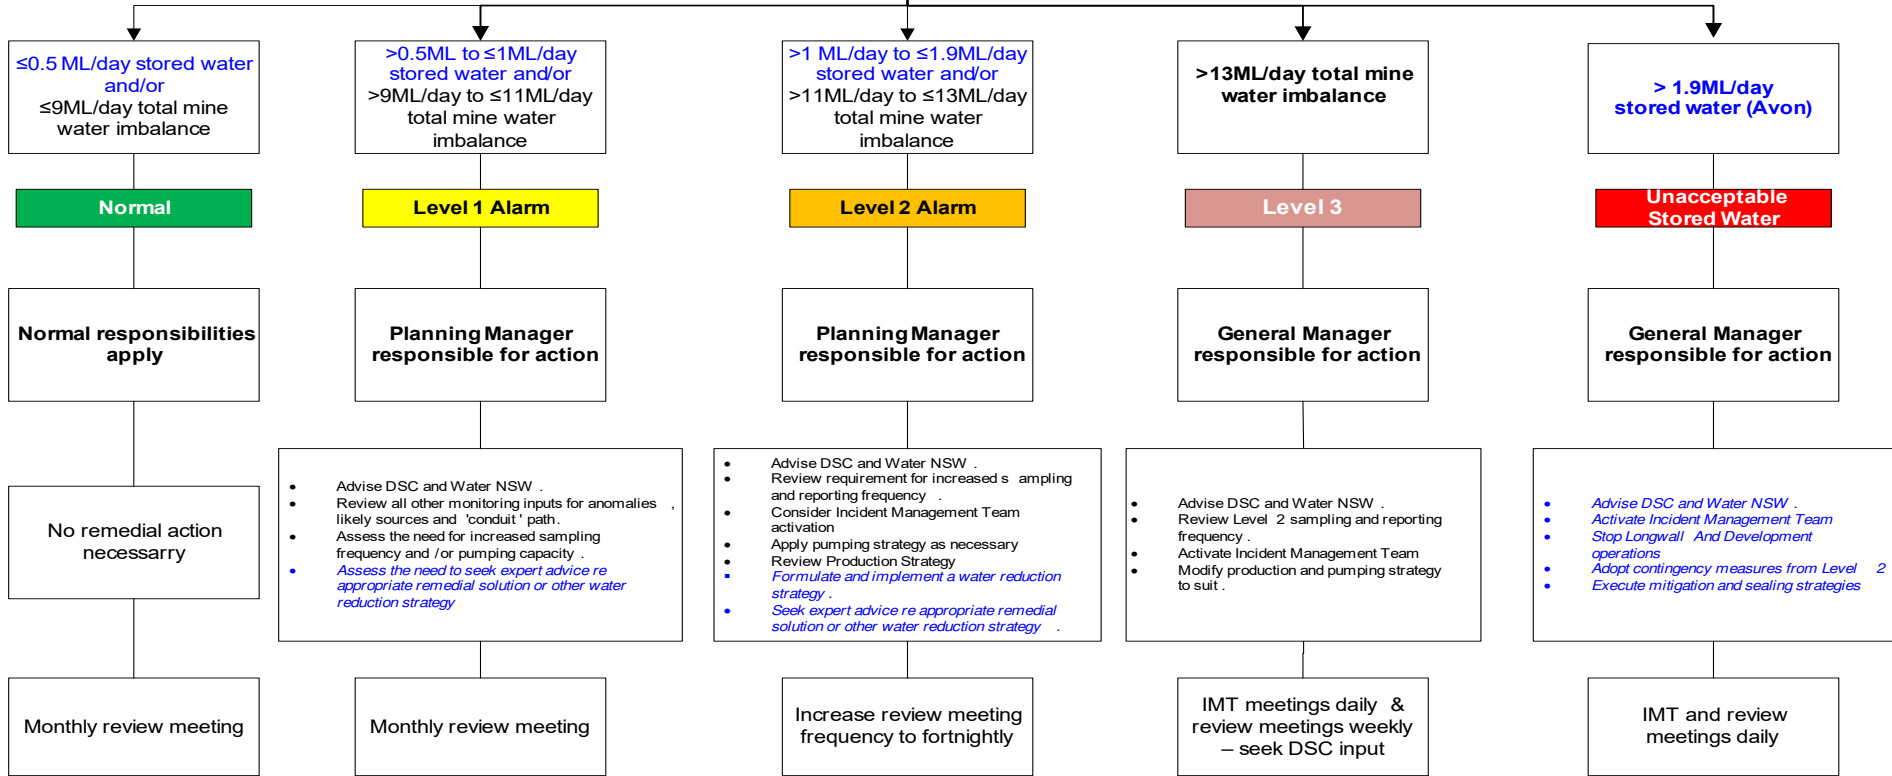
**Figure 2b – Principal Response Flowchart - Avon**

- Water Balance volumes exclude Area 2 rainfall related inflows
- Actions in blue *Italic* are only for Stored Water

Daily Data Input and Review

- It is critical that Dendrobium Mine is able to detect early presence of stored water and deal with the source and treatment deliberately in the TARPs. A second TARP has been incorporated into the Plan to cater for stored water from Lake Avon (Figure 2b).

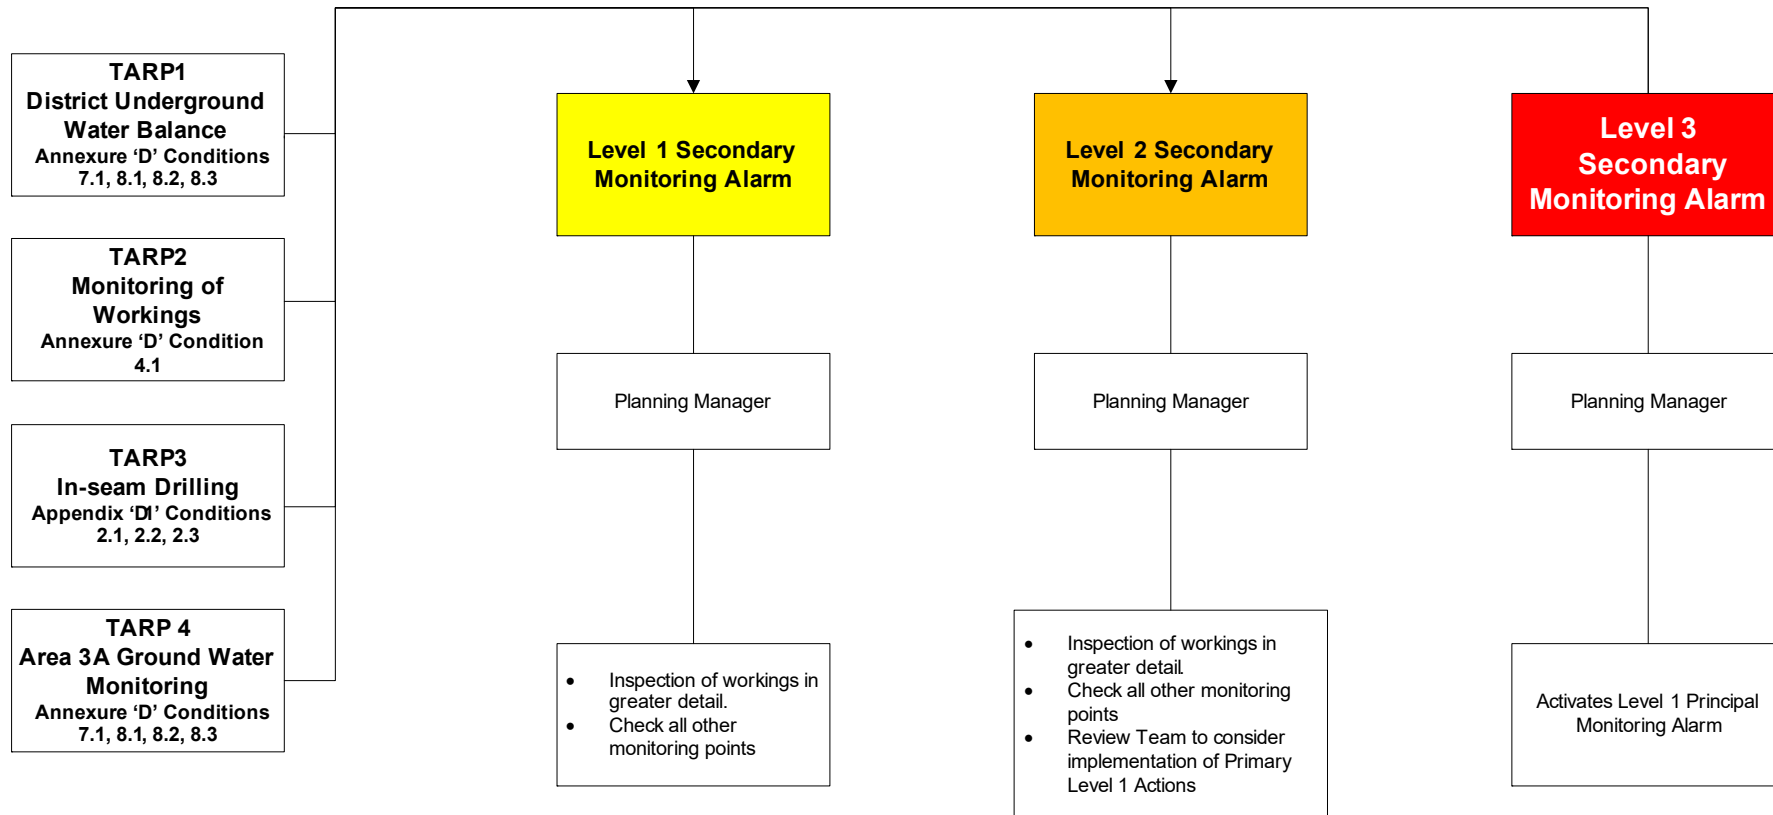
**Figure 3** - Represents the relationship between the Secondary Monitoring TARPs and the Principal Monitoring TARP
