ANNEX E

LAND MANAGEMENT PLAN

WEST CLIFF AREA 5

LONGWALLS 37 AND 38 EXTRACTION PLAN

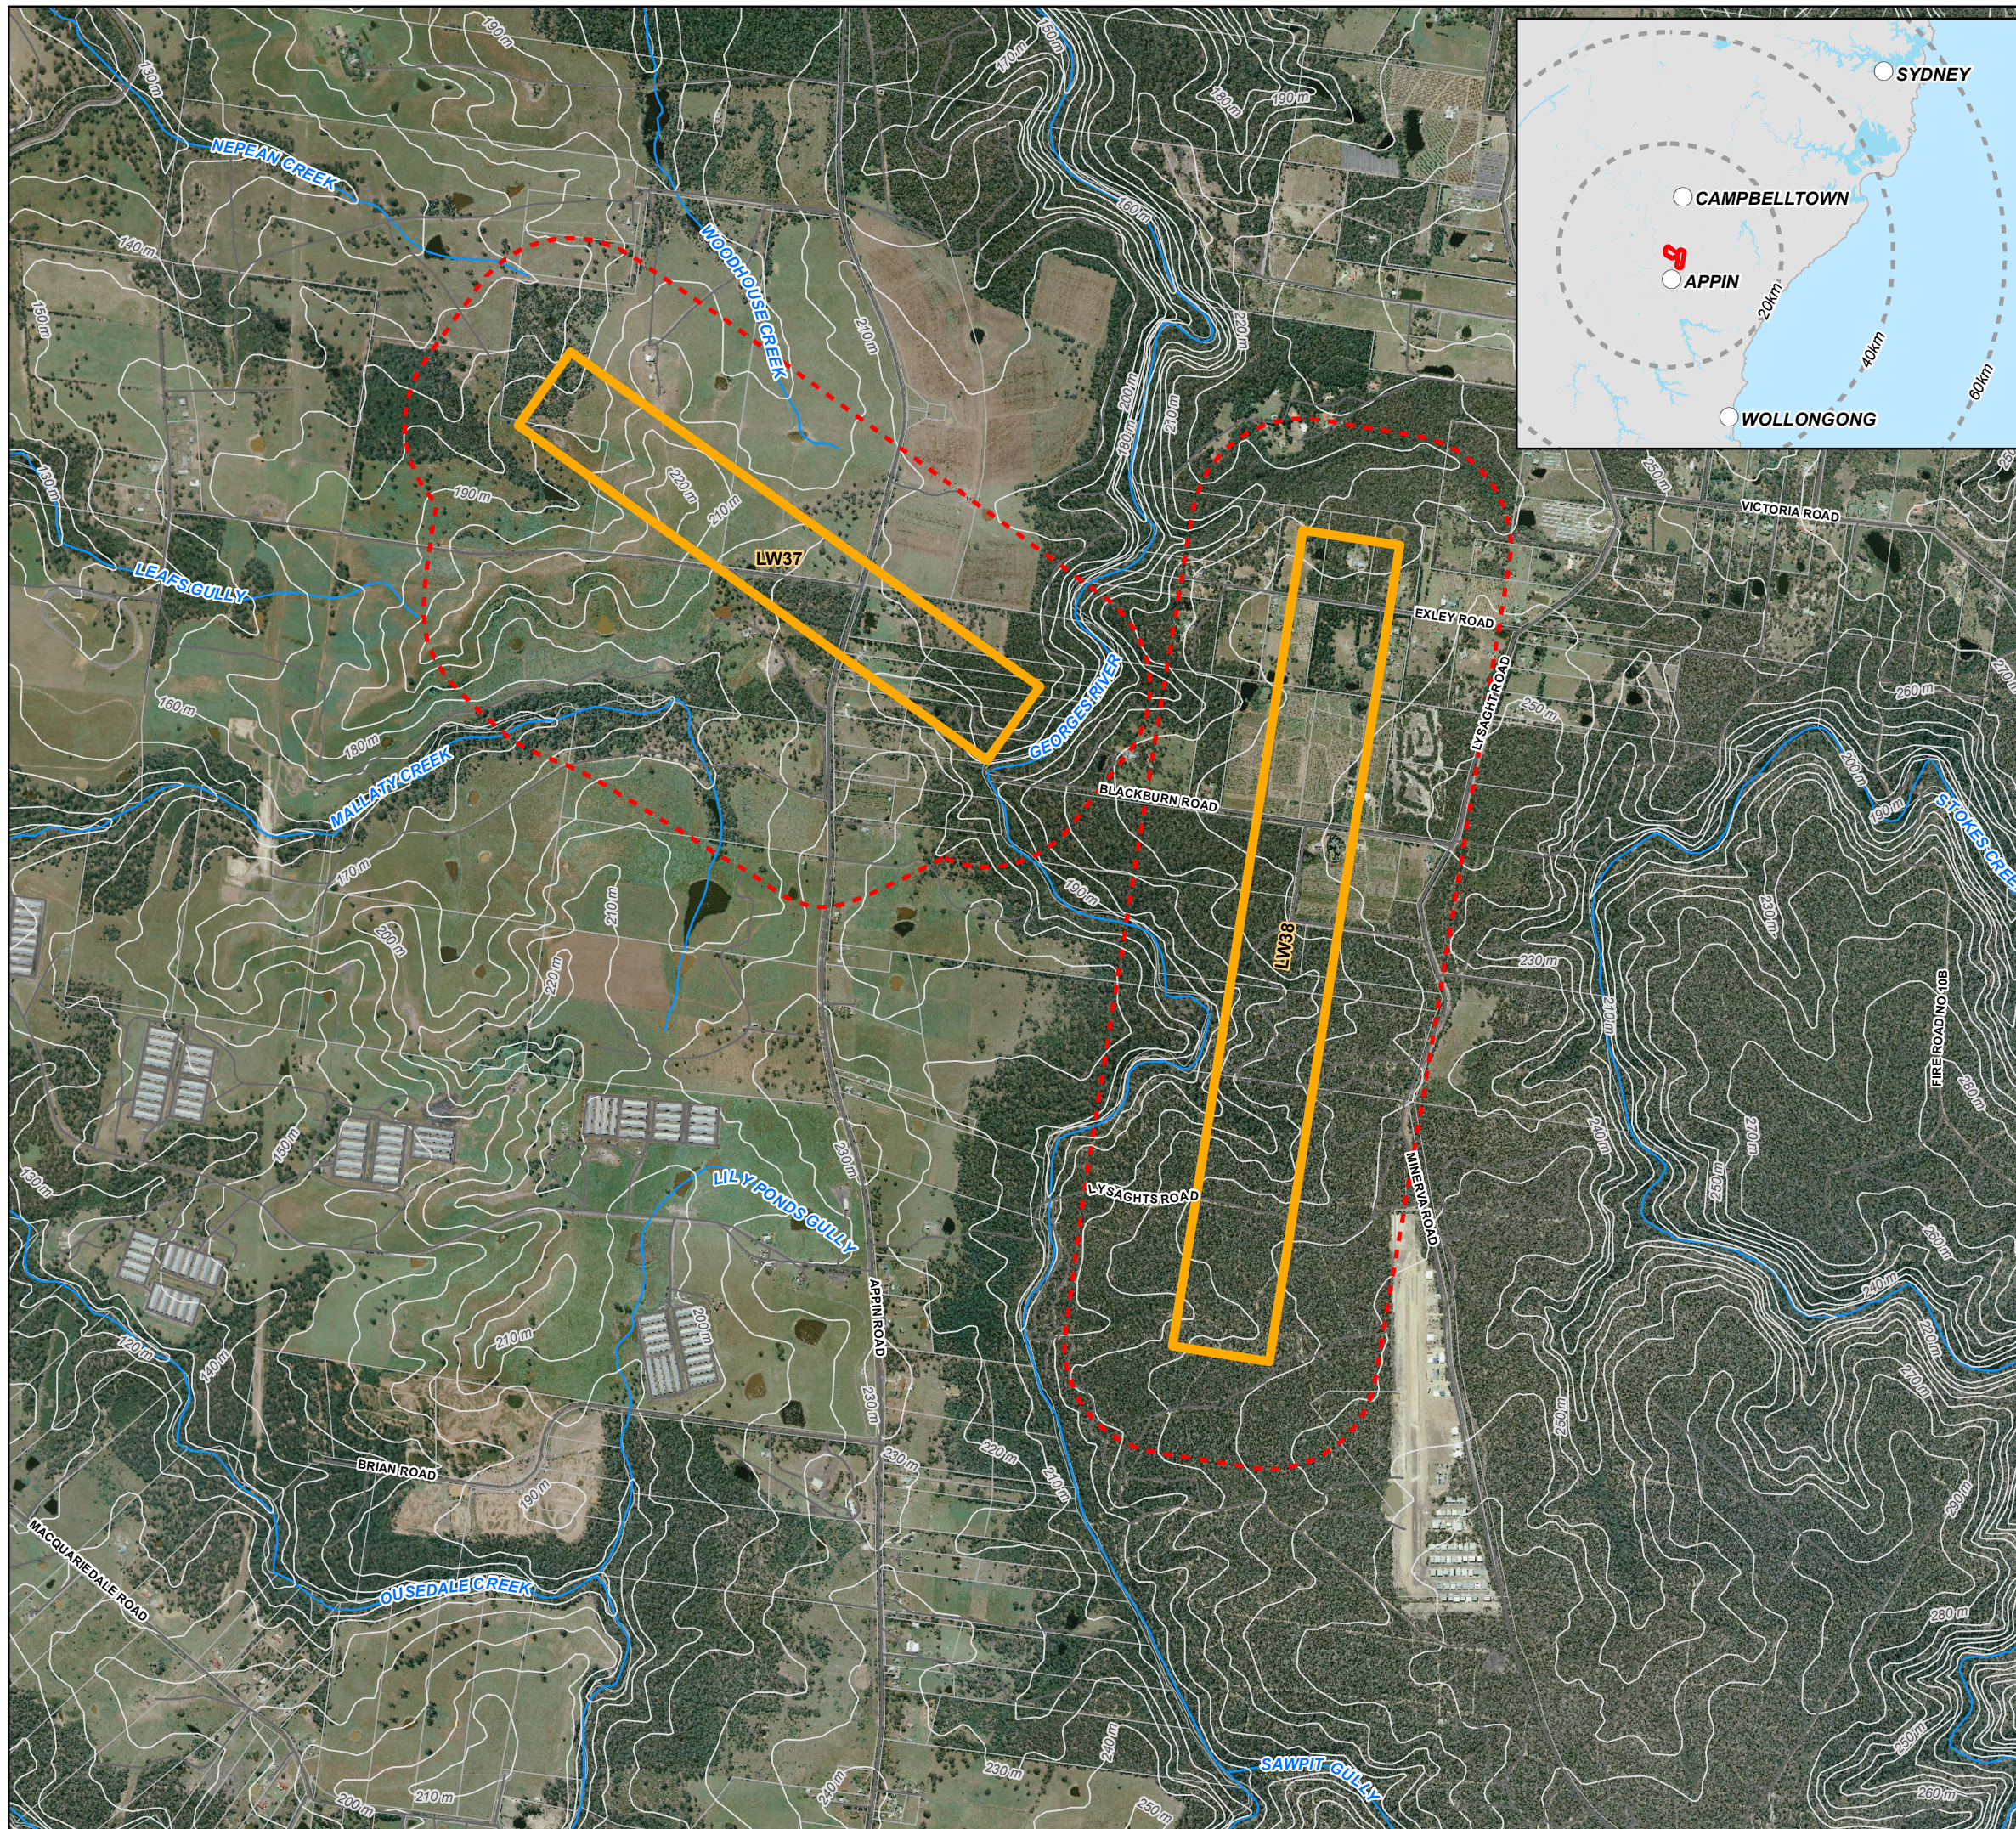
**West Cliff Area 5
Study Areas
(LW37 and 38)**

Two separate Study Areas have been defined, one for each of the longwalls. The Longwall 37 Study Area is located primarily to the west of the Georges River, with the Longwall 38 Study Area primarily to the east of the Georges River. The Study Area locations are illustrated by **Figure 1** (MSEC, 2013). It is noted that while the Study Areas do traverse the Georges River, neither of the proposed longwalls would result in mining under the River.

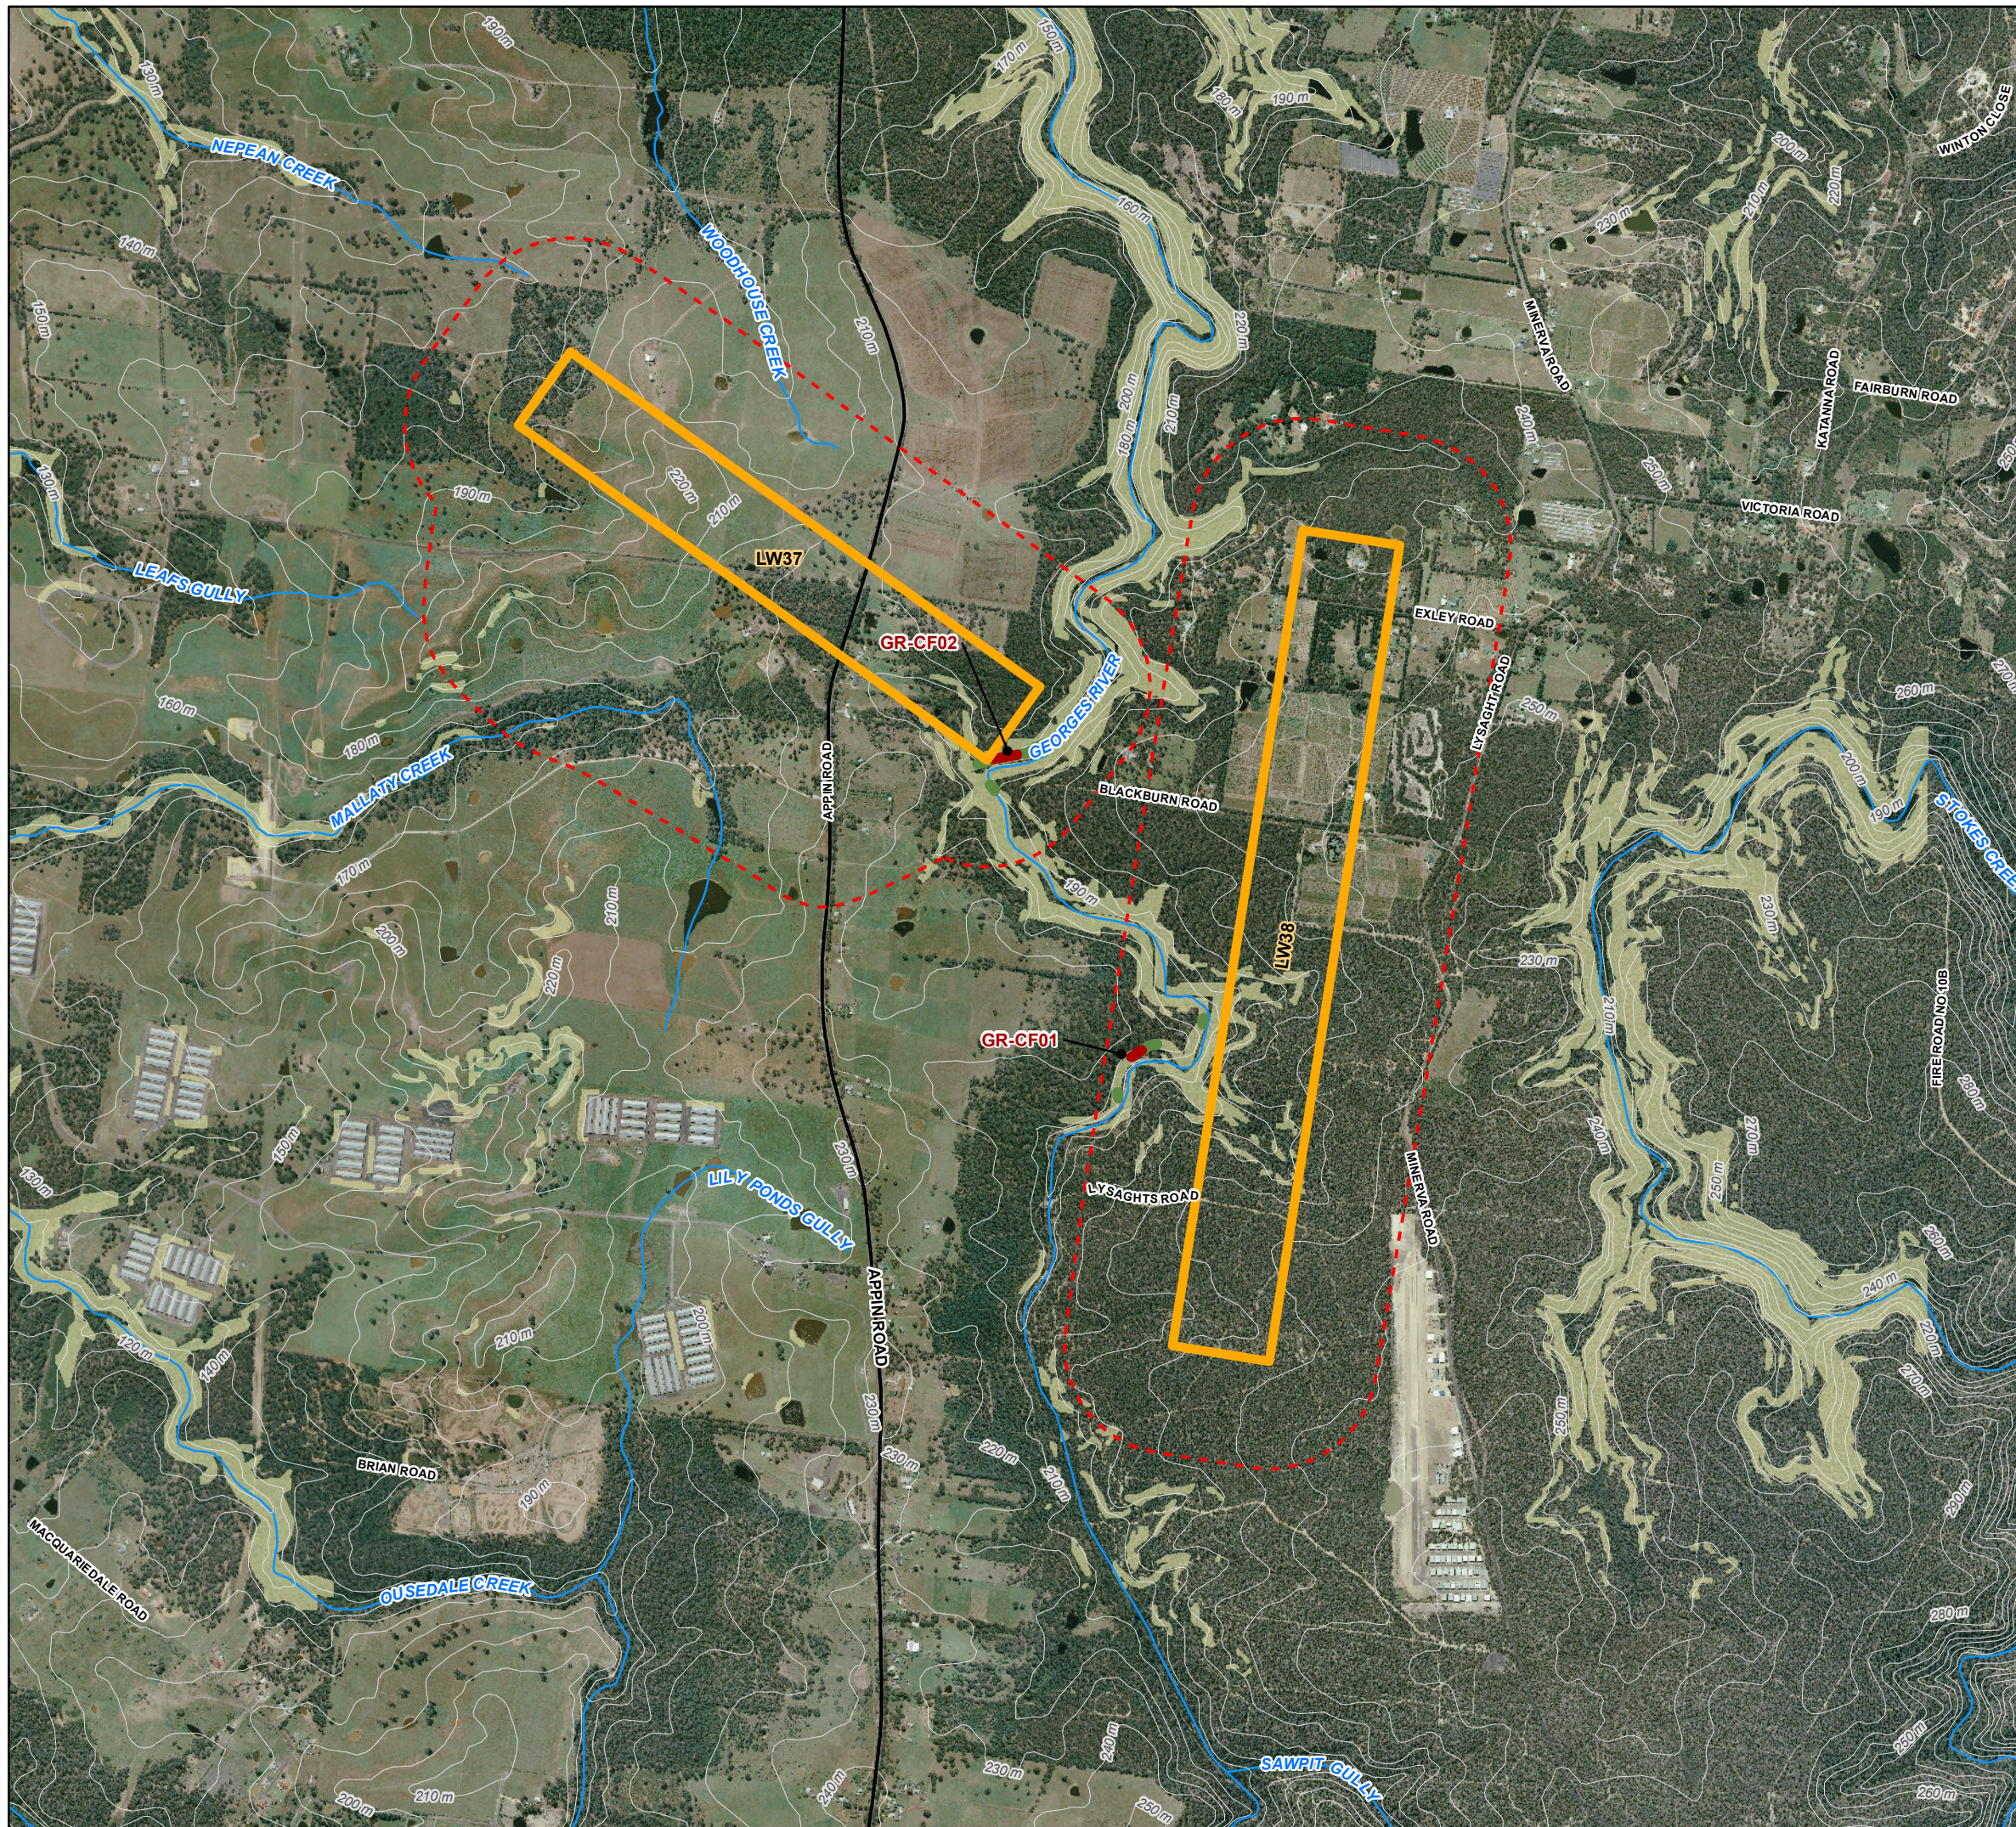
WESTCLIFF AREA 5
 LW 37 and 38

**Locations of Cliffs,
 Steep Slopes and
 Rock Outcrops**

Specific focus will be on cliffs and steep slopes including cliffs of 'special significance' (i.e. longer than 200 m and/or higher than 40 m and cliff like rock faces higher than 5 m that constitute waterfalls, as defined by BSO approval *Condition 1, Schedule 3*), and other cliffs flanking the Georges River and associated tributaries, as shown in **Figure 2** and the drawing in MSEC (2013), Drawing No. MSEC533-10.
