SANDY CREEK WATERFALL MANAGEMENT PLAN

1 INTRODUCTION

1.3 Purpose

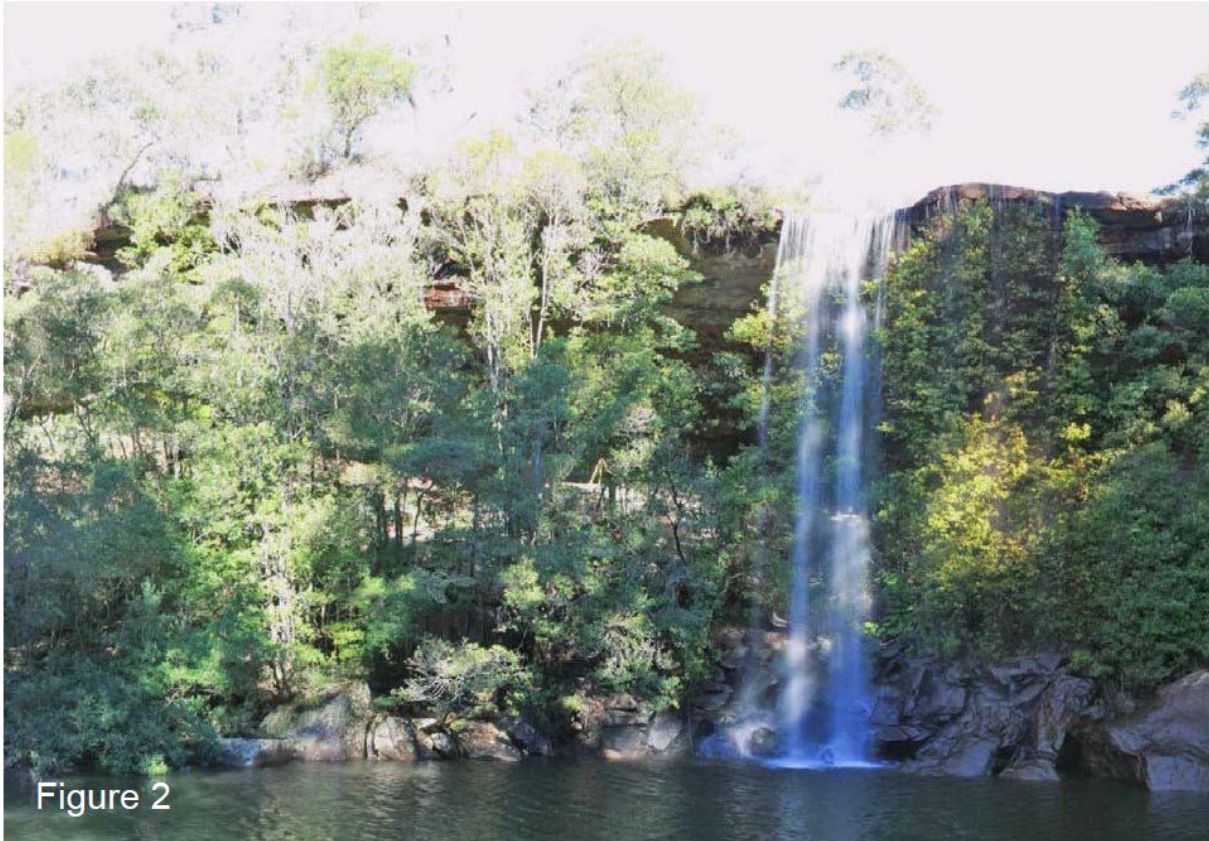
Figure 2 Photograph of Sandy Creek Waterfall

Sandy Creek Waterfall is located within the Metropolitan Special Catchment Area, at the point where Sandy Creek flows into Cordeaux Reservoir. The waterfall is a 25 m high concave cliff face with a maximum overhang of 20 m. Figure 1 shows the location of the waterfall in relation to the reservoir. Figure 2 and Figure 3 are images which capture the nature of the waterfall and the overhang.

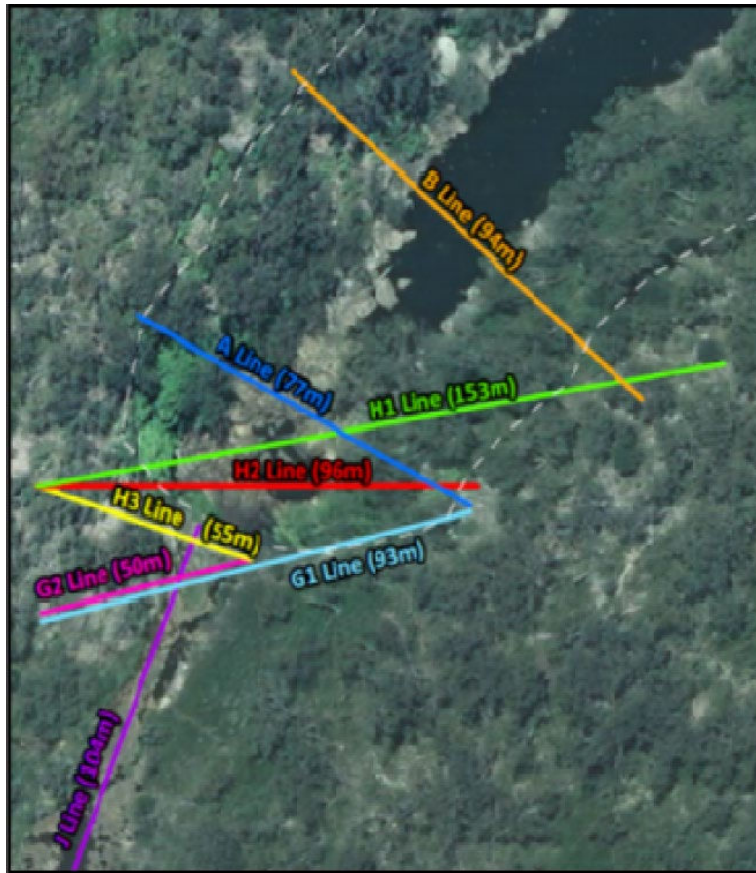
Figure 7 Sandy Creek Waterfall High Resolution Survey H1, H2, H3, G1, G2 and AA Lines

The valley closure effects across Sandy Creek Waterfall due to the mining of Longwalls 6 to 8 were measured using the Sandy Creek Waterfall High Resolution Survey (HRS) H1, H2, H3, G1, G2 and AA Lines. The locations of these monitoring lines are shown in Figure 7.
